2016 ANNUAL DAM AND DIKE INSPECTION REPORT

**West Boiler Slag Pond
&
Landfill Runoff Collection Pond**

**CLIFTY CREEK PLANT
Indiana-Kentucky Electric Corporation
MADISON, INDIANA**

**Dam & Dike Inspection Report
West Boiler Slag Pond &
Landfill Runoff Collection Pond**

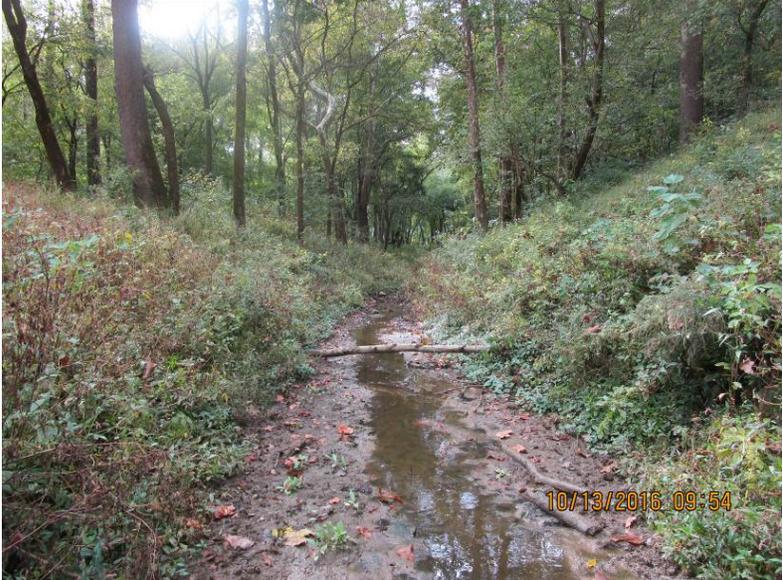
<p>Photo No. 15</p> <p>Fly Ash Pond Principal Spillway Outlet Channel Looking Downstream</p> <p>General Overview</p>
