2017 ANNUAL DAM AND DIKE INSPECTION REPORT

**West Boiler Slag Pond
&
Landfill Runoff Collection Pond**

**CLIFTY CREEK PLANT
Indiana-Kentucky Electric Corporation
MADISON, INDIANA**

GERS-17-043

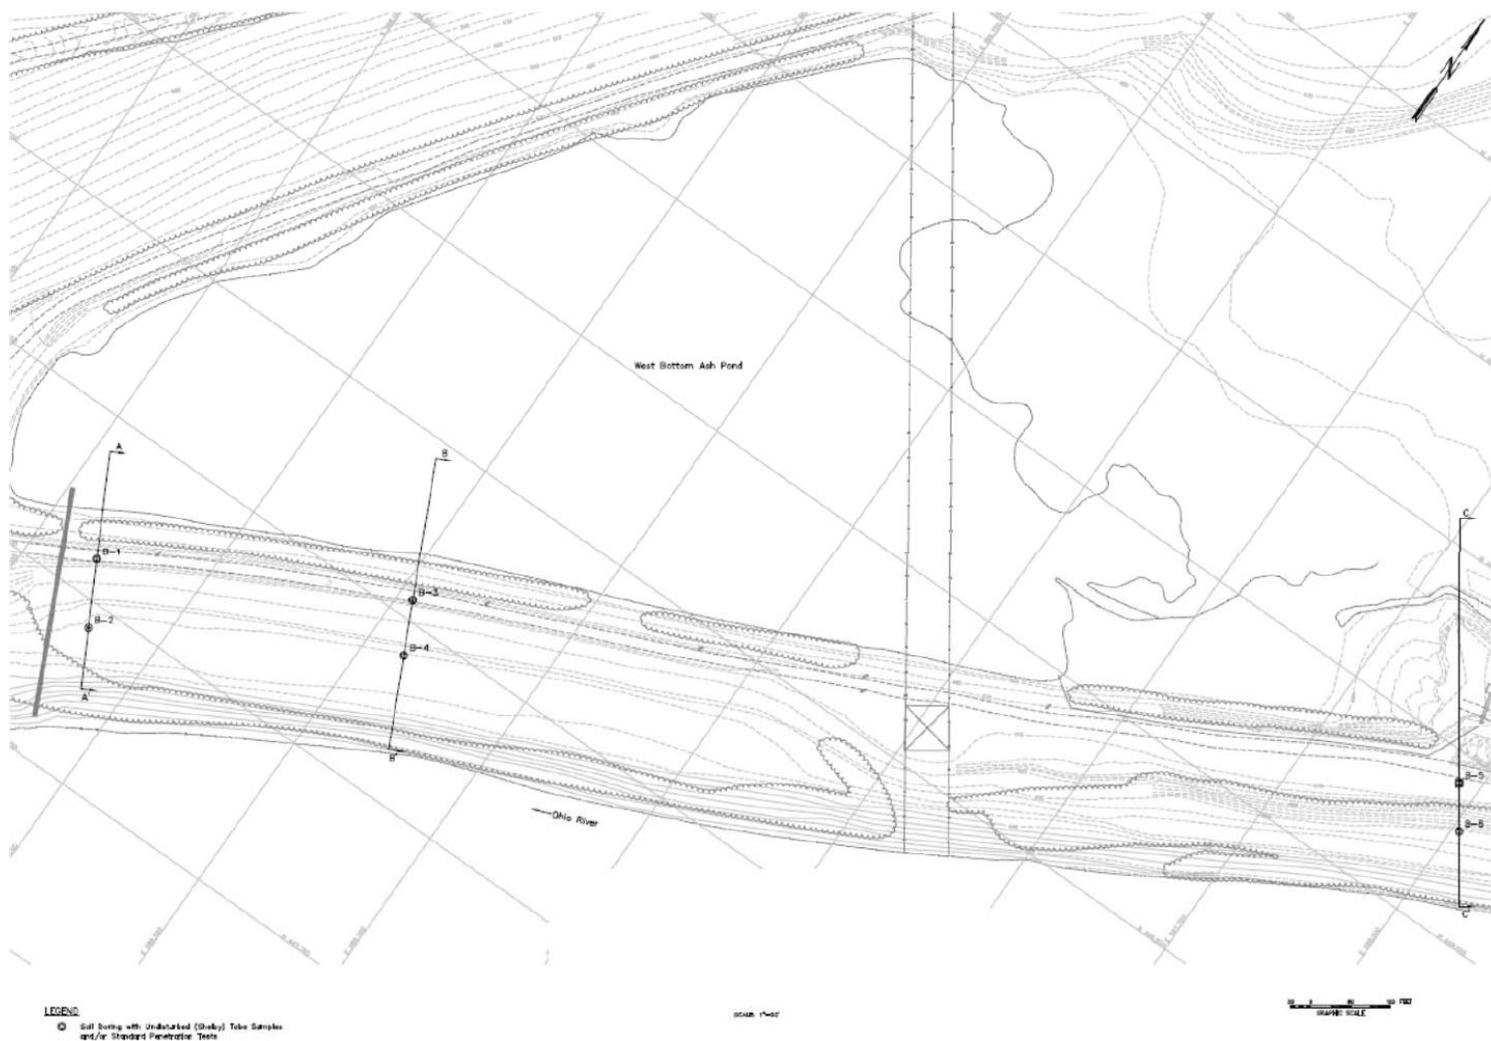
FIGURE 1. WEST BOILER SLAG POND INSTRUMENTS LOCATION PLAN

The location and type of instrumentation is shown on Figure 1. The results of the measurements of various piezometers since September 2015 are shown in Figure 2. The maximum recorded readings of each instrument since the previous annual inspection is shown in Table 1.

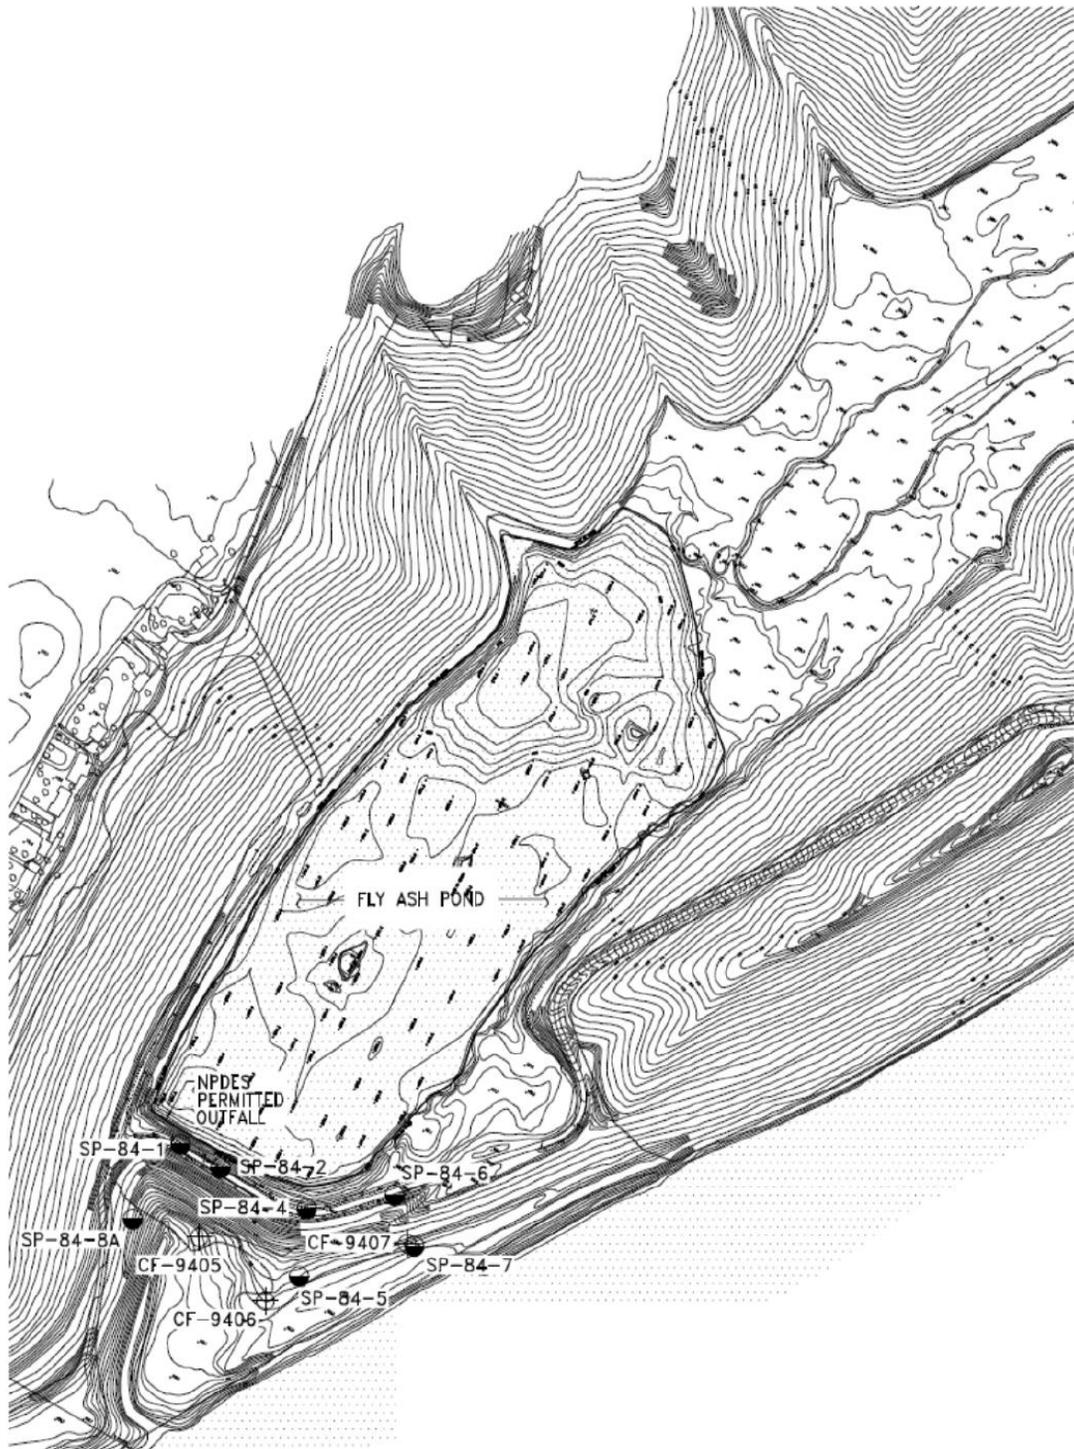
FIGURE 3. LANDFILL RUNOFF COLLECTION POND INSTRUMENTS LOCATION PLAN

The location and type of instrumentation is shown on Figure 3. The results of the measurements of various piezometers since September 2015 are shown in Figure 4. The maximum recorded readings of each instrument since the previous annual inspection is shown in Table 3 below.
