# 2019 ANNUAL DAM AND DIKE INSPECTION REPORT

**West Boiler Slag Pond  
& Landfill Runoff Collection Pond**

**CLIFTY CREEK PLANT  
Indiana-Kentucky Electric Corporation  
MADISON, INDIANA**

Document ID: GERS-22-003

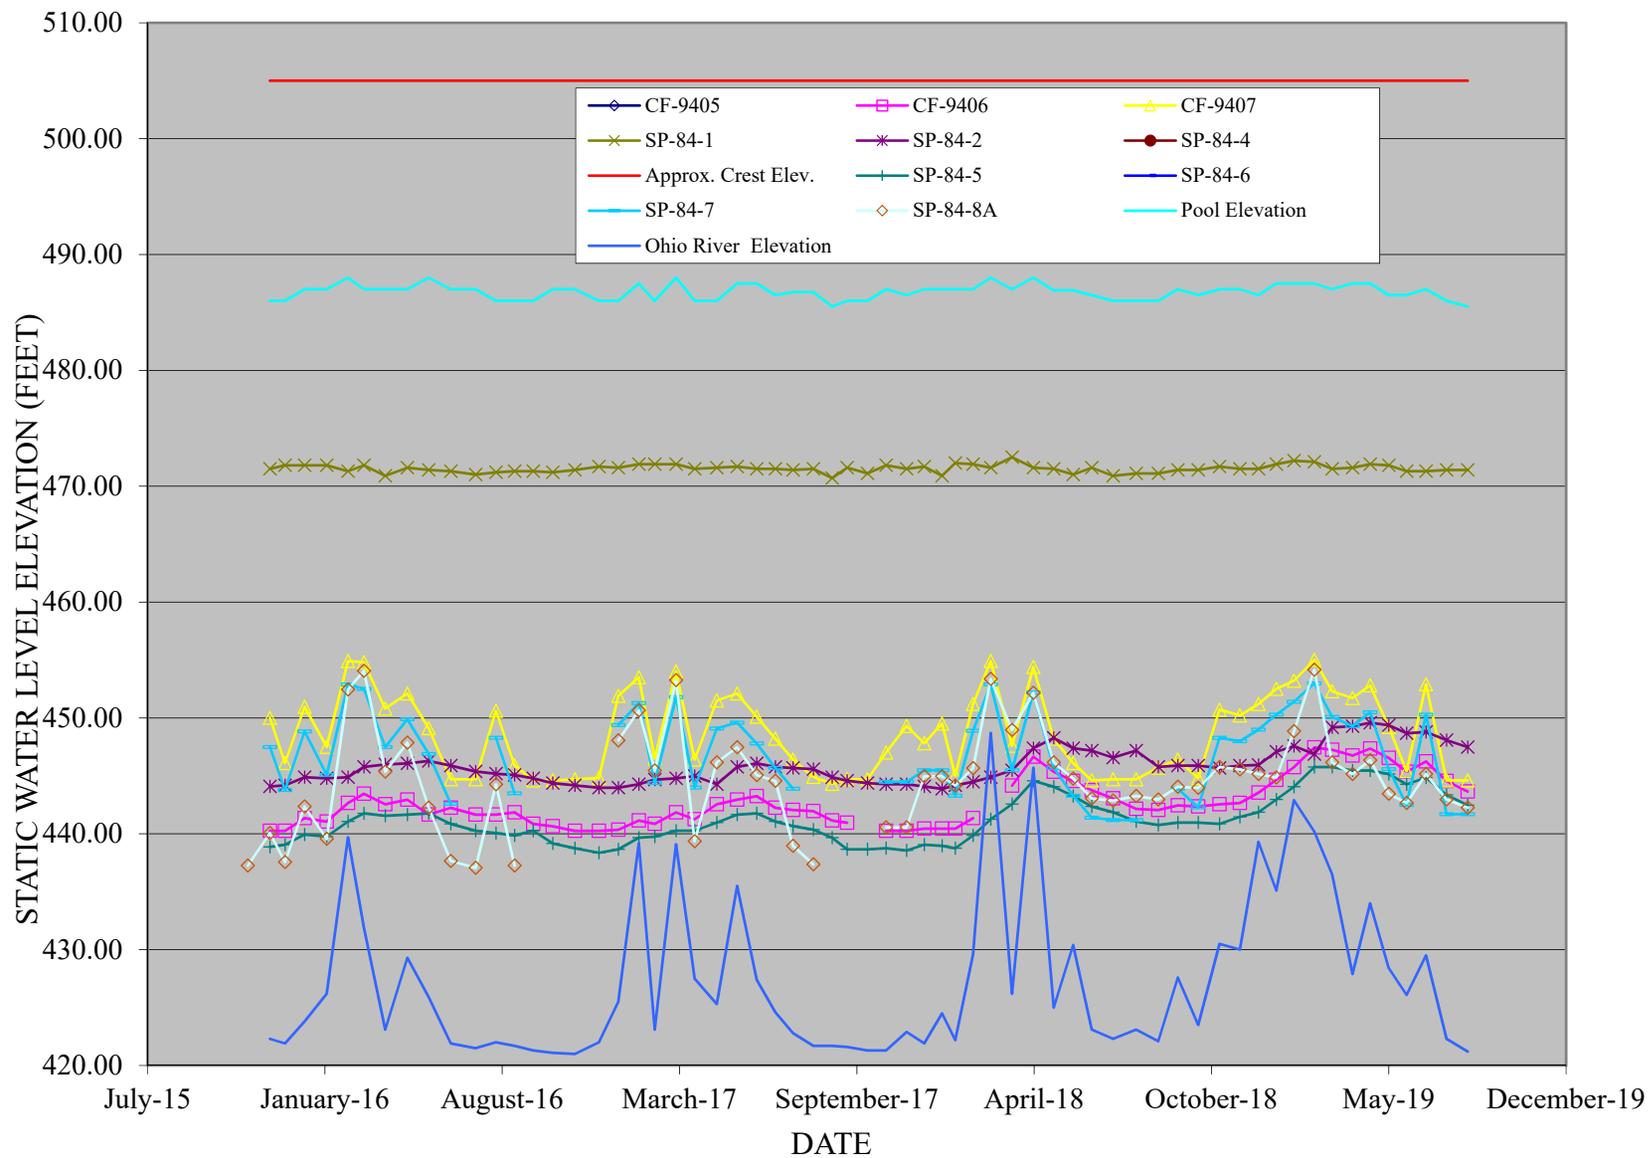
FIGURE 3. LANDFILL RUNOFF COLLECTION POND PIEZOMETERS LOCATION PLAN

The location and type of instrumentation is shown on Figure 3. The results of the measurements of various piezometers since November 2015 are shown in Figure 4. The maximum recorded readings of each instrument since the previous annual inspection is shown in Table 3 below.
