2018 Annual Dam and Dike Inspection Report

Kyger Creek Plant

Boiler Ash Pond Complex & South Fly Ash Pond

Document Number: GERS-18-045

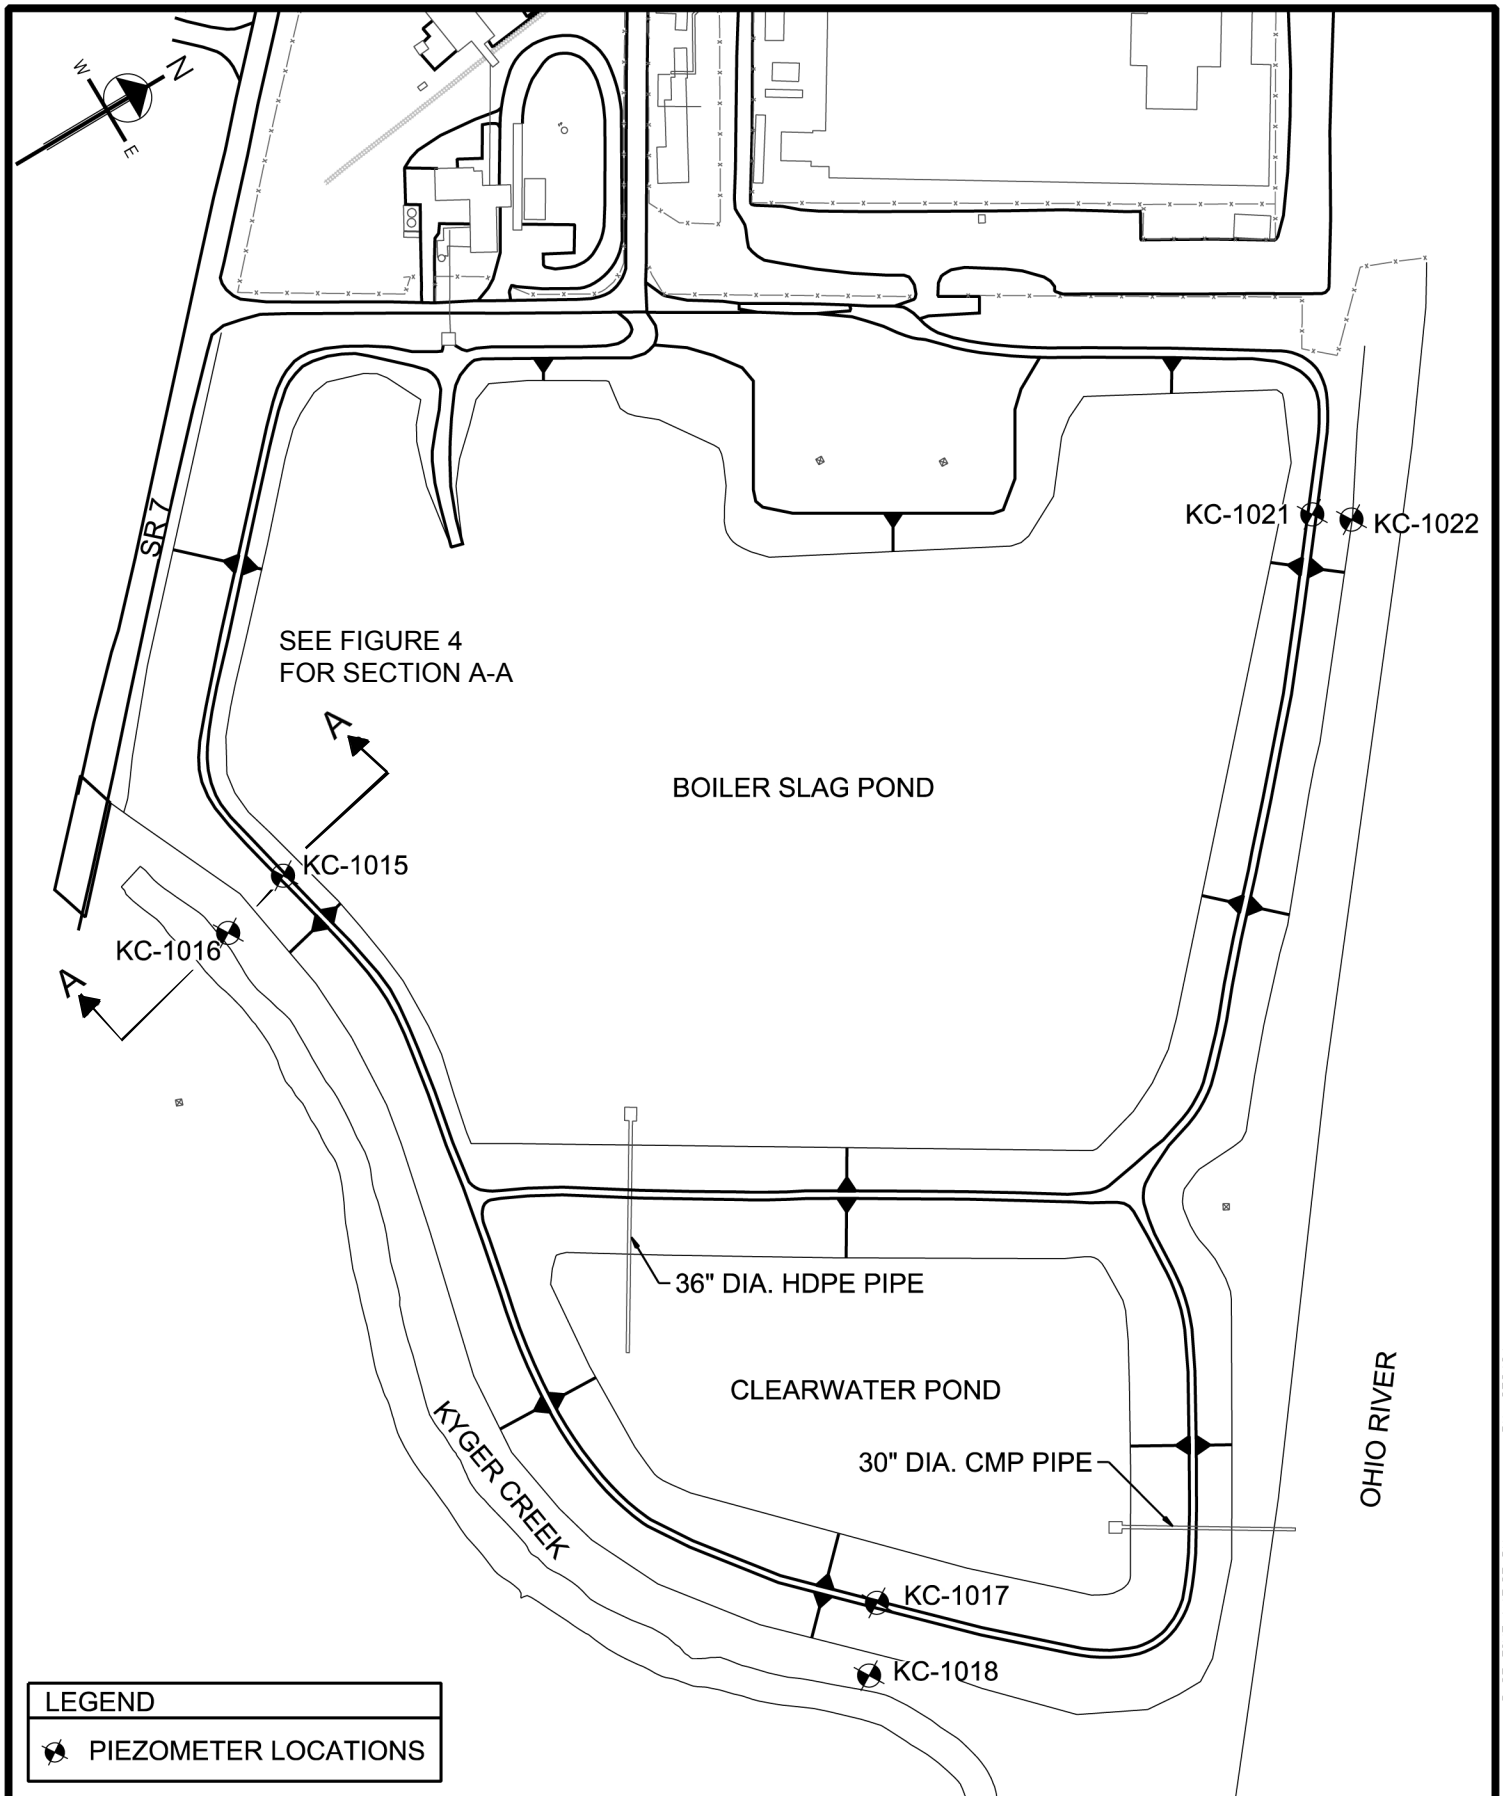
DRN BY:	KYGER CREEK POWER STATION	DWG NO: FIGURE 2
DATE:	SHEET 1 OF 1	 AEP SERVICE CORP. 1 RIVERSIDE PLAZA COLUMBUS, OH 43215
SCALE: 1"=250'	BOTTOM ASH POND COMPLEX

The location and type of instrumentation is shown on Figure 2. The maximum recorded readings of each instrument since the previous annual inspection is shown in Table 1.
