**Re: Ohio Valley Electric Corporation
Kyger Creek Station's 2018 Annual Landfill Inspection**

**Reference: 2018 CCR Rule Inspection
Annual Landfill Inspection
Kyger Creek Generating Station
Cheshire, Ohio**

**2018 CCR Rule Inspection
Kyger Creek Landfill**

Kyger Creek Generating Station
Cheshire, Ohio
Gallia County

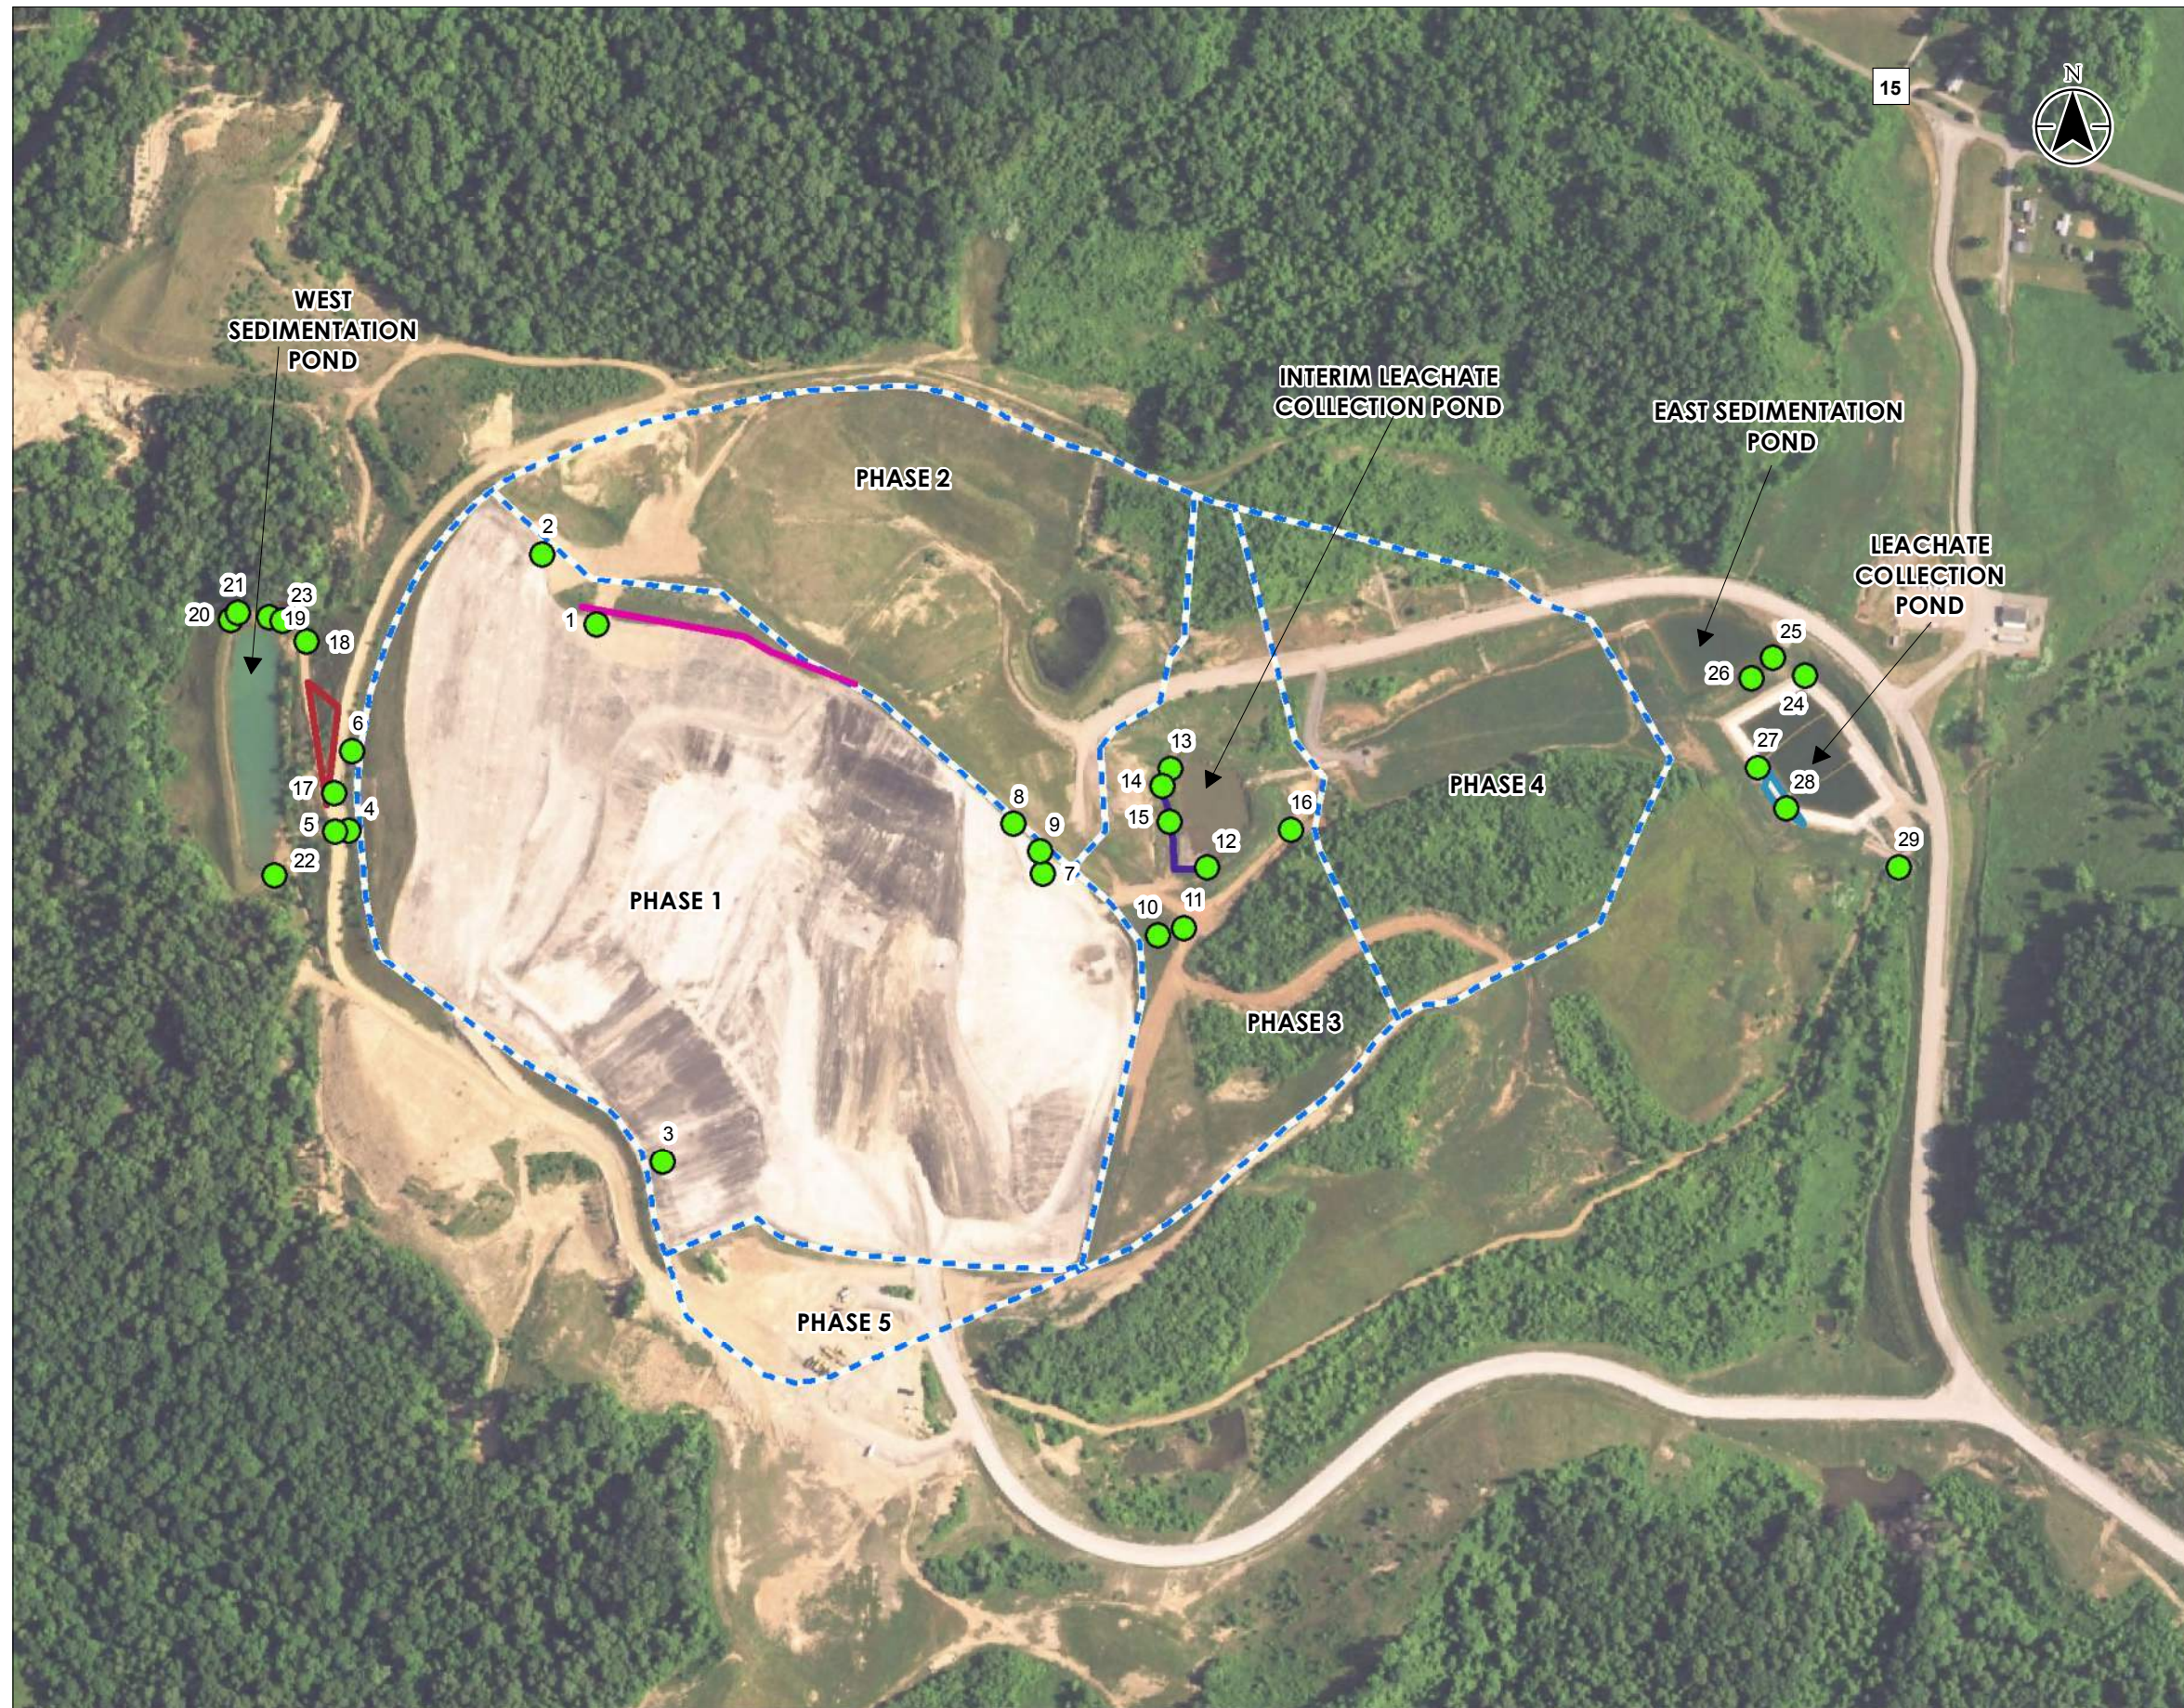
Figure No. **1**
 Title: **2018 Annual CCR Landfill Inspection**

- Temporary CCR within the landfill are being placed at a slope of approximately 2.7H:1V (horizontal to vertical) on the interior slopes at the southwestern edge of Phase 1 (Point 3, Appendix A), flattening to 7.1H:1V at the northwestern edge of Phase 1 (near Point 2, Appendix A; Photo 9, Appendix B). Signs of instability such as sloughs or slides were not noted.

- At the northern edge of the eastern Phase 1 face, an erosion hole and gully have formed near the transition from Phase 1 to Phase 2. The erosion hole is approximately four feet by two feet. Two points are noted for the top and toe of the gully (Points 8 and 9, Appendix A; Photos 15 and 16, Appendix B).

- Deep erosion gullies were noted on the western and southern interior slopes of the Interim Leachate Collection Pond. Gullies measured one to three feet wide with depths up to 2.5 feet (Points 12 through 15 (area denoted by the navy line), Appendix A; Photos 23 and 24, Appendix B). Taller vegetation obscures visual observation along the crest of the dike.

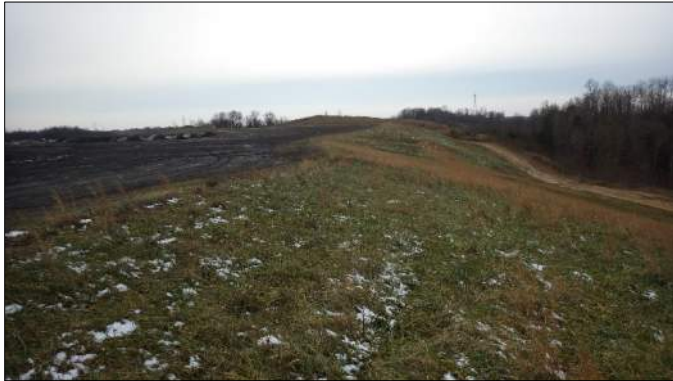
Photo 1

- The exterior temporary northern, western, and eastern slopes of Phase 1 are mowed sufficiently for a visual inspection, uniform, and vegetated (Photos 1 through 3, Appendix B).

Exterior temporary western slope of Phase 1, looking south. The entrance road to the West Sedimentation Pond is on the right.

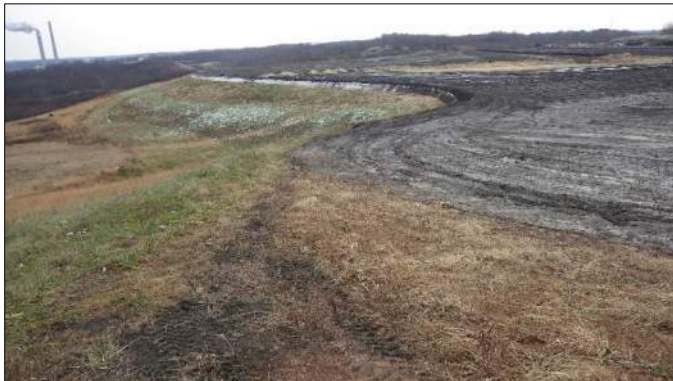
Photo 2

Exterior temporary northern slope of Phase 1, looking east. Phase 1/Phase 2 separation/transition berm is in the background.

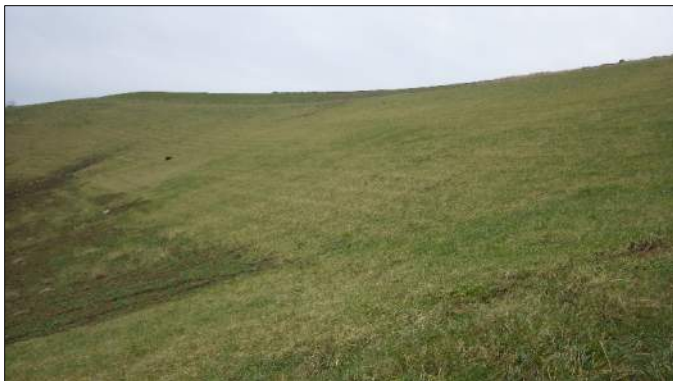
Photo 3

Phase 1 eastern temporary slope, looking southwest.

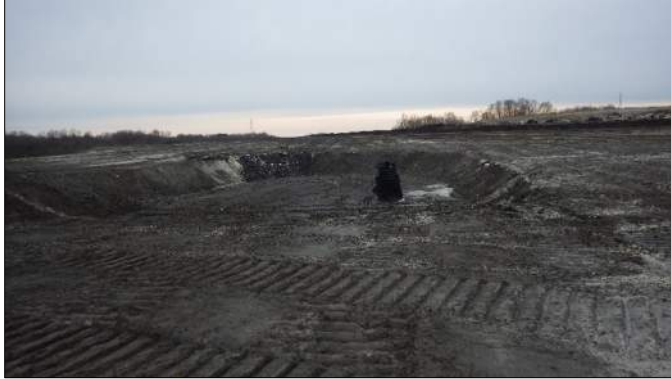
Photo 7

- Chimney drains were visible at regular intervals in the active cell. Most will need to be raised this spring as part of operations. (Photos 7 and 8, Appendix B).

A chimney drain in the Phase 1 footprint, looking south.

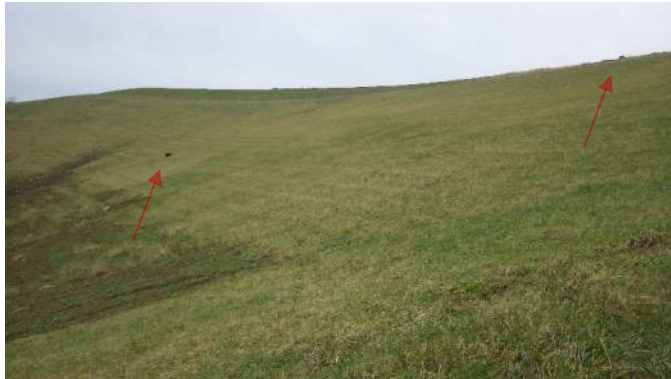
Photo 8

- The change of slope noted in the 2017 report on the northern section of the eastern Phase 1 face was not observed. The erosion control socks have been removed, and the vegetation looks uniform and maintained. No additional indicators of slope instability were observed (Photos 8 and 13, Appendix B).

Chimney drains in the Phase 1 footprint, looking south.
