2015 DAM & DIKE INSPECTION REPORT

GERS-15-020

**BOTTOM ASH COMPLEX
SOUTH FLY ASH POND**

**KYGER CREEK STATION
GALLIPOLIS, OHIO**

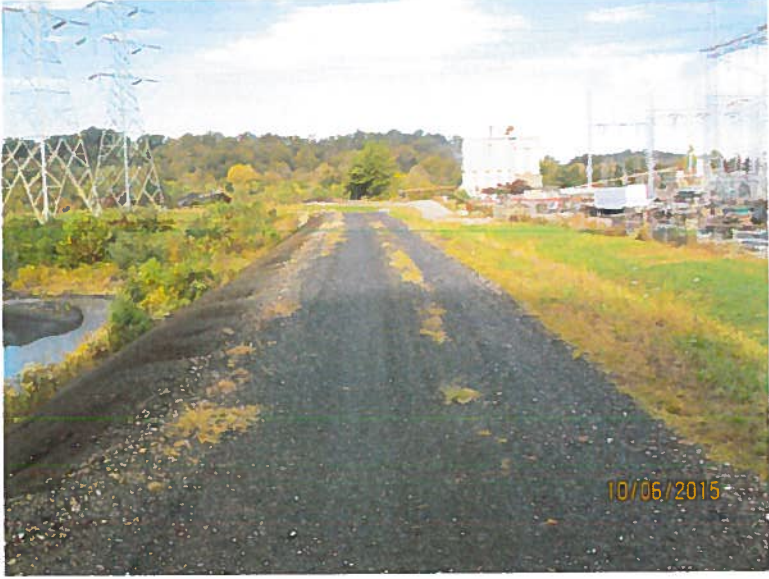
<p>A gravel path leads from the foreground towards a pond in the distance. The path is flanked by grass and some dry vegetation. In the background, there are power lines and a building. A date stamp '10/06/2015' is visible in the bottom right corner of the photo.</p>
<p>Photo # BAP- 02</p>

1. The crest of the bottom ash pond which is used for vehicular traffic for operations and maintenance activities appeared in good and stable condition with no significant settlement, misalignment, potholes, or noticeable sign of distress. There were newly drilled monitoring wells located in the crest in several locations. The wells were covered with a flushed mounted cap supported by concrete. In general the crest is in good condition. (See Photos BAP-01 to BAP-03)

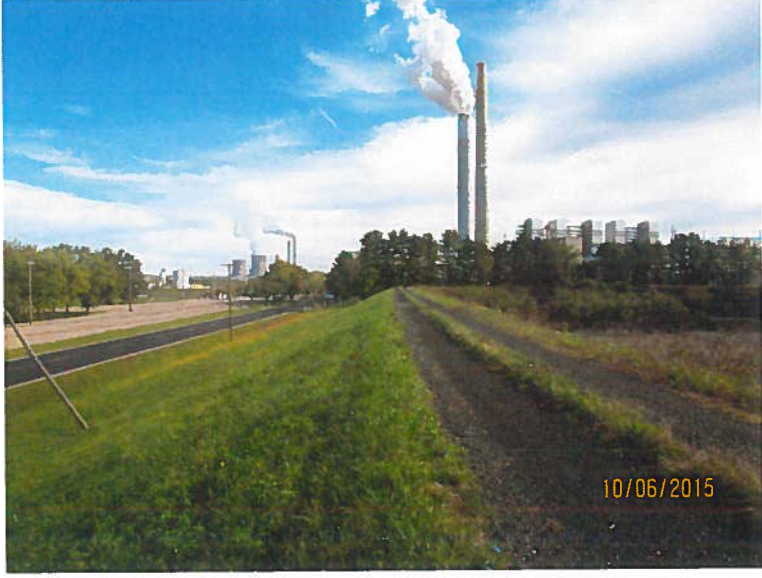
<p>A gravel path leads from the foreground towards a pond in the distance. The path is flanked by grass and some dry vegetation. In the background, there are power lines and a building. A date stamp '10/06/2015' is visible in the bottom right corner of the photo.</p>
<p>Photo # BAP- 03</p>

<p>Crest of Bottom Ash Pond</p>

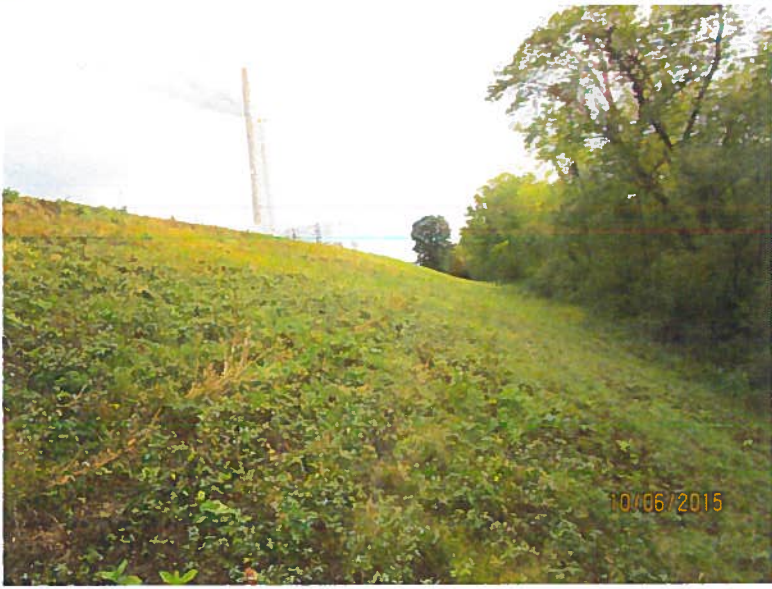
2. The outboard slope of the east dike adjacent to the Ohio River is generally in good condition. It is well vegetated and was recently mowed within the past 4 weeks. There were no signs of bulging or settlement. There were no seepage or wet areas observed. No animal activity was observed. There is an area on the south end of the dike that appeared to have rutting possibly from the recent drilling activities or mowing. (See Photos BAP-04 to BAP-05)

<p>A photograph showing a dirt embankment with several deep, parallel ruts running down its length. The ground is uneven and appears to have been driven on. In the background, there are trees and a utility structure. A date stamp '10/06/2015' is visible in the bottom right corner of the photo.</p>
<p>Rutting along East dike.</p>

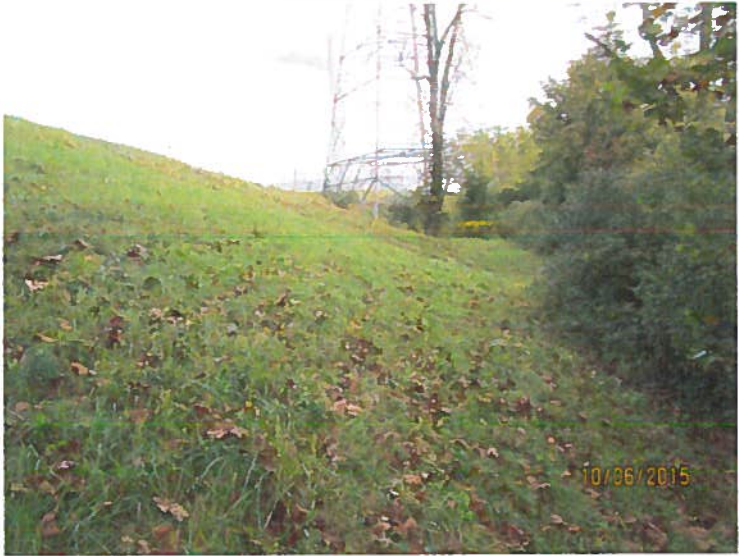
1. The outboard slope of the Clearwater Pond is in good and stable condition. The slopes have recently been mowed. There were no signs of animal activity, sloughs, bulges or settlement. The area near the outlet pipe showed no signs of instability. Some overgrown, matured trees were noticed near the toe of the slope of the east dike. (See Photo BAP-14 to BAP-15)

<p>Outboard slope of east dike of the Clearwater Pond. A few mature trees were observed.</p>	
<p>Photo # BAP- 15</p>

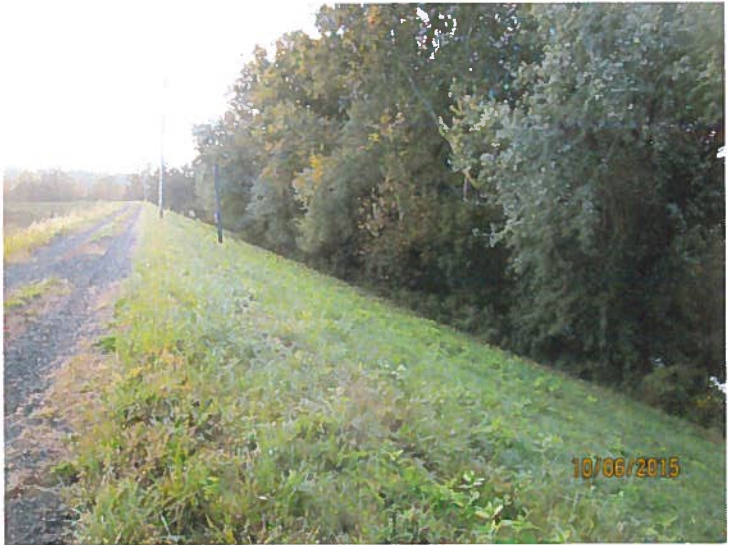
<p>Typical view of the outboard slope of the Clearwater pond.</p>

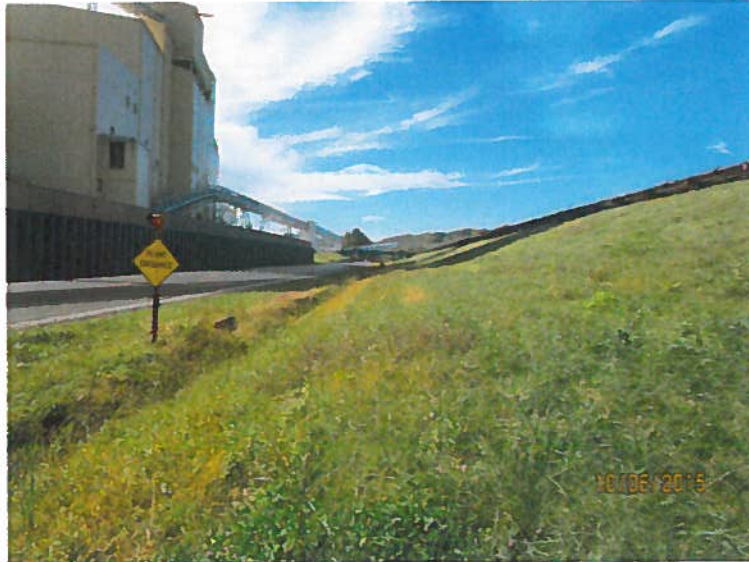
Photo # FAP- 08

Typical view of seepage repair along east dike

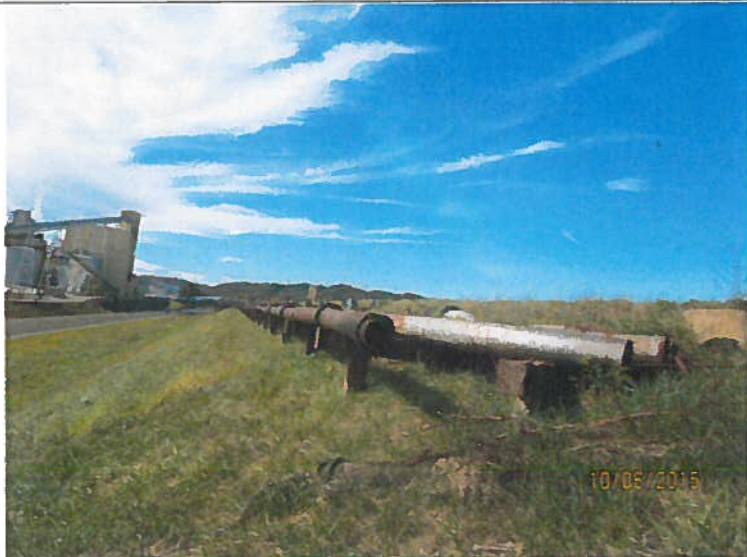
<p>Photo # FAP- 10</p> <p>Piping and support along crest of east dike</p>

5. The piping and supports located along the top of the east dike appear to be in good condition and there does not appear to be any settlement or movement of these structures. (See Photo FAP-10)

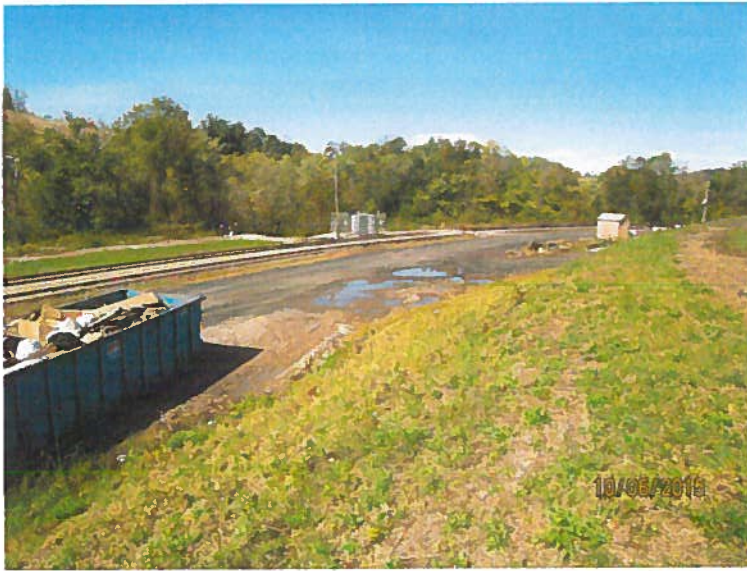
<p>A photograph showing a long, dark, cylindrical pipe supported by wooden posts along the crest of a grassy dike. In the background, there are industrial structures and a clear blue sky with some clouds. A date stamp '10/06/2015' is visible in the bottom right corner of the image.</p>
<p>Photo # FAP- 11</p> <p>Outboard slope of south dike with standing water along toe.</p>

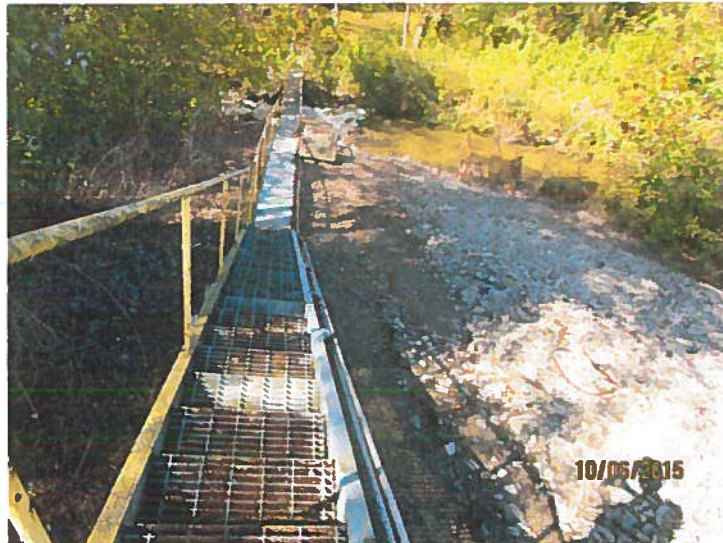
Photo # FAP- 21

Seepage located beyond
the toe of the southeast
corner of the pond
