2022 Annual Dam and Dike Inspection Report

**Bottom Ash Pond Complex
South Fly Ash Pond**

**Kyger Creek Plant
Ohio Valley Electric Corporation (OVEC)
Gallia County, Ohio**

Document Number: GERS-22-030

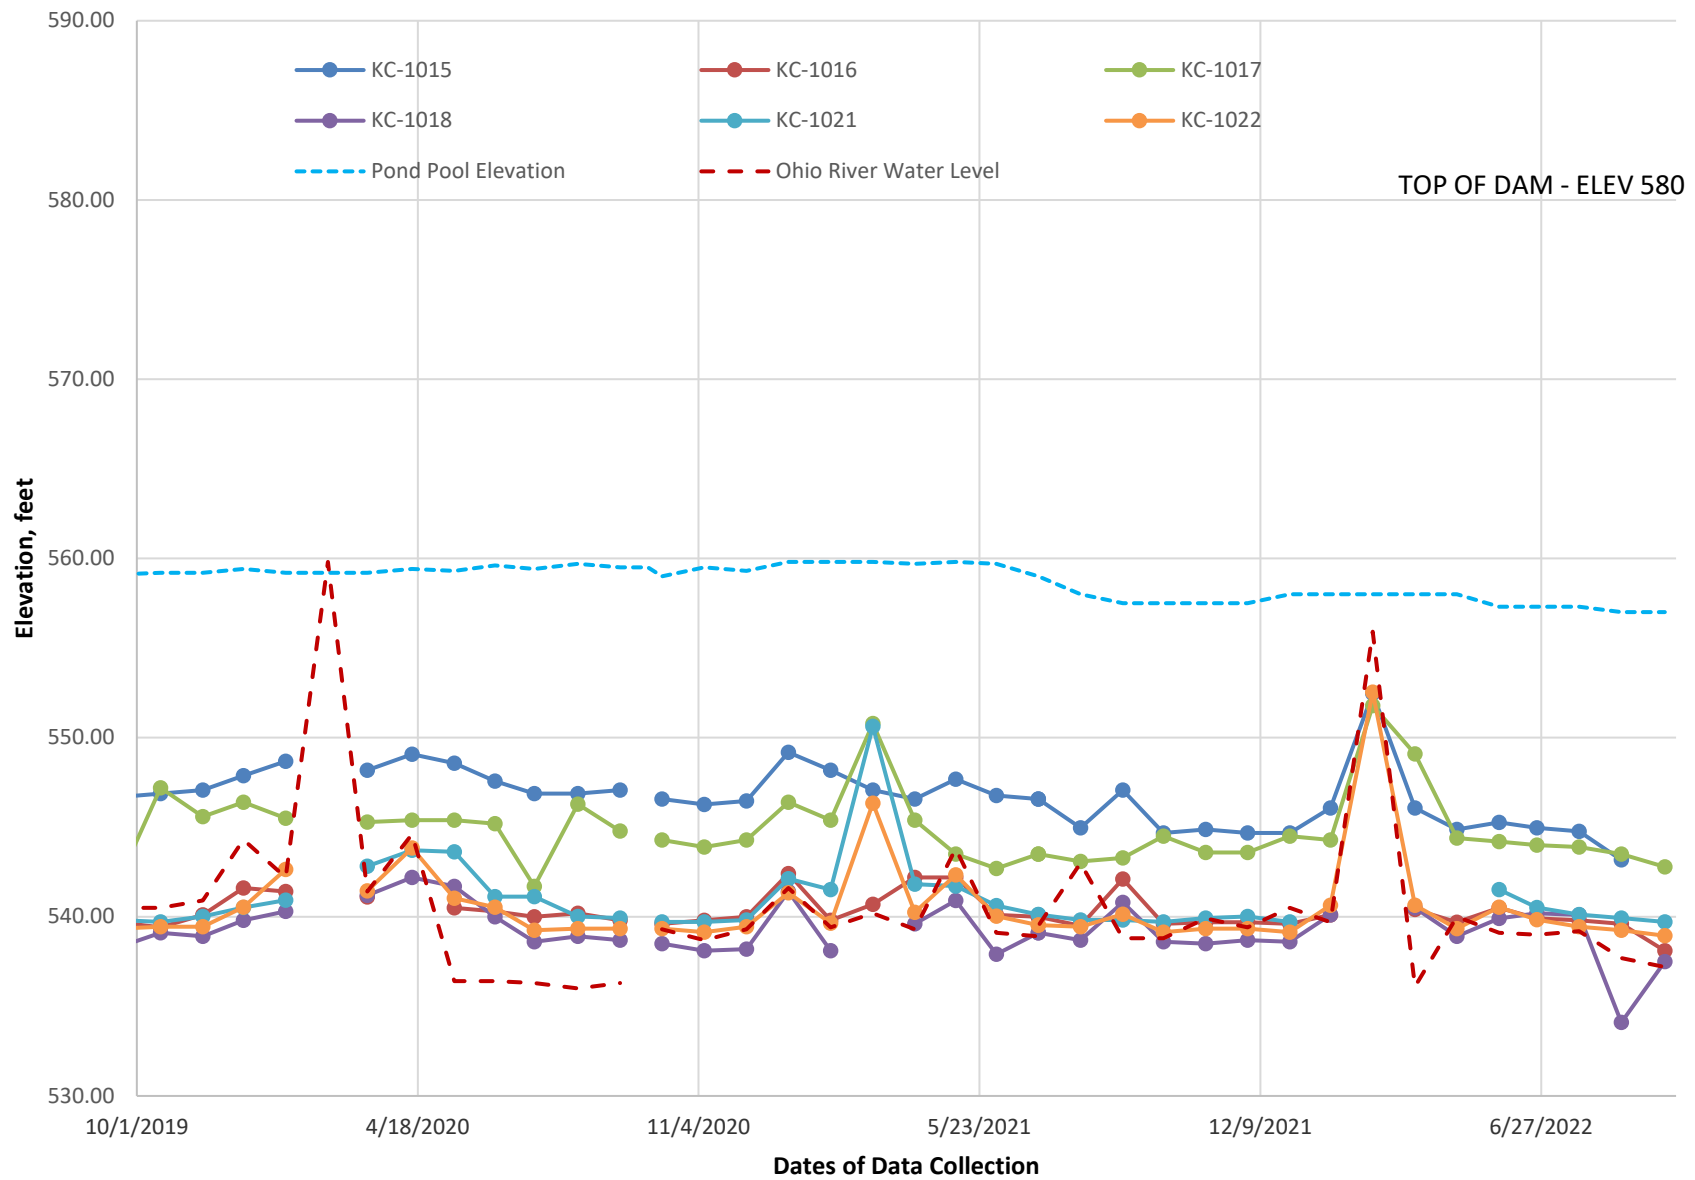
Figure 3 - Bottom Ash Pond Piezometer Data.

Piezometers are the only instrumentation installed in the Bottom Ash Pond Complex. The locations of the piezometers are shown on Figure 1. The maximum recorded readings of each piezometer since the previous annual inspection is shown in Table 1. The range of the piezometer levels during the past year are consistent with the historical range. The piezometers are influenced by high water levels in the Ohio River. The maximum recorded levels for piezometers noted below with (*) coincide with elevated river conditions. Comments on the summary sheet of the readings also indicate flooding/icing that prevented readings in February for piezometers KC - 1016/1018/1021. The piezometer data and pond levels are shown on Figure 3.

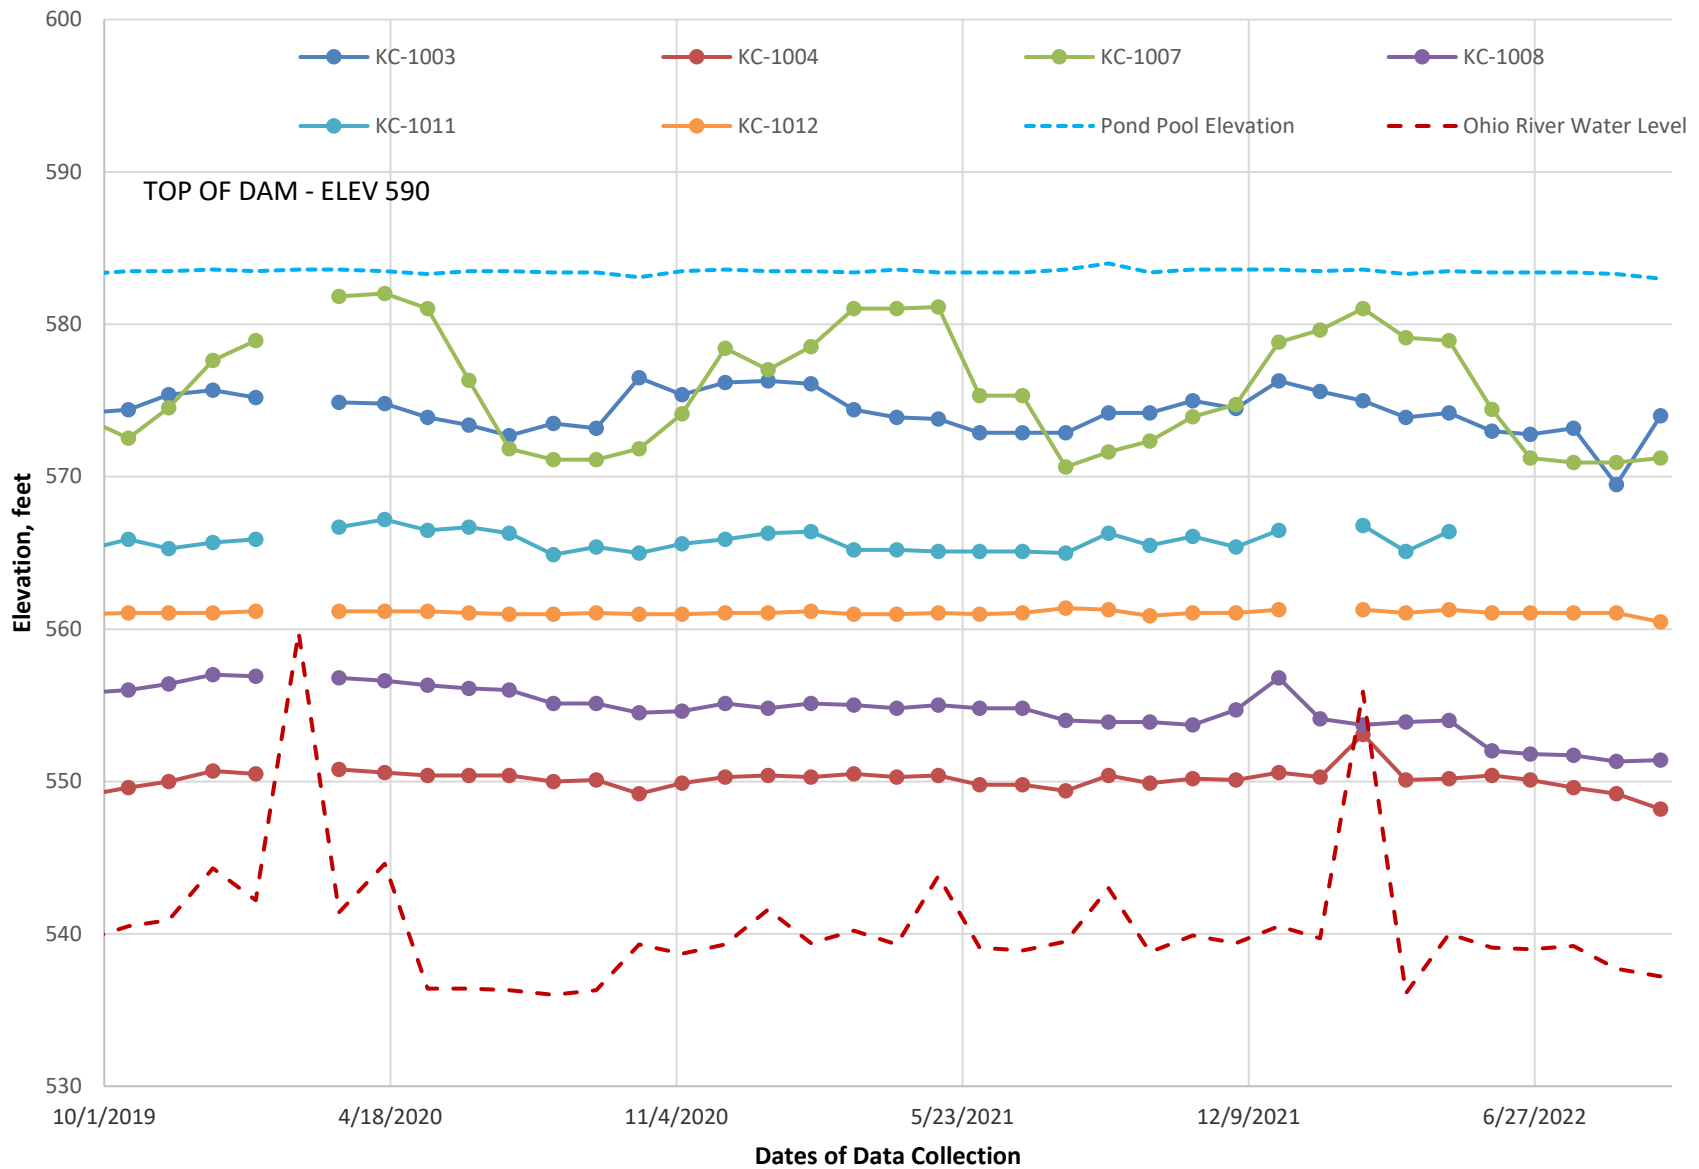
Figure 4 - South Flyash Pond Piezometer Data.

Piezometers are the only instrumentation installed in the South Fly Ash Pond. The locations of the piezometers are shown on Figure 2. The maximum recorded readings of each piezometer since the previous annual inspection is shown in Table 3. The range of the piezometer levels during the past year are consistent with the historical range. The piezometers are influenced by high water levels in the Ohio River. The piezometer data and pond levels are shown on Figure 4.
