**2023 CCR Rule – Surface Impoundments  
Kyger Creek Dam/Dike Inspections**

Kyger Creek Generating Station  
Cheshire, Ohio  
Gallia County

January 19, 2024

Stantec Consulting Services Inc.  
Cincinnati, Ohio

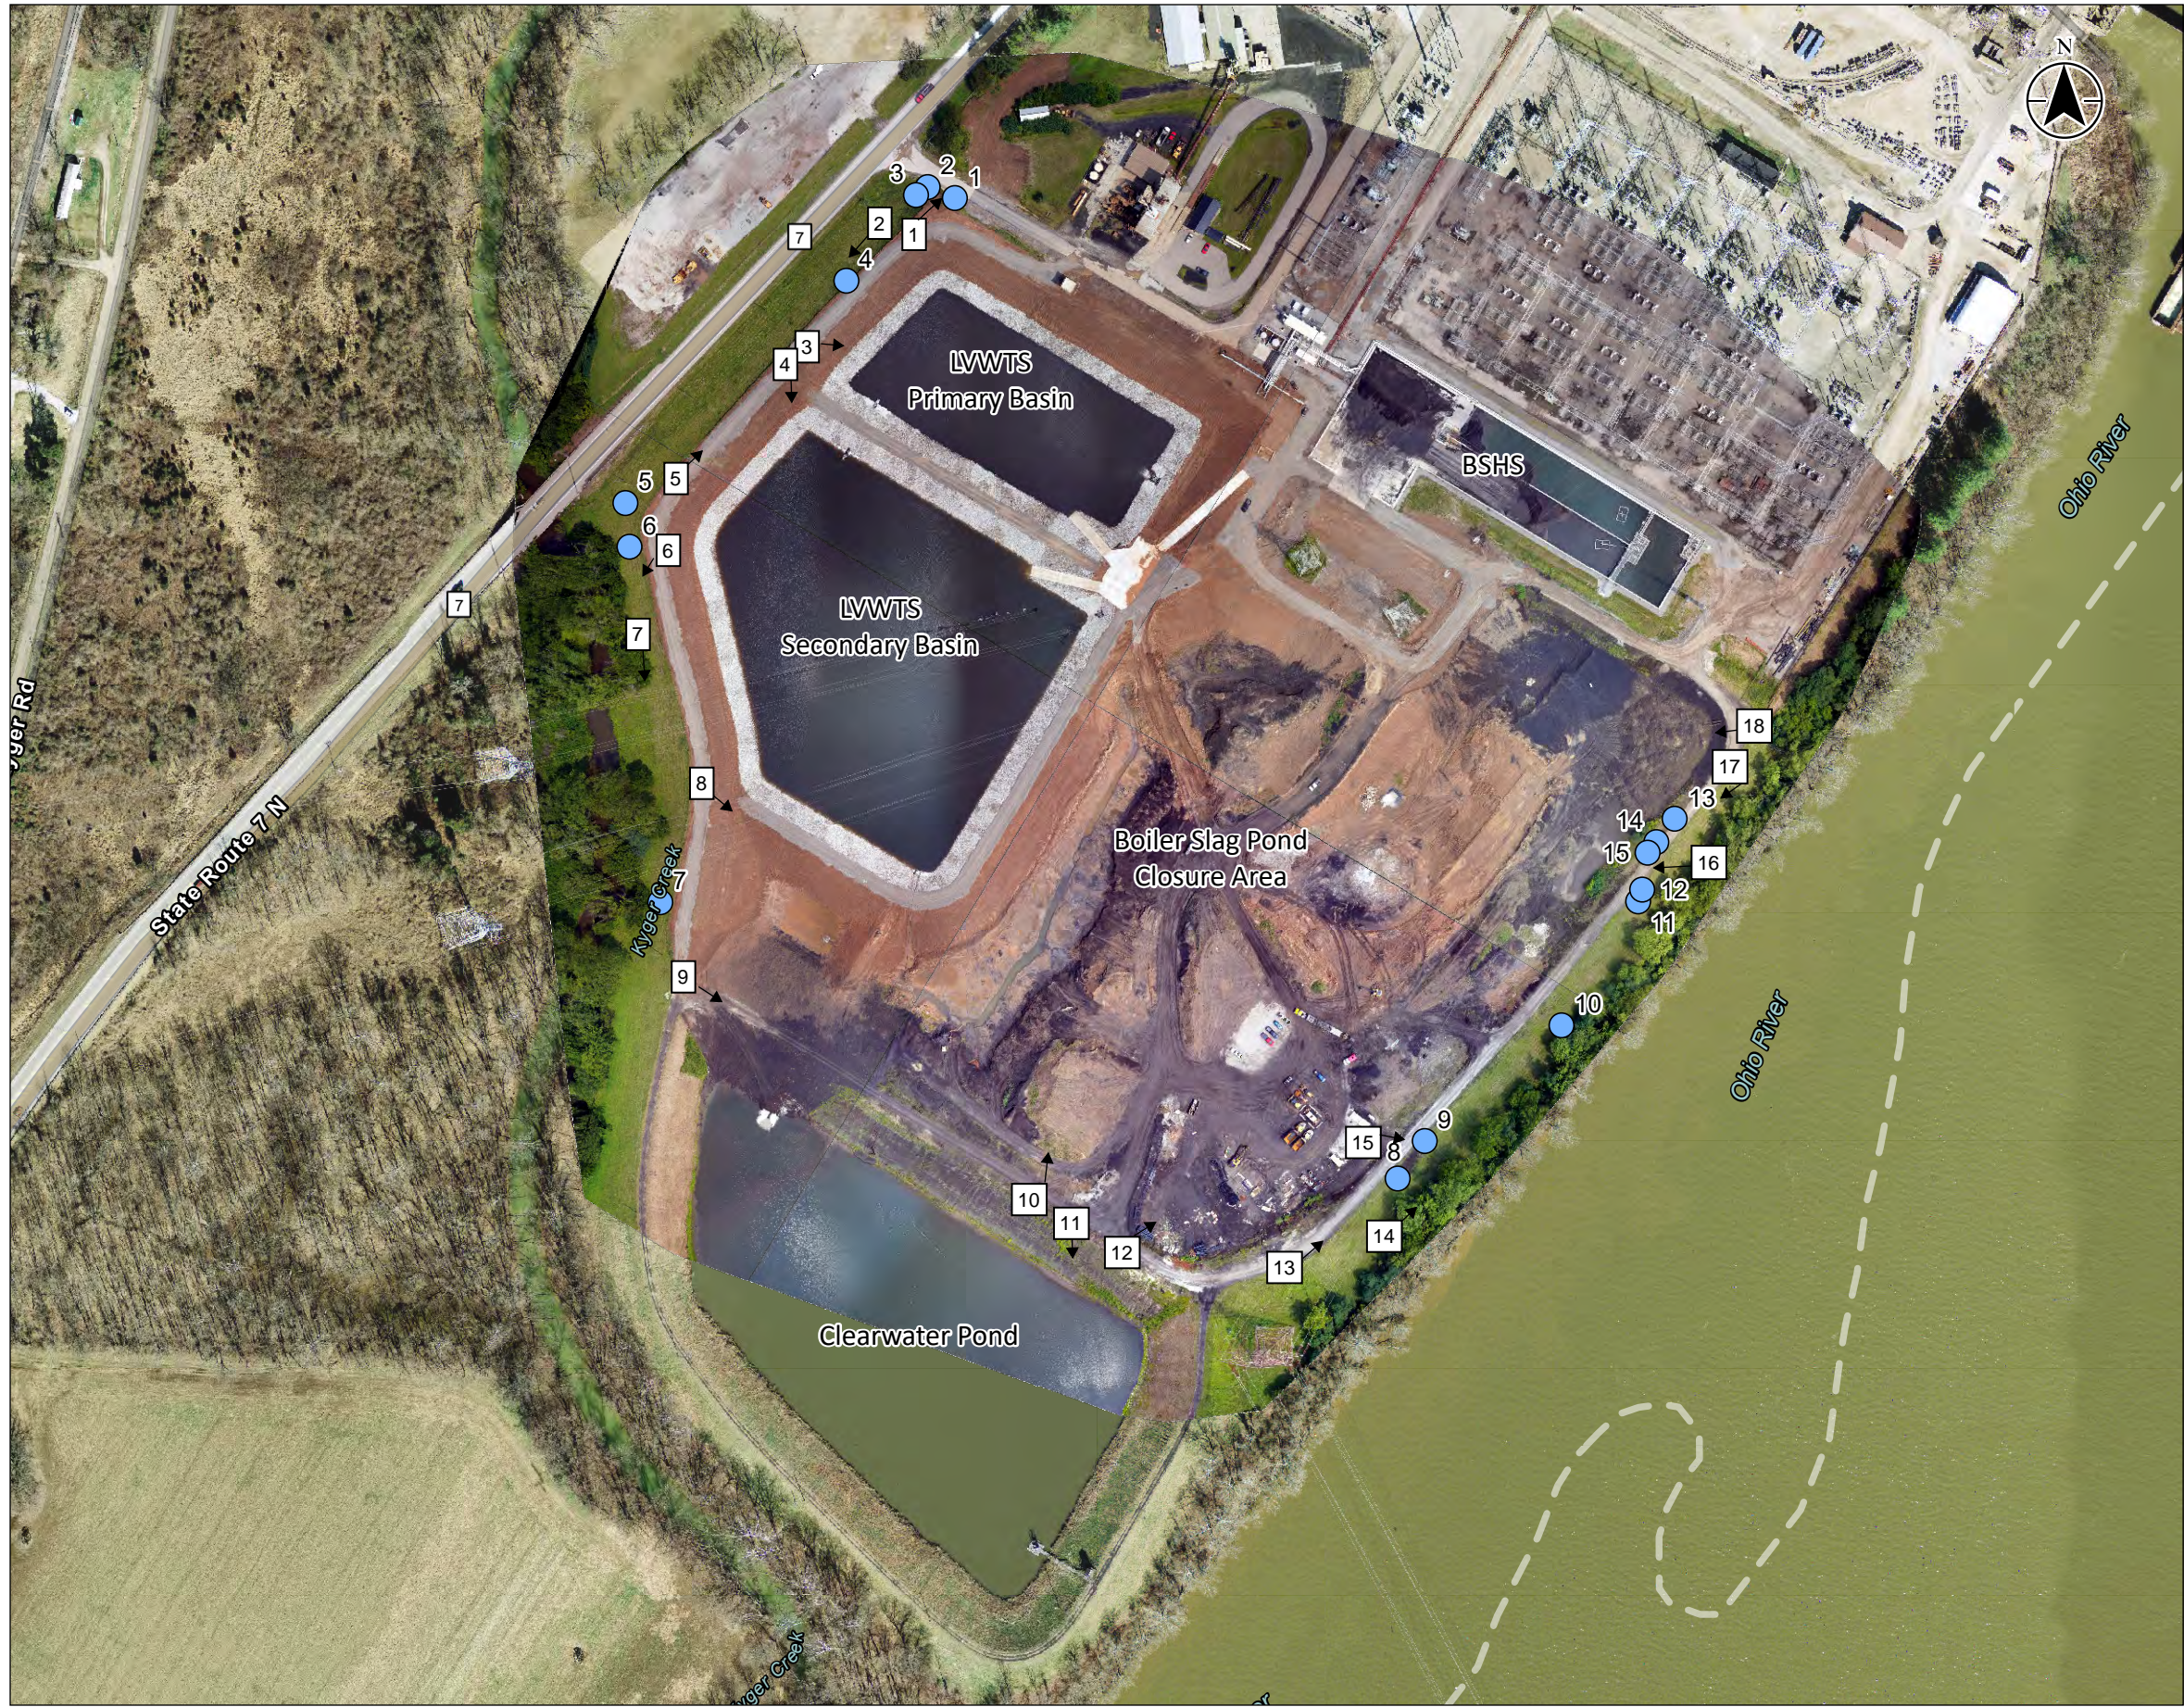
Figure No.  
**2**

The visual inspection began with observations of the perimeter embankment and splitter dike. In general, the upstream and downstream embankment slopes appear to be in good condition. The northwest corner has woody vegetation and stumps on the exterior slope (Photograph 1, Points 1 through 3). The interior slopes around the LVWTS are newly vegetated with grass visible. Erosion rills are noted, particularly where the material changes from the road surfacing to the grassy slopes (Photographs 5 and 6, Points 5 through 7; Photographs 15 and 16). Vegetation is thin in a few areas. A potentially wet spot (Point 9) was noted

on the slope near Kyger Creek. CCR and a bare area noted on the southern slope near the roadway (Points 10 and 11). The toe of the interior slope was excavated in the northeast corner near the historic sluice lines (Photograph 18, Points 13 and 14).

No flows were noted during the site visit into the boiler slag pond closure area. Piping for the LVWTS was noted. The outlet structure for the Clearwater Pond was observed (Photograph 11). Pounded water was limited to an area at the toe of the LVWTS within the boiler slag pond closure area (Photograph 10). A pump and hose were present at the southern end.

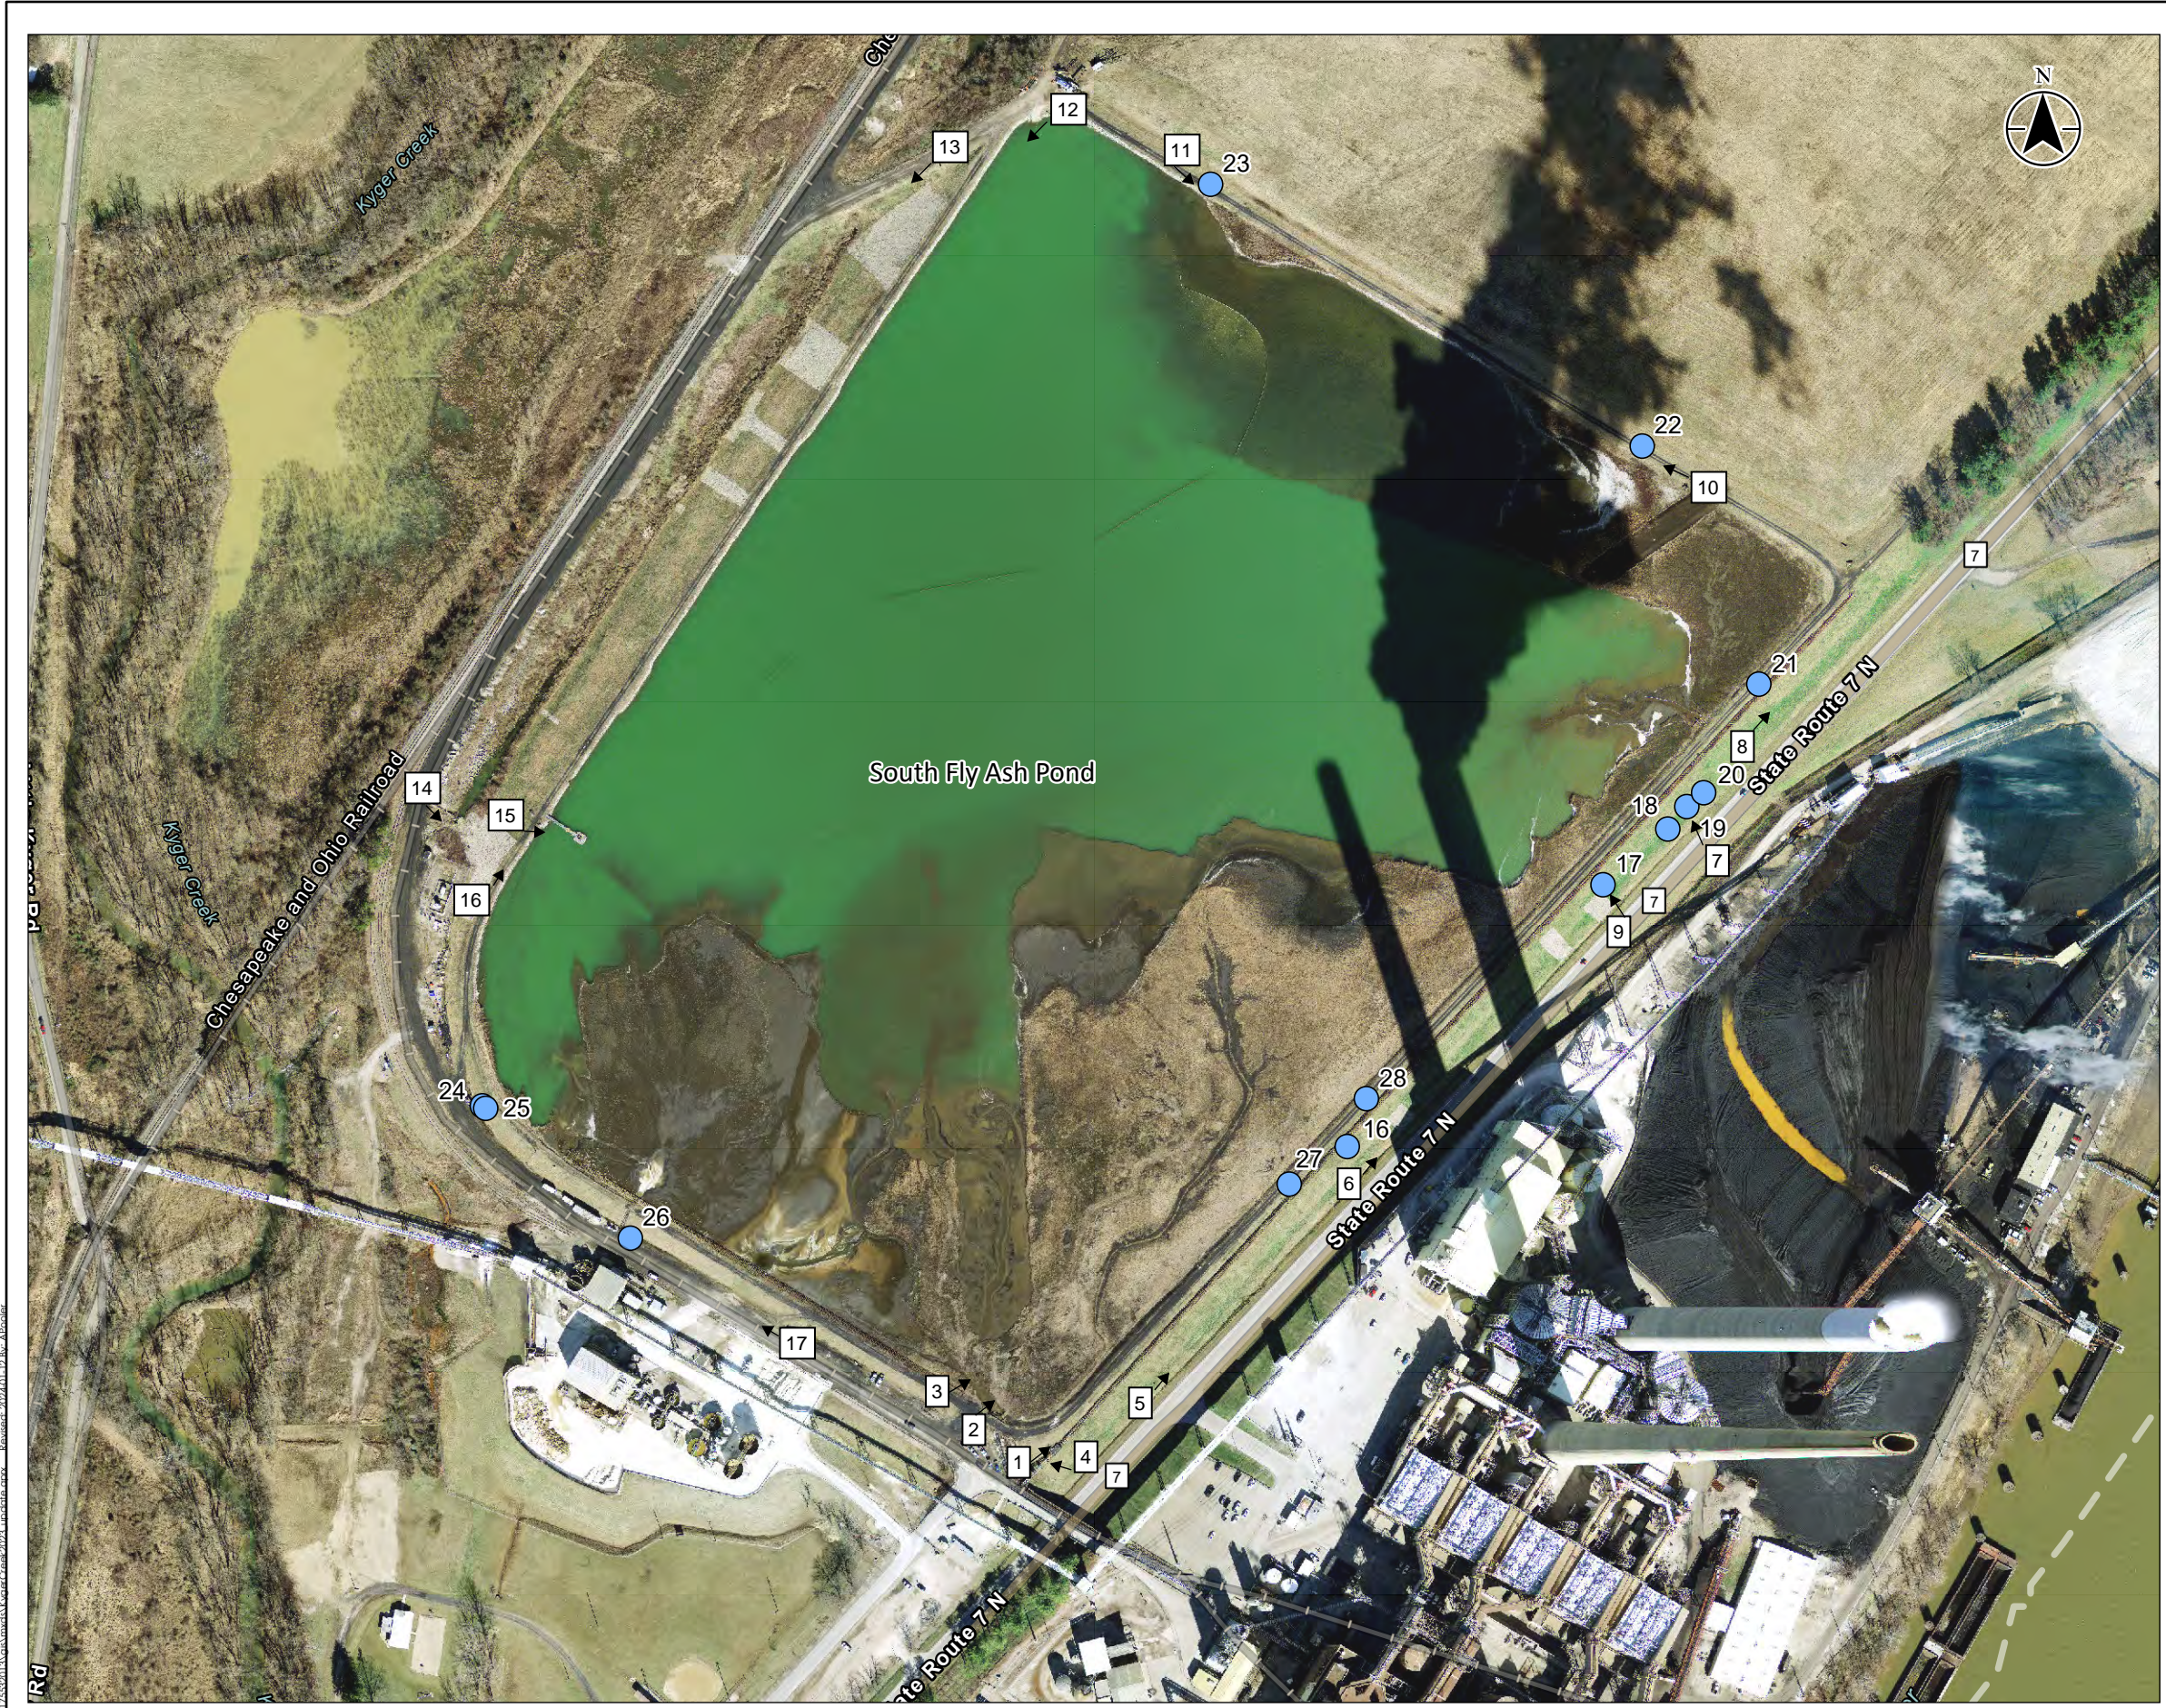
Client/Project: Ohio Valley Electric Corporation, South Fly Ash Pond

Observations began with the upstream and downstream embankment slopes. In general, the downstream slopes appear to be in good condition with established, mowed grass and limited woody vegetation. Historic sluice lines are located along the southern and eastern dikes. The recently constructed LVWTS piping is visible entering the southeastern corner of the SFAP embankment dike (Photograph 1). An area of new vegetation was noted (Photograph 8; Points 20 and 21), suggesting the crossing location of the piping to the coal pile runoff pond. The new piping is not visible at this location.
