**Re: Indiana-Kentucky Electric Corporation  
Clifty Creek Station's 2025 Annual CCR Landfill  
Inspection Posting Notification**

**2025 CCR Rule – Landfill  
Clifty Creek Landfill Inspection**

Clifty Creek Generating Station  
Madison, Indiana  
Jefferson County

January 19, 2026

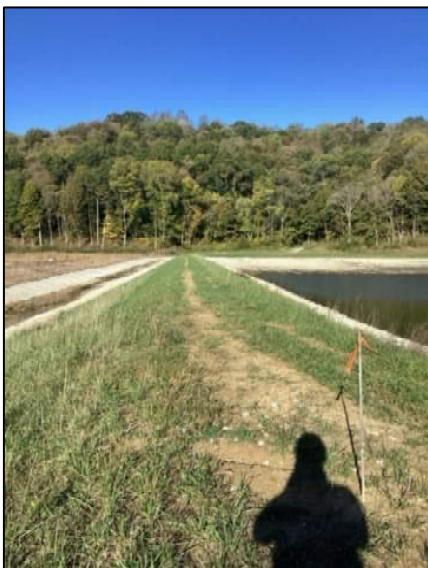
**Photo 2, Point 2**

- Areas of bare earth are present on the south slope, west slope, northeast corner, and east slope of the Southwest Sediment Basin (Points 2, 6, 10, 17, and 20, Appendix A; Photos 2, 6, 10, 17, and 20, Appendix B).

Southwest Sediment Basin – Bare spots along dike.

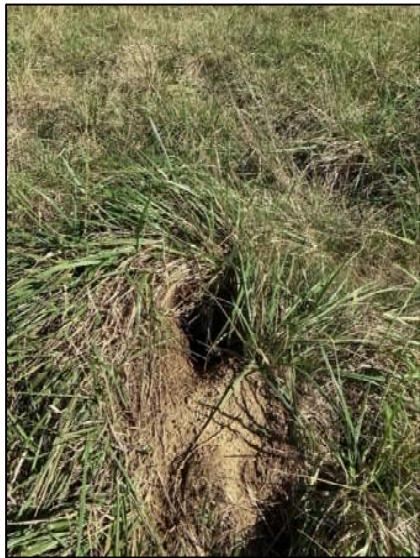
- A hole is present on the north slope of the Southwest Sediment Basin (Point 16, Appendix A; Photo 16, Appendix B).
- Erosion rills present on the north slope of the Southwest Sediment Basin (Point 18, Appendix A; Photo 18, Appendix B).

**Photo 16, Point 16**  
Southwest Sediment Basin – Hole near slope.

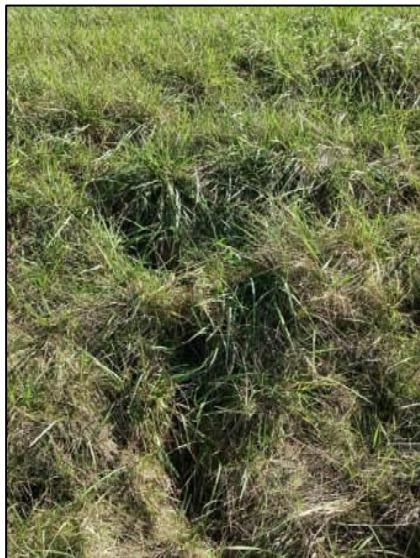
**Photo 18, Point 18**  
Southwest Sediment Basin – Erosion rills on slope.

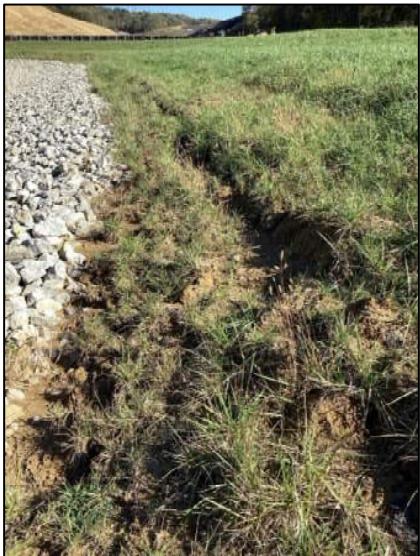
**Photo 19, Point 19**  
Southwest Sediment Basin – Sloughing on inside slope.

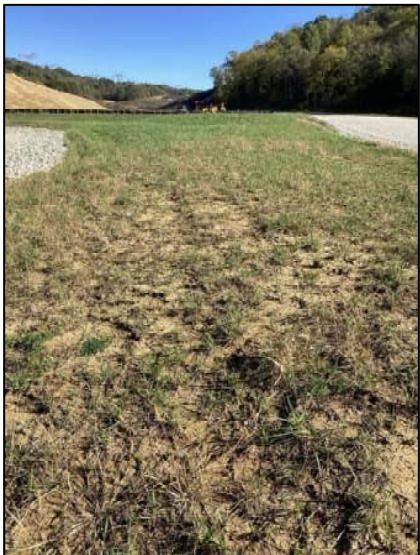
**Photo 20, Point 20**  
Southwest Sediment Basin – Bare spot.

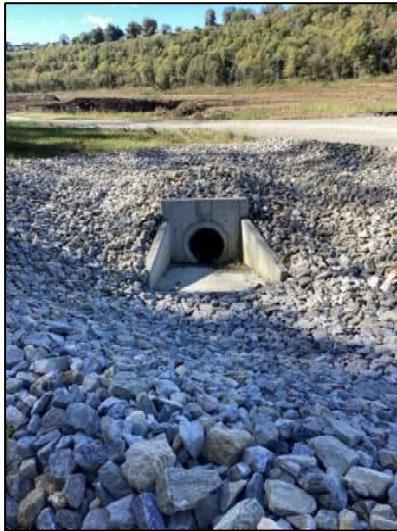
- The headwall from stormwater channel located east of the Southwest Leachate Pond connects to a pipe outlet to the lined stormwater channel. No obstructions or hinderances to flow were observed (Point 25, Appendix A; Photo 25, Appendix B).

**Photo 25, Point 25**  
Stormwater channel inlet headwall  
adjacent to Southwest Leachate Pond.

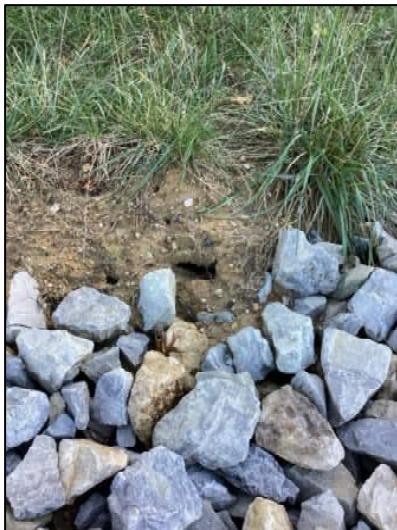
- A series of small holes are present on the east slope of stormwater channel located east of the Southwest Leachate Pond (Point 26, Appendix A; Photo 26, Appendix B).

**Photo 26, Point 26**  
Small holes on inside slope of stormwater  
channel.

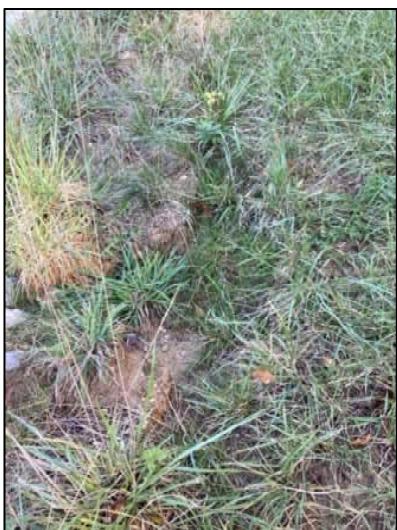
- A small depression, approximately 6 inches in depth, is present on the east slope of stormwater channel located east of the Southwest Leachate Pond (Point 27, Appendix A; Photo 27, Appendix B).

**Photo 27, Point 27**  
Depression (6 in. deep max.) on slope of  
stormwater channel.

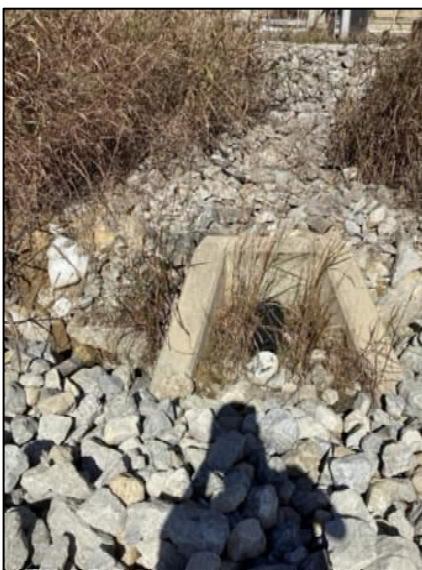
- Small holes are present on the north slope of the Northeast Sedimentation Basin (Point 38, Appendix A; Photo 38, Appendix B).
- The headwall adjacent to the truck wash appears to be obstructed by riprap and vegetation. (Point 39, Appendix A; Photo 39, Appendix B).

**Photo 39, Point 39**  
Northeast Sedimentation Basin –  
Headwall adjacent to truck washing station  
appears to be blocked.

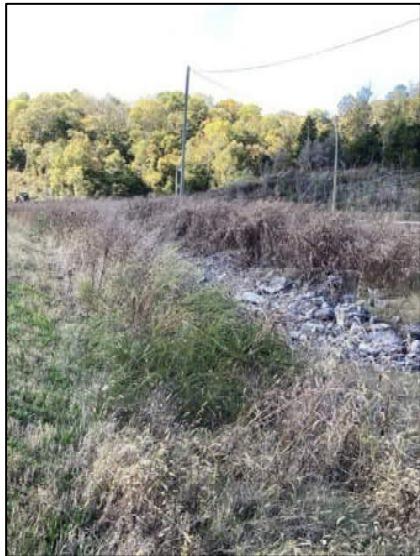
**Photo 40, Point 40**

Northeast Sedimentation Basin -  
Vegetation in stormwater channel.

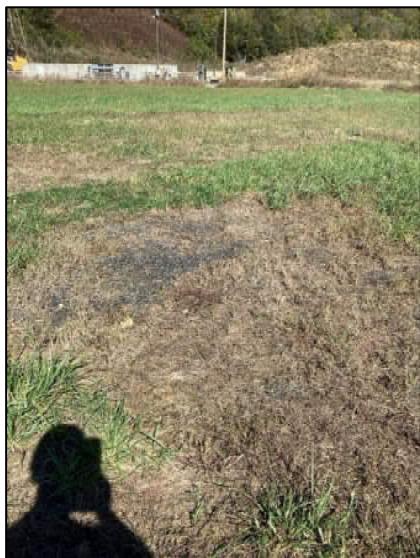
**Photo 42, Point 42**

- Areas of standing water, bare earth, and exposed CCR materials were observed west of the Northeast Sedimentation Basin (Points 41 and 42, Appendix A; Photos 41 and 42, Appendix B).

Bare spot with exposed CCR in area  
northwest of Northeast Sedimentation  
Basin.

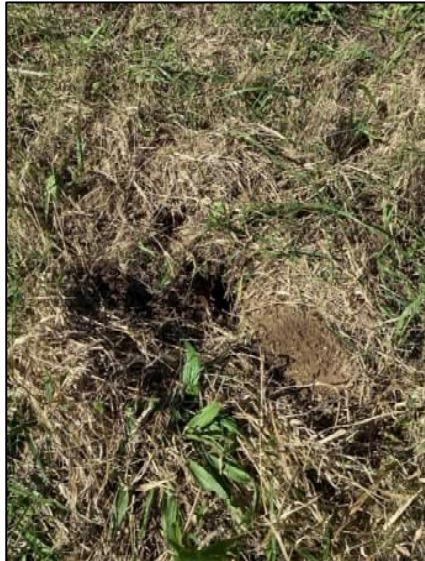
- Concrete debris was found on the southeast slope of the temporary cover of Phase 1 (Point 47, Appendix A; Photo 47 Appendix B).
- Holes were identified at several locations in the temporary cover of Phase 1 (Points 49, 56, and 61, Appendix A; Photos 49, 56, and 61, Appendix B).

**Photo 49, Point 49**  
Phase 1 – Hole on southeast slope temporary cover.

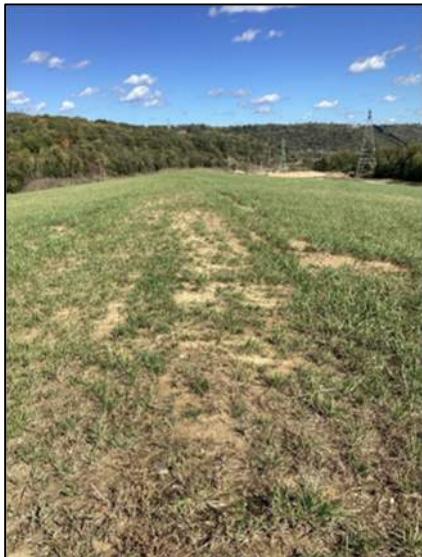
**Photo 53, Point 53**  
Phase 1 – Bare spot on crest temporary cover.

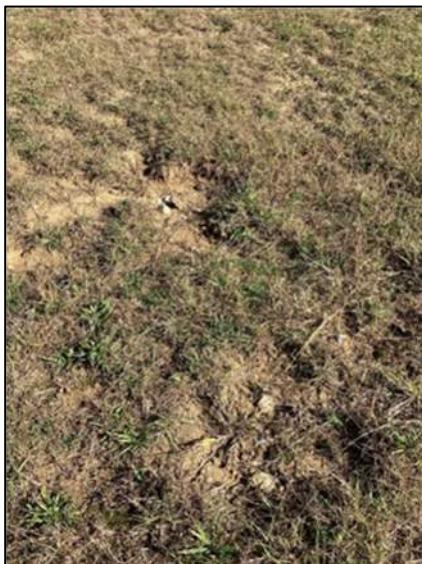
- Active CCR placement was observed on the southwest side of Phase 1 landfill (Point 54, Appendix A; Photo 54 Appendix B).
- Surficial erosion rills, rutting, and depressions were noted in the temporary cover of Phase 1 (Points 57 through 59, Appendix A; Photos 57 through 59, Appendix B).

**Photo 57, Point 57**  
Phase 1 – Rutting (6 in. deep max.) on northwest slope temporary cover.

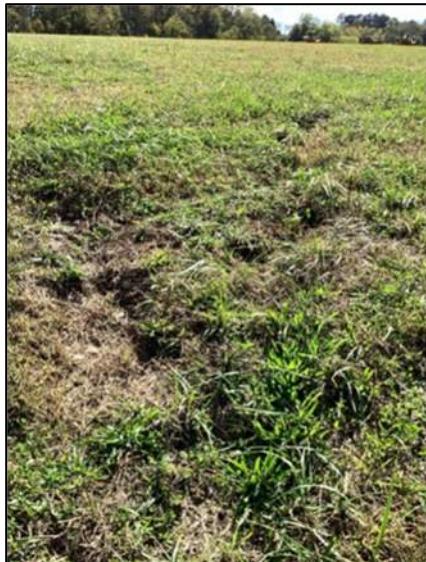
**Photo 59, Point 59**

Phase 1 – Erosion rills (6 in. - 12 in) on northwest slope temporary cover.

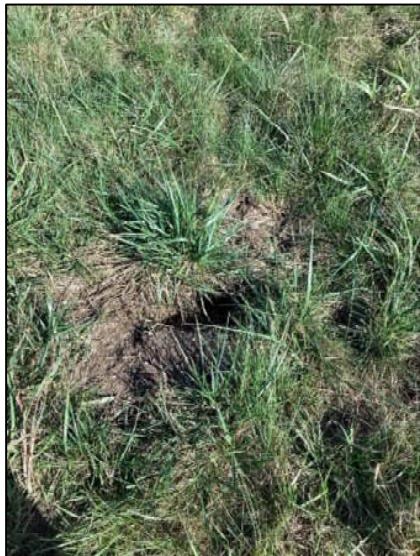
**Photo 61, Point 61**  
Phase 1 – Hole on crest temporary cover.

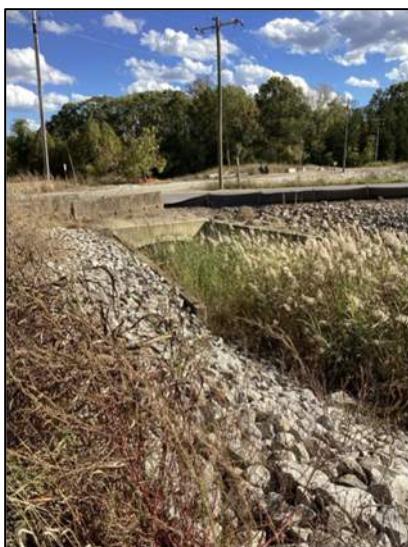
- The northern ditch crossing was observed to have heavy vegetation present. No obstructions or other hindrances to flow were observed (Point 63, Appendix A; Photo 63, Appendix B).

**Photo 63, Point 63**  
Vegetation around northern ditch crossing.

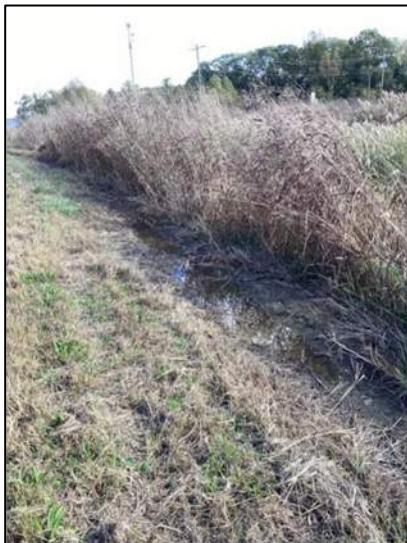
- Standing water and rutting were observed to the north of the northern ditch (Point 64, Appendix A; Photo 64, Appendix B).
- A failed siltfence was identified along the northern ditch (Point 65, Appendix A; Photo 65, Appendix B).

**Photo 64, Point 64**  
Standing water/rutting slope of northern  
ditch.
