**Re: Indiana-Kentucky Electric Corporation**  
**Clifty Creek Station's 2019 Annual Landfill Inspection**

**Reference: 2019 CCR Rule Inspection  
Annual Landfill Inspection  
Clifty Creek Generating Station  
Madison, Indiana**

**2019 CCR Rule Inspection  
Clifty Creek Landfill**

Clifty Creek Generating Station  
Madison, Indiana  
Jefferson County

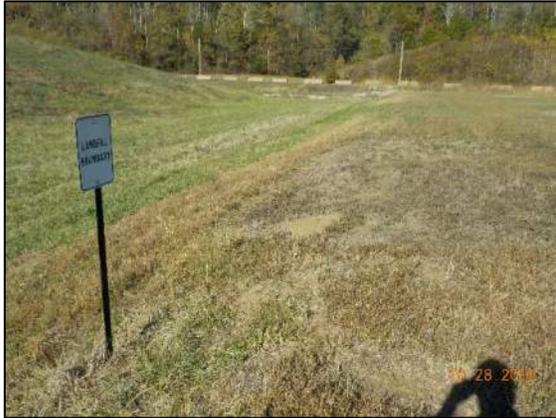
**Photo 21**

Toe of repaired slope on east side of landfill. Collected sediment at bottom of slope. (Point 57, Appendix A)

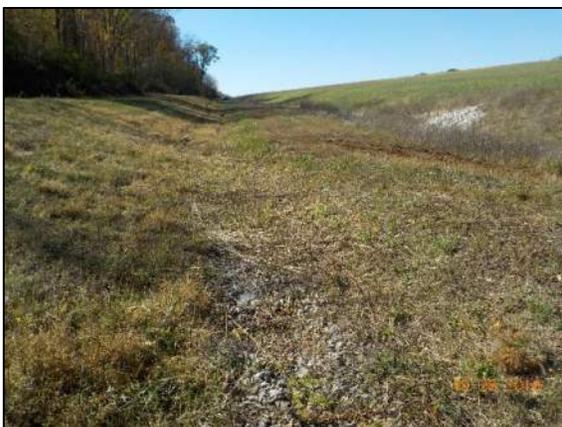
**Photo 26**

- Erosion rills (3'w x 3'd to 2'w x 1'd) were observed at the southwest corner of the inactive landfill. (Points 59 & 60, Appendix A; Photo 26)
- As observed in 2018, Subphases 1A1 and 1B1 were observed to be nearly built to permitted final CCR grades. The subphases have been temporarily covered with approximately six inches of soil, and vegetation has generally been established.

Erosion rills (3'w x 3'd to 2'w x 1'd) at southwest corner of inactive landfill Subphases 1A and 1B. (Points 59 & 60, Appendix A)

- Repair erosion feature near the truck wash surface water drainage pipe outlet/headwall area.

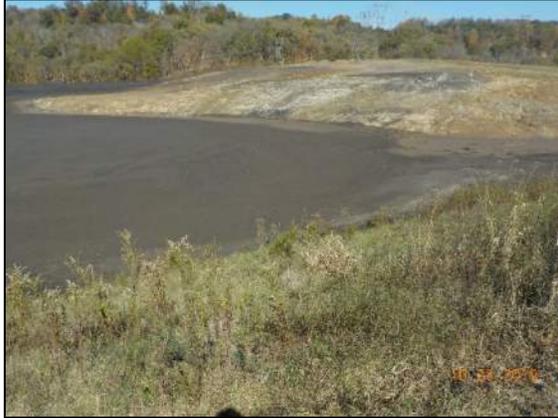
**Photo 30**

Unseeded/bare area above full rock check dam at southeastern edge of active ash area on south side of landfill. (Point 65, Appendix A)

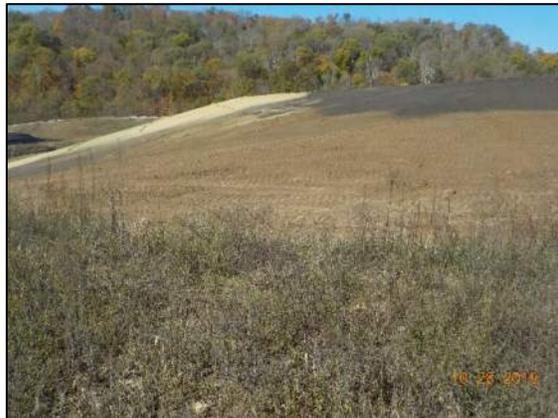
**Photo 31**

Southeastern corner of active ash area.  
(Point 66, Appendix A)

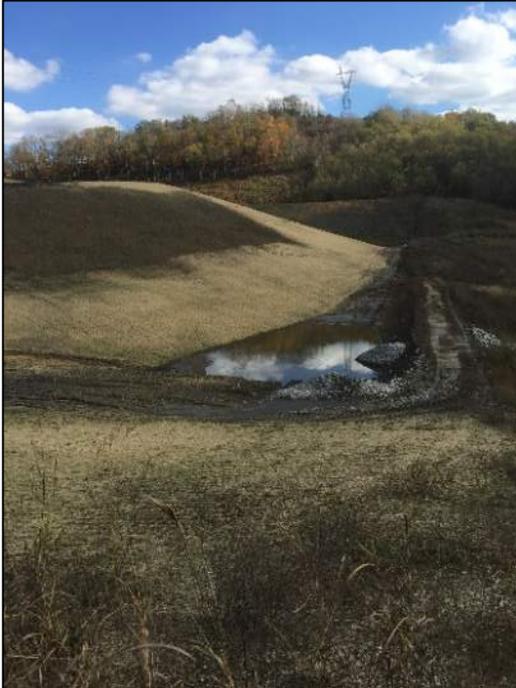
- The leachate pipe appeared unrestricted and actively flowing. Vegetation was dense around the headwall making visual observation difficult. (Point 88, Appendix A; Photo 38, Appendix B).

**Photo 38**  
Leachate pipe outlet, west of Subphase 1C. (Point 88, Appendix A)

- Remove excess vegetation from drainage channels, pipe inlets, and outlets. Flow was visible at the pipes observed by Stantec during the October site visit.

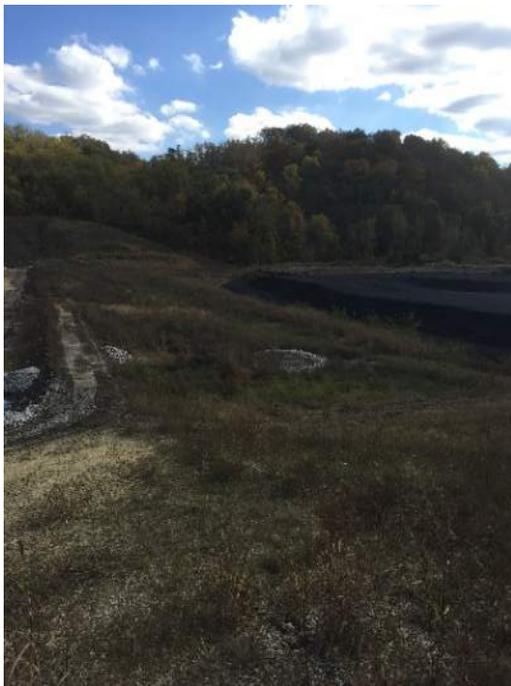
**Photo 39**  
Pond at west end of active landfill.

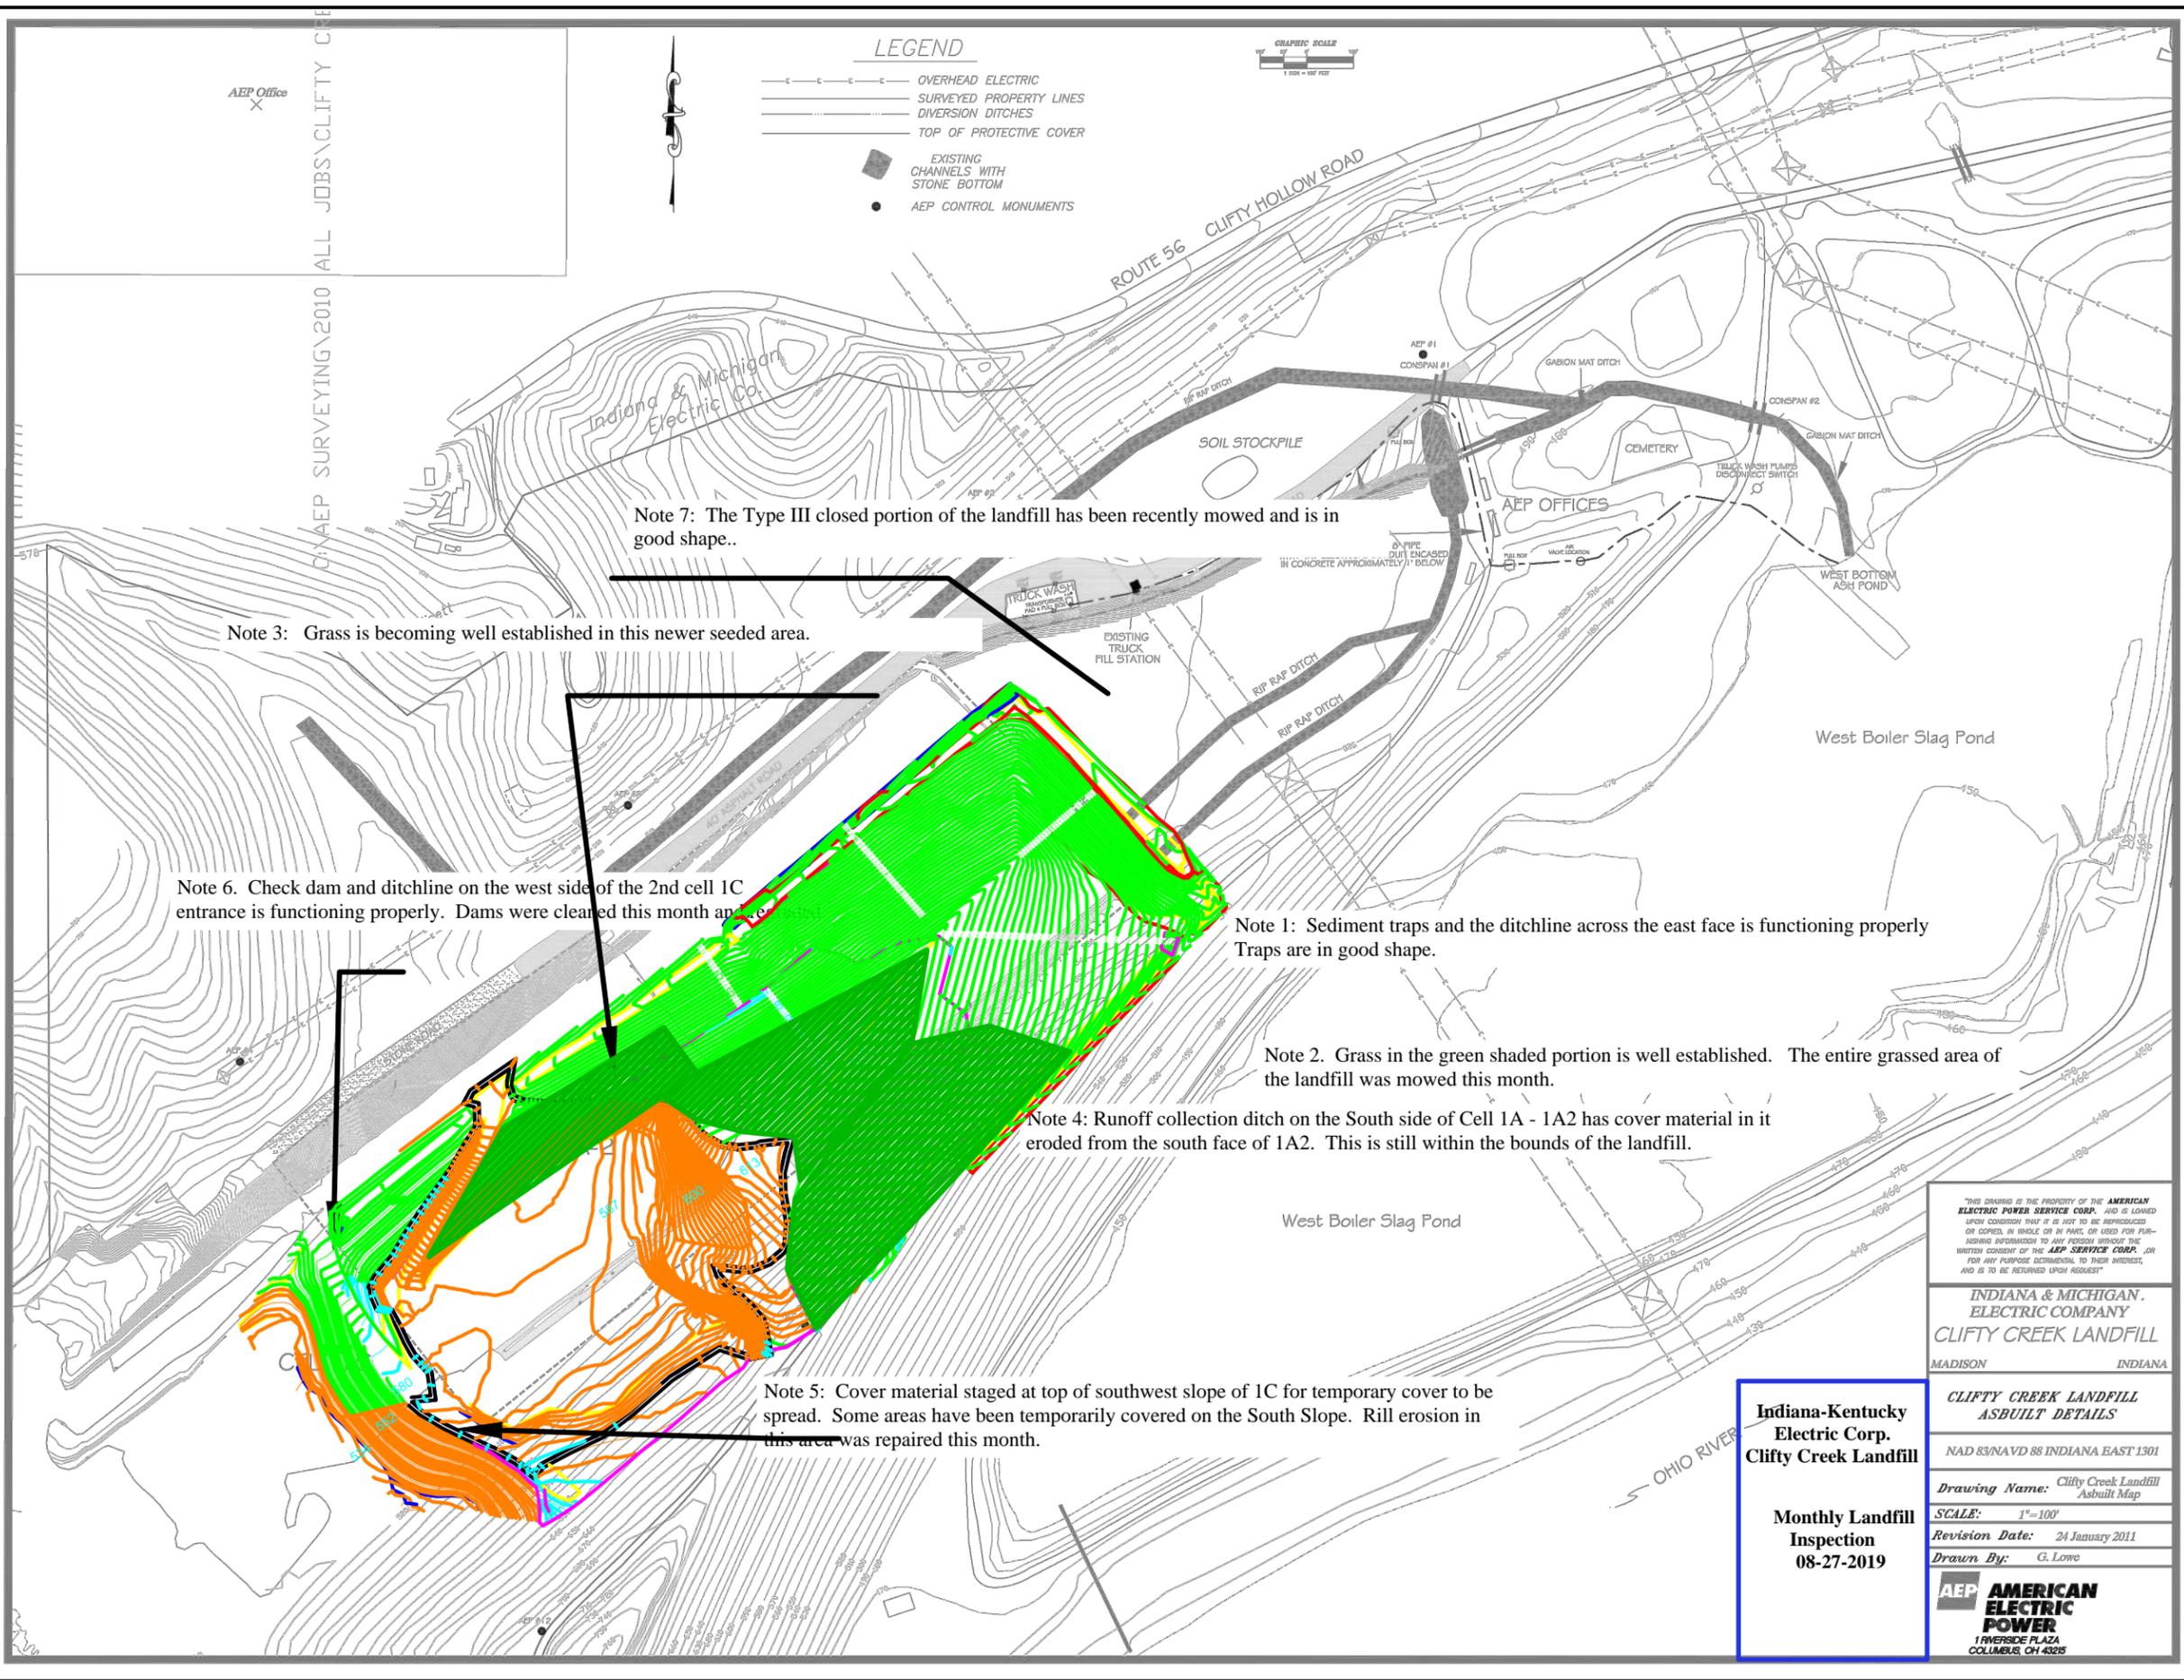
Note 7: The Type III closed portion of the landfill has been recently mowed and is in good shape..

Note 3: Grass is becoming well established in this newer seeded area.
