**Re: Indiana-Kentucky Electric Corporation
Clifty Creek Station's 2021 Annual Landfill Inspection**

**2021 CCR Rule Inspection
Clifty Creek Landfill**

Clifty Creek Generating Station
Madison, Indiana
Jefferson County

February 2, 2022

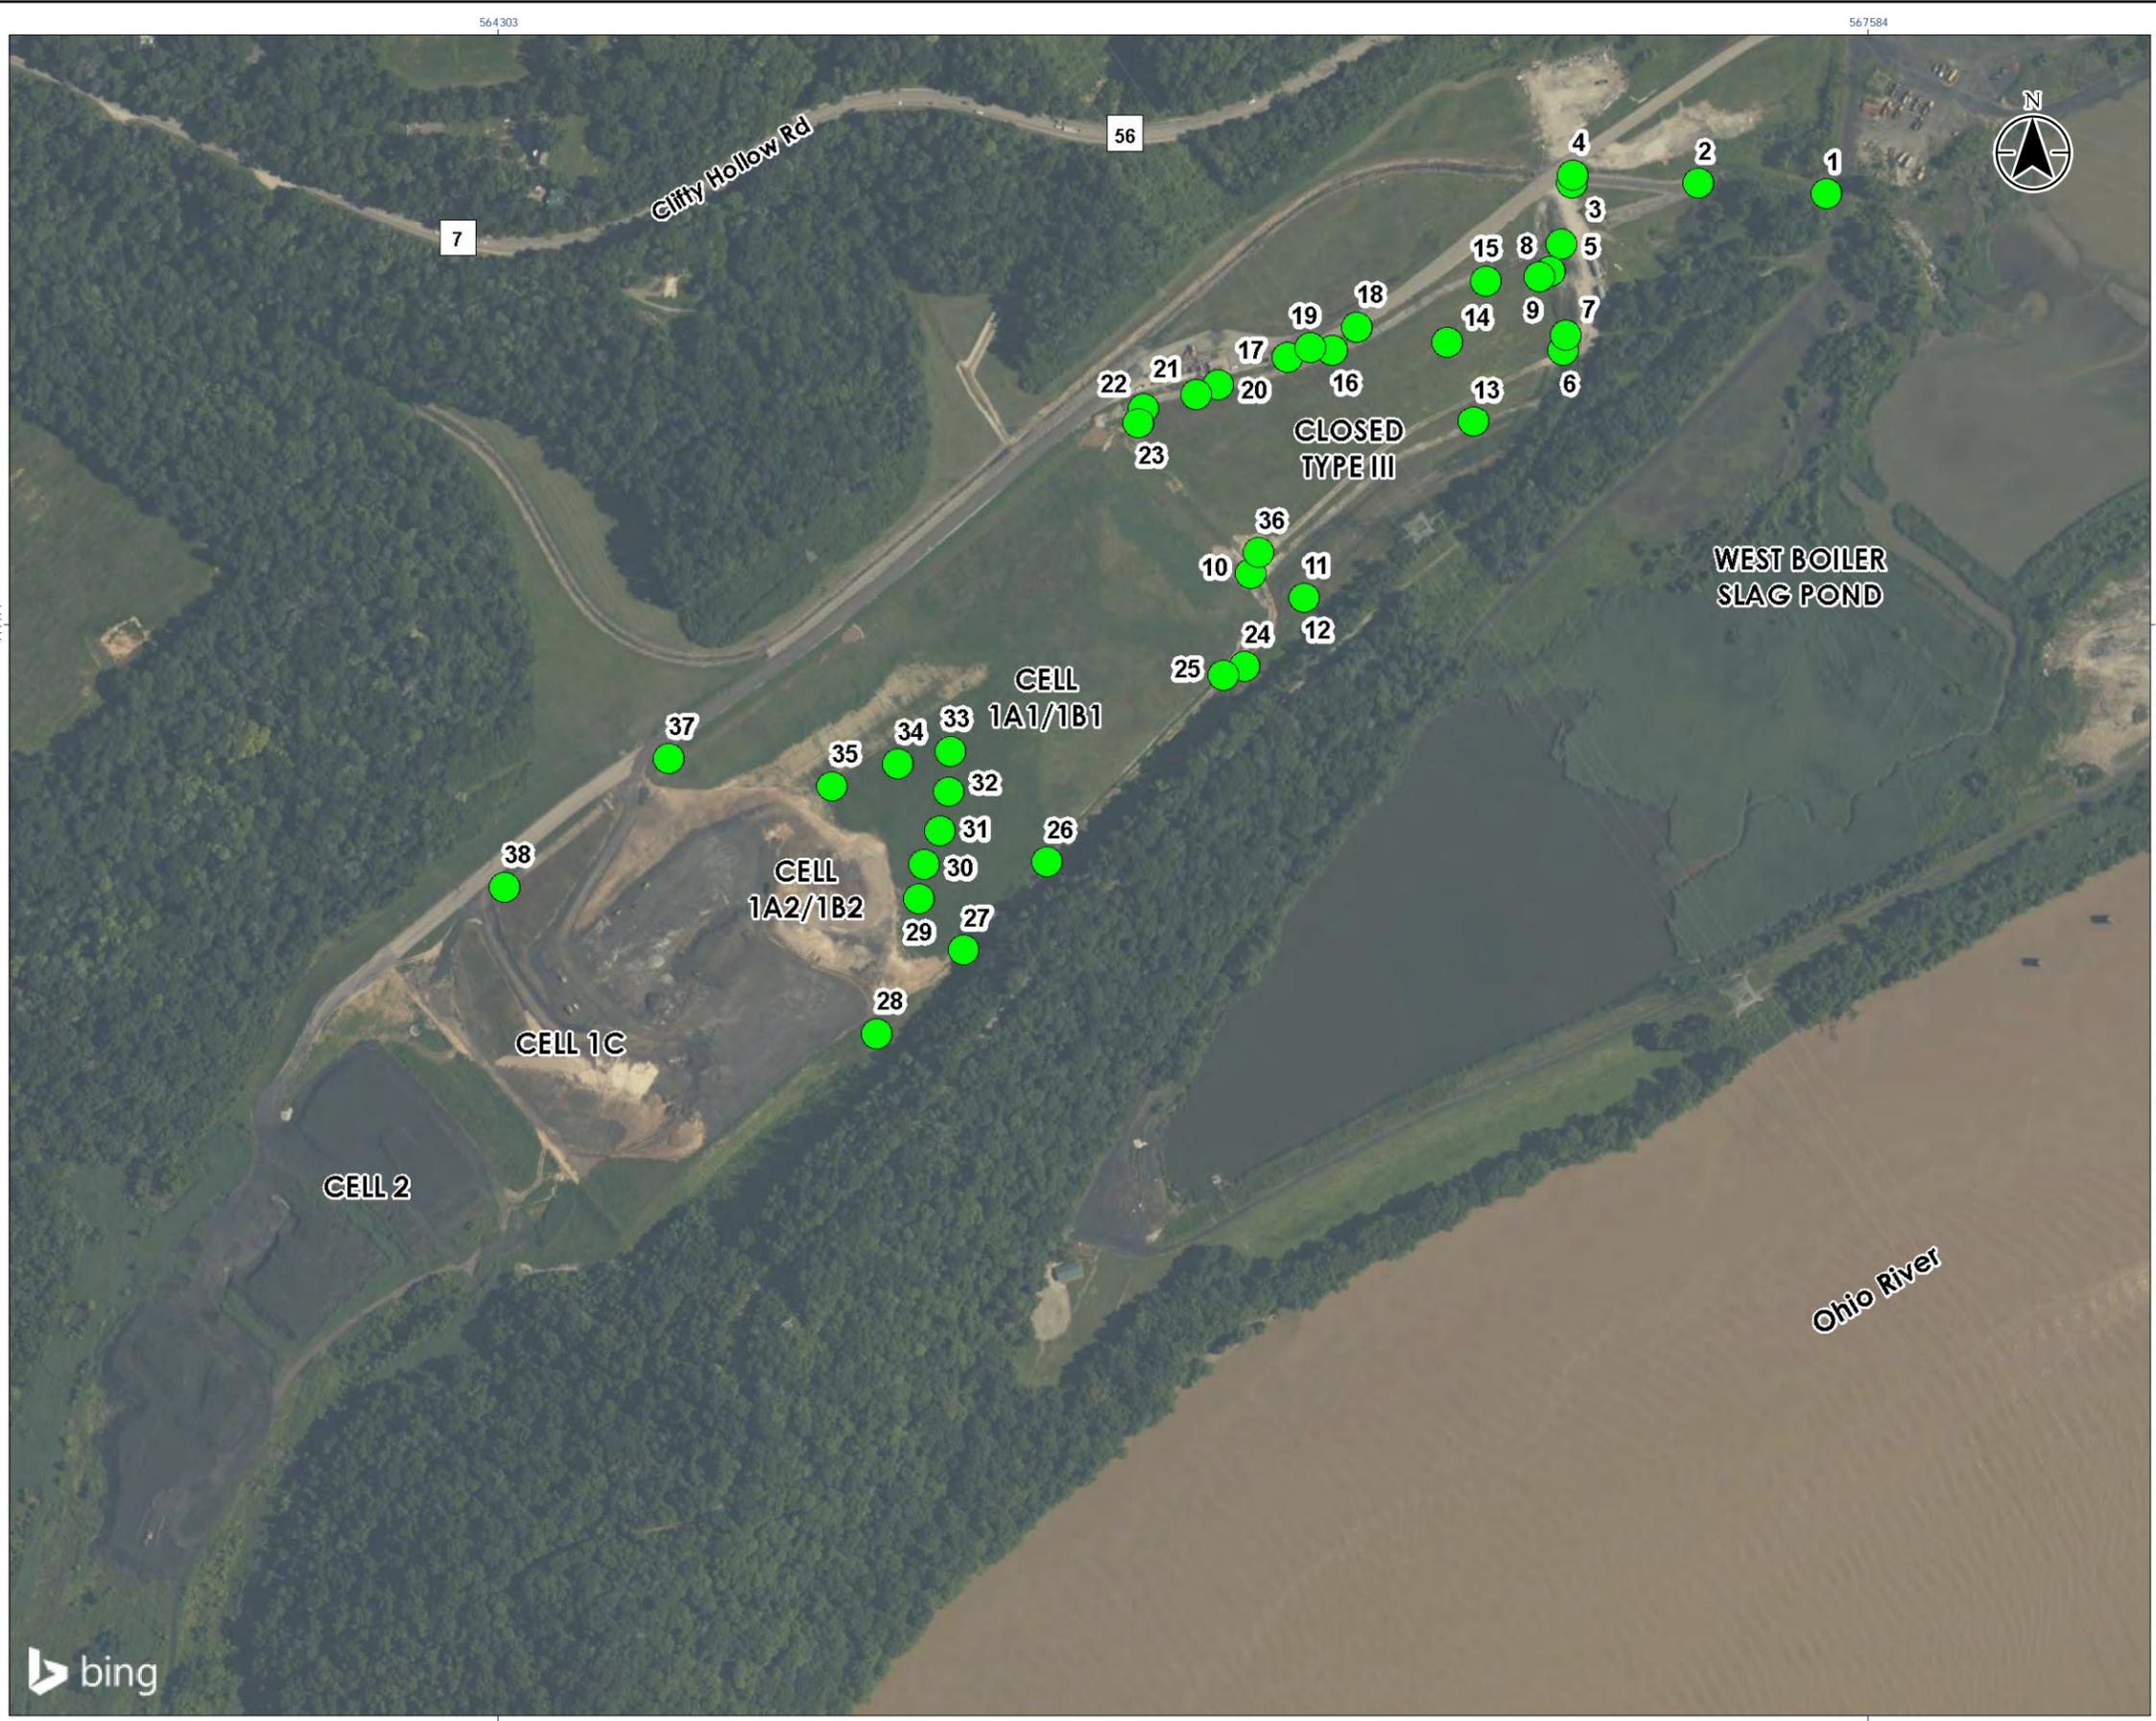
**APPENDIX A – PLAN VIEW AND TABLE OF
INSPECTION LOCATIONS**

Point ID No.	Comment	Latitude	Longitude
1	heavy vegetation in channel at conspan 1	38.73690767827	-85.43009521158
2	heavy vegetation in channel at conspan 2	38.73697950167	-85.43116834739
3	low backfill at headwall	38.73698400632	-85.43222813174
4	cracks in headwall	38.73703688421	-85.43222291181
5	heavy vegetation in channel	38.73657865591	-85.43232207266
6	roadway drainage pipe inundated	38.73588487208	-85.43231072698
7	edge of vegetation in channel	38.73598667557	-85.43228561443
8	orange sheen seepage at headwall	38.73640063735	-85.43241778590
9	wet spot on cover	38.73636442012	-85.43250181621
10	standing water southeast corner	38.73442780809	-85.43493401846
11	heavy vegetation in exterior channel	38.73426641764	-85.43448636690
12	sediment in exterior channel	38.73426662596	-85.43448627424
13	change to taller vegetation in channel	38.73542057384	-85.43305933977
14	undulating low spots on cover	38.73593827266	-85.43327778808
