**Re: Indiana-Kentucky Electric Corporation  
Clifty Creek Station's 2023 Annual Landfill  
Inspection Posting Notification**

**2023 CCR Rule – Landfill  
Clifty Creek Landfill Inspection**

Clifty Creek Generating Station  
Madison, Indiana  
Jefferson County

January 19, 2024

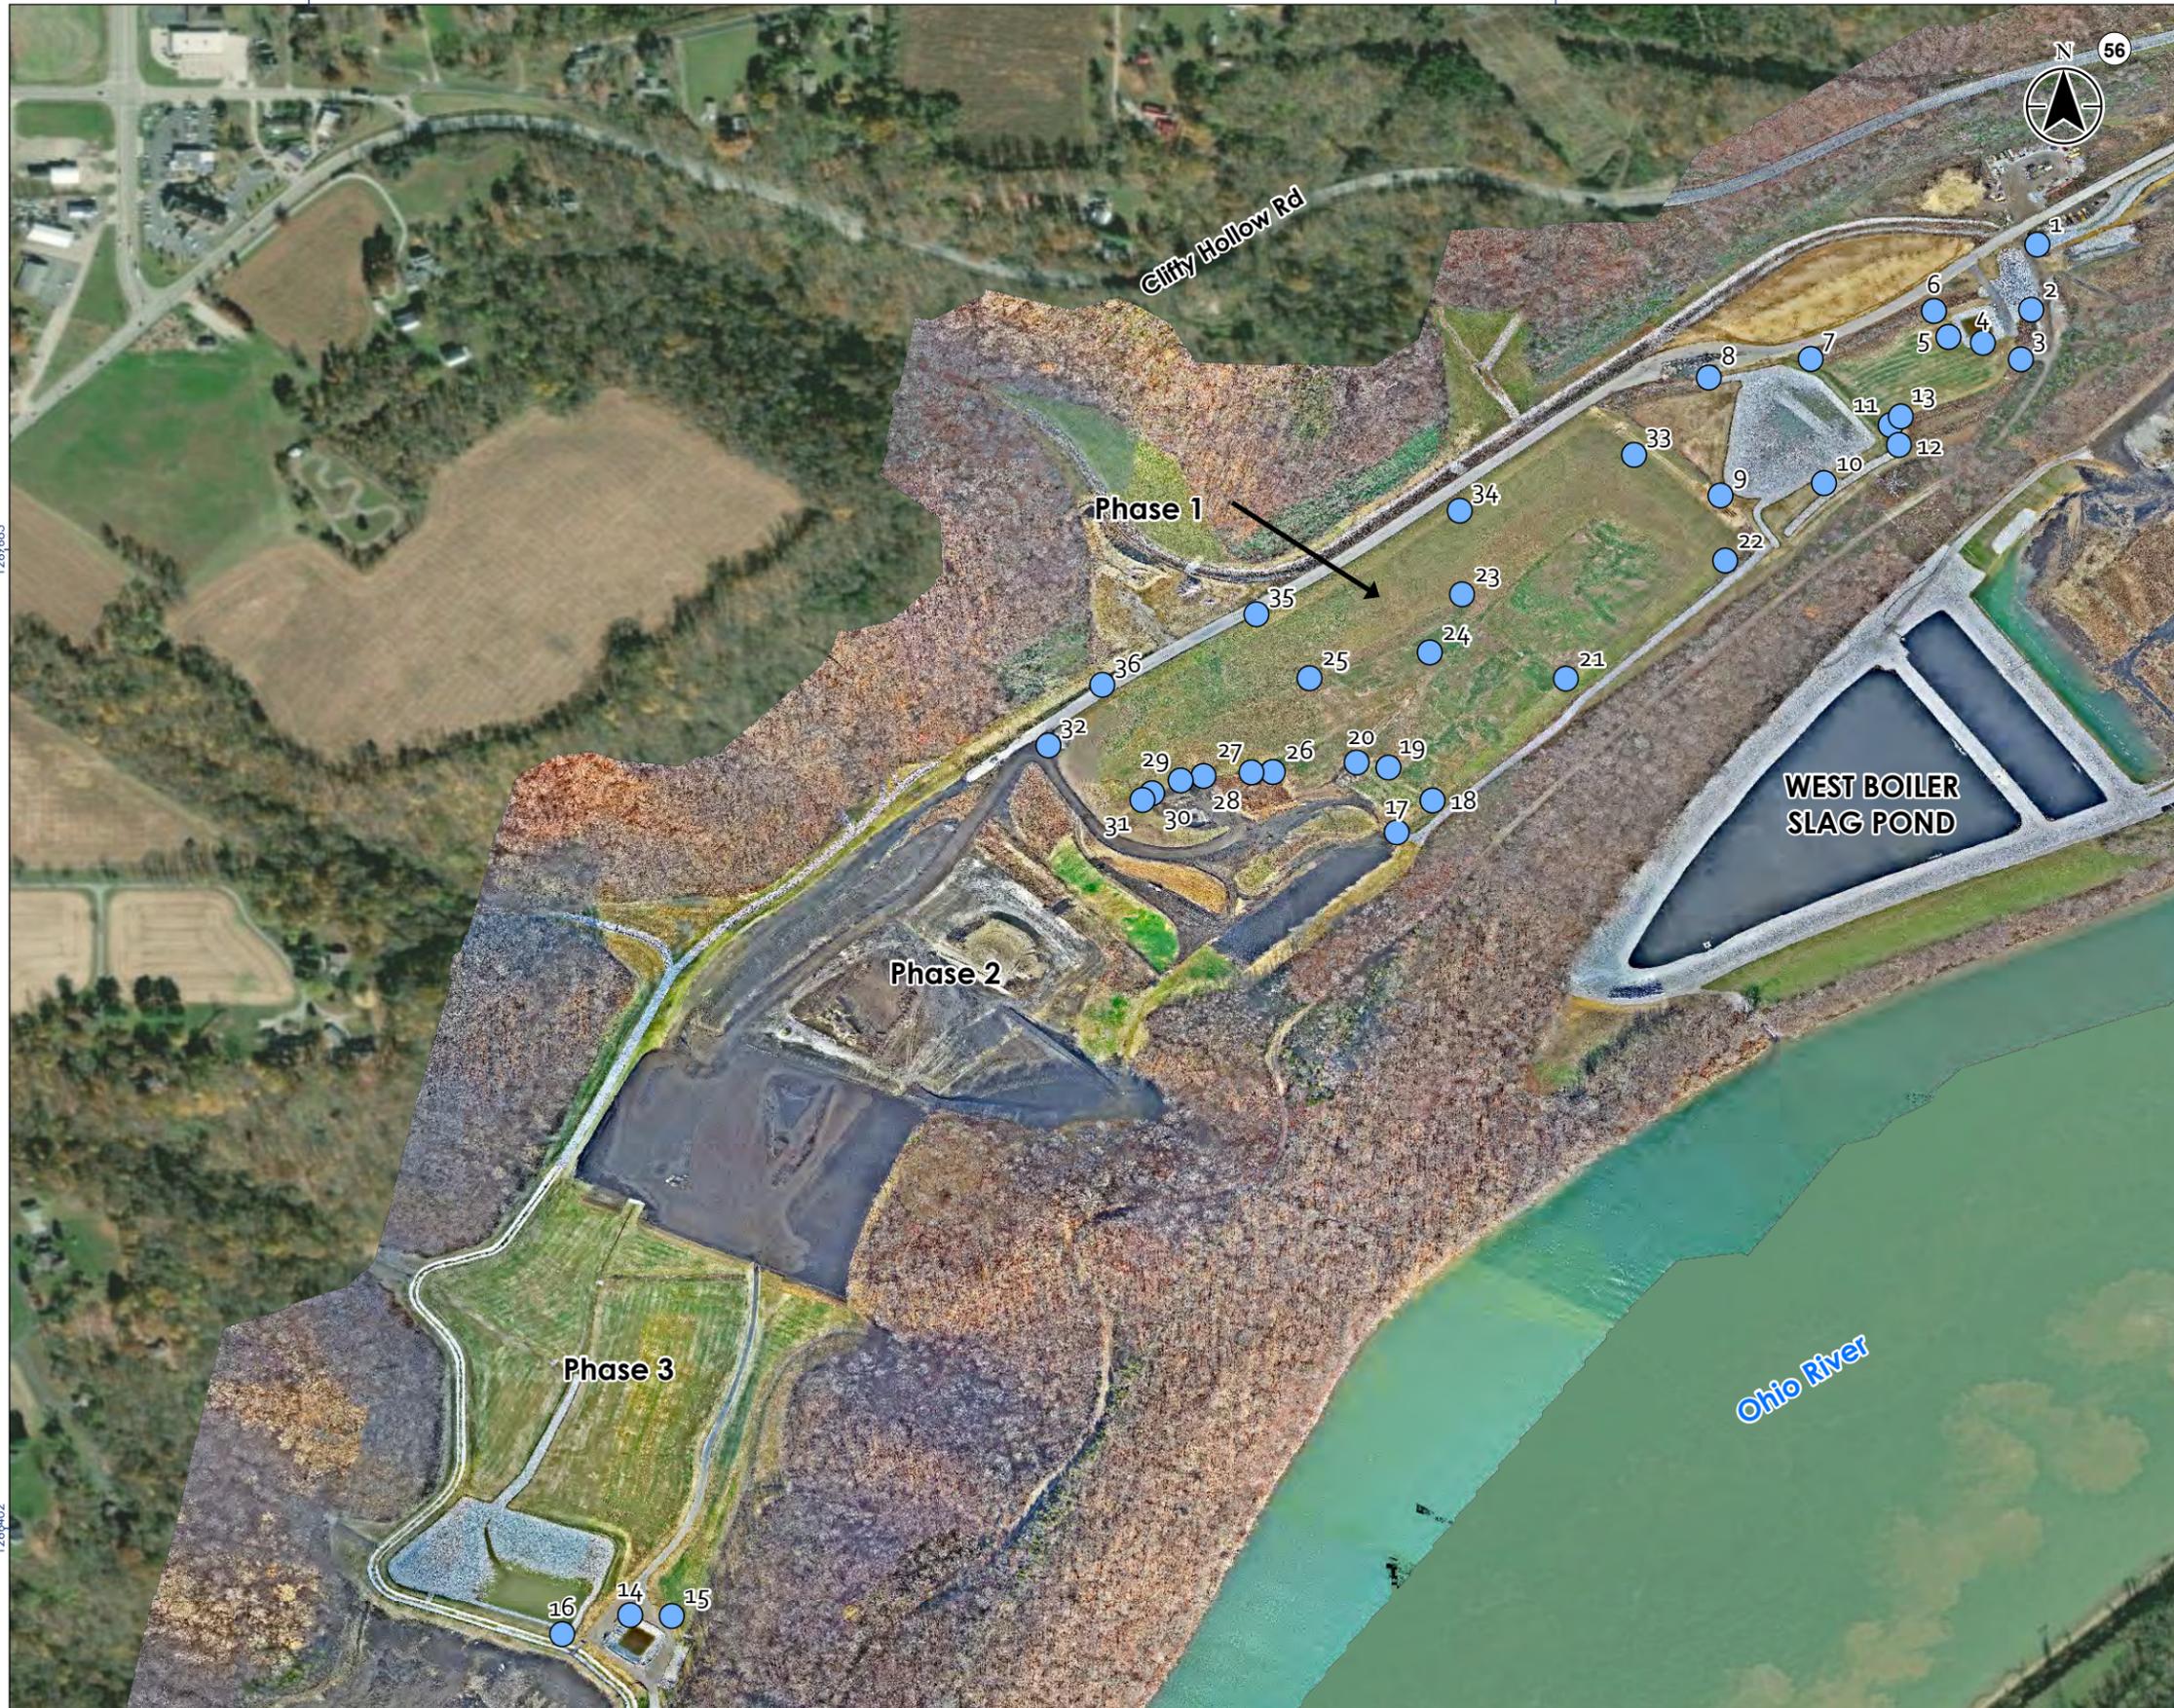
- The stormwater drainage channel from the landfill to the WBSP appears abandoned with its flows redirected to the northern stormwater ditch and the new northeast sediment basin and leachate collection pond. The culverts from the east end of the Type III landfill have been removed and backfilled. The slopes have been mulched and seeded. Some dense vegetation obscures the channel east towards the WBSP. No flow was observed in this channel. (Point 1, Appendix A; Photos 1 and 2, Appendix B)

- Heavy vegetation was noted within the southern final cover stormwater channel. (Point 2, Appendix A; Photos 7 and 8, Appendix B)
- A dip in the access road allowed access to the Type III landfill. Erosion and accumulated sediment were observed. (Point 3, Appendix A; Photos 8-9, Appendix B)

- A plastic standpipe was located west of the northeast leachate pond. Water was observed within the standpipe. (Point 5, Appendix A; Photo 12, Appendix B)

- Heavy vegetation, exposed soil channel edges, and failed silt fence were observed in the northern final cover stormwater channel. (Point 6 and 7, Appendix A; Photos 13-14, Appendix B)

- A wet, soft area was noted at the toe of slope of the Type I landfill at the southeast corner. A soil stockpile was also located within the wet area. (Point 9, Appendix A; Photo 19, Appendix B)
