**Re: Ohio Valley Electric Corporation  
Kyger Creek Station  
Notification of CCR Rule Information Posting  
Annual Certified CCR Dam and Dike (Surface Impoundment)  
Inspection Report Posting**

**2025 CCR Rule – Surface Impoundments  
Kyger Creek Dam/Dike Inspections**

Kyger Creek Generating Station  
Cheshire, Ohio  
Gallia County

January 19, 2026

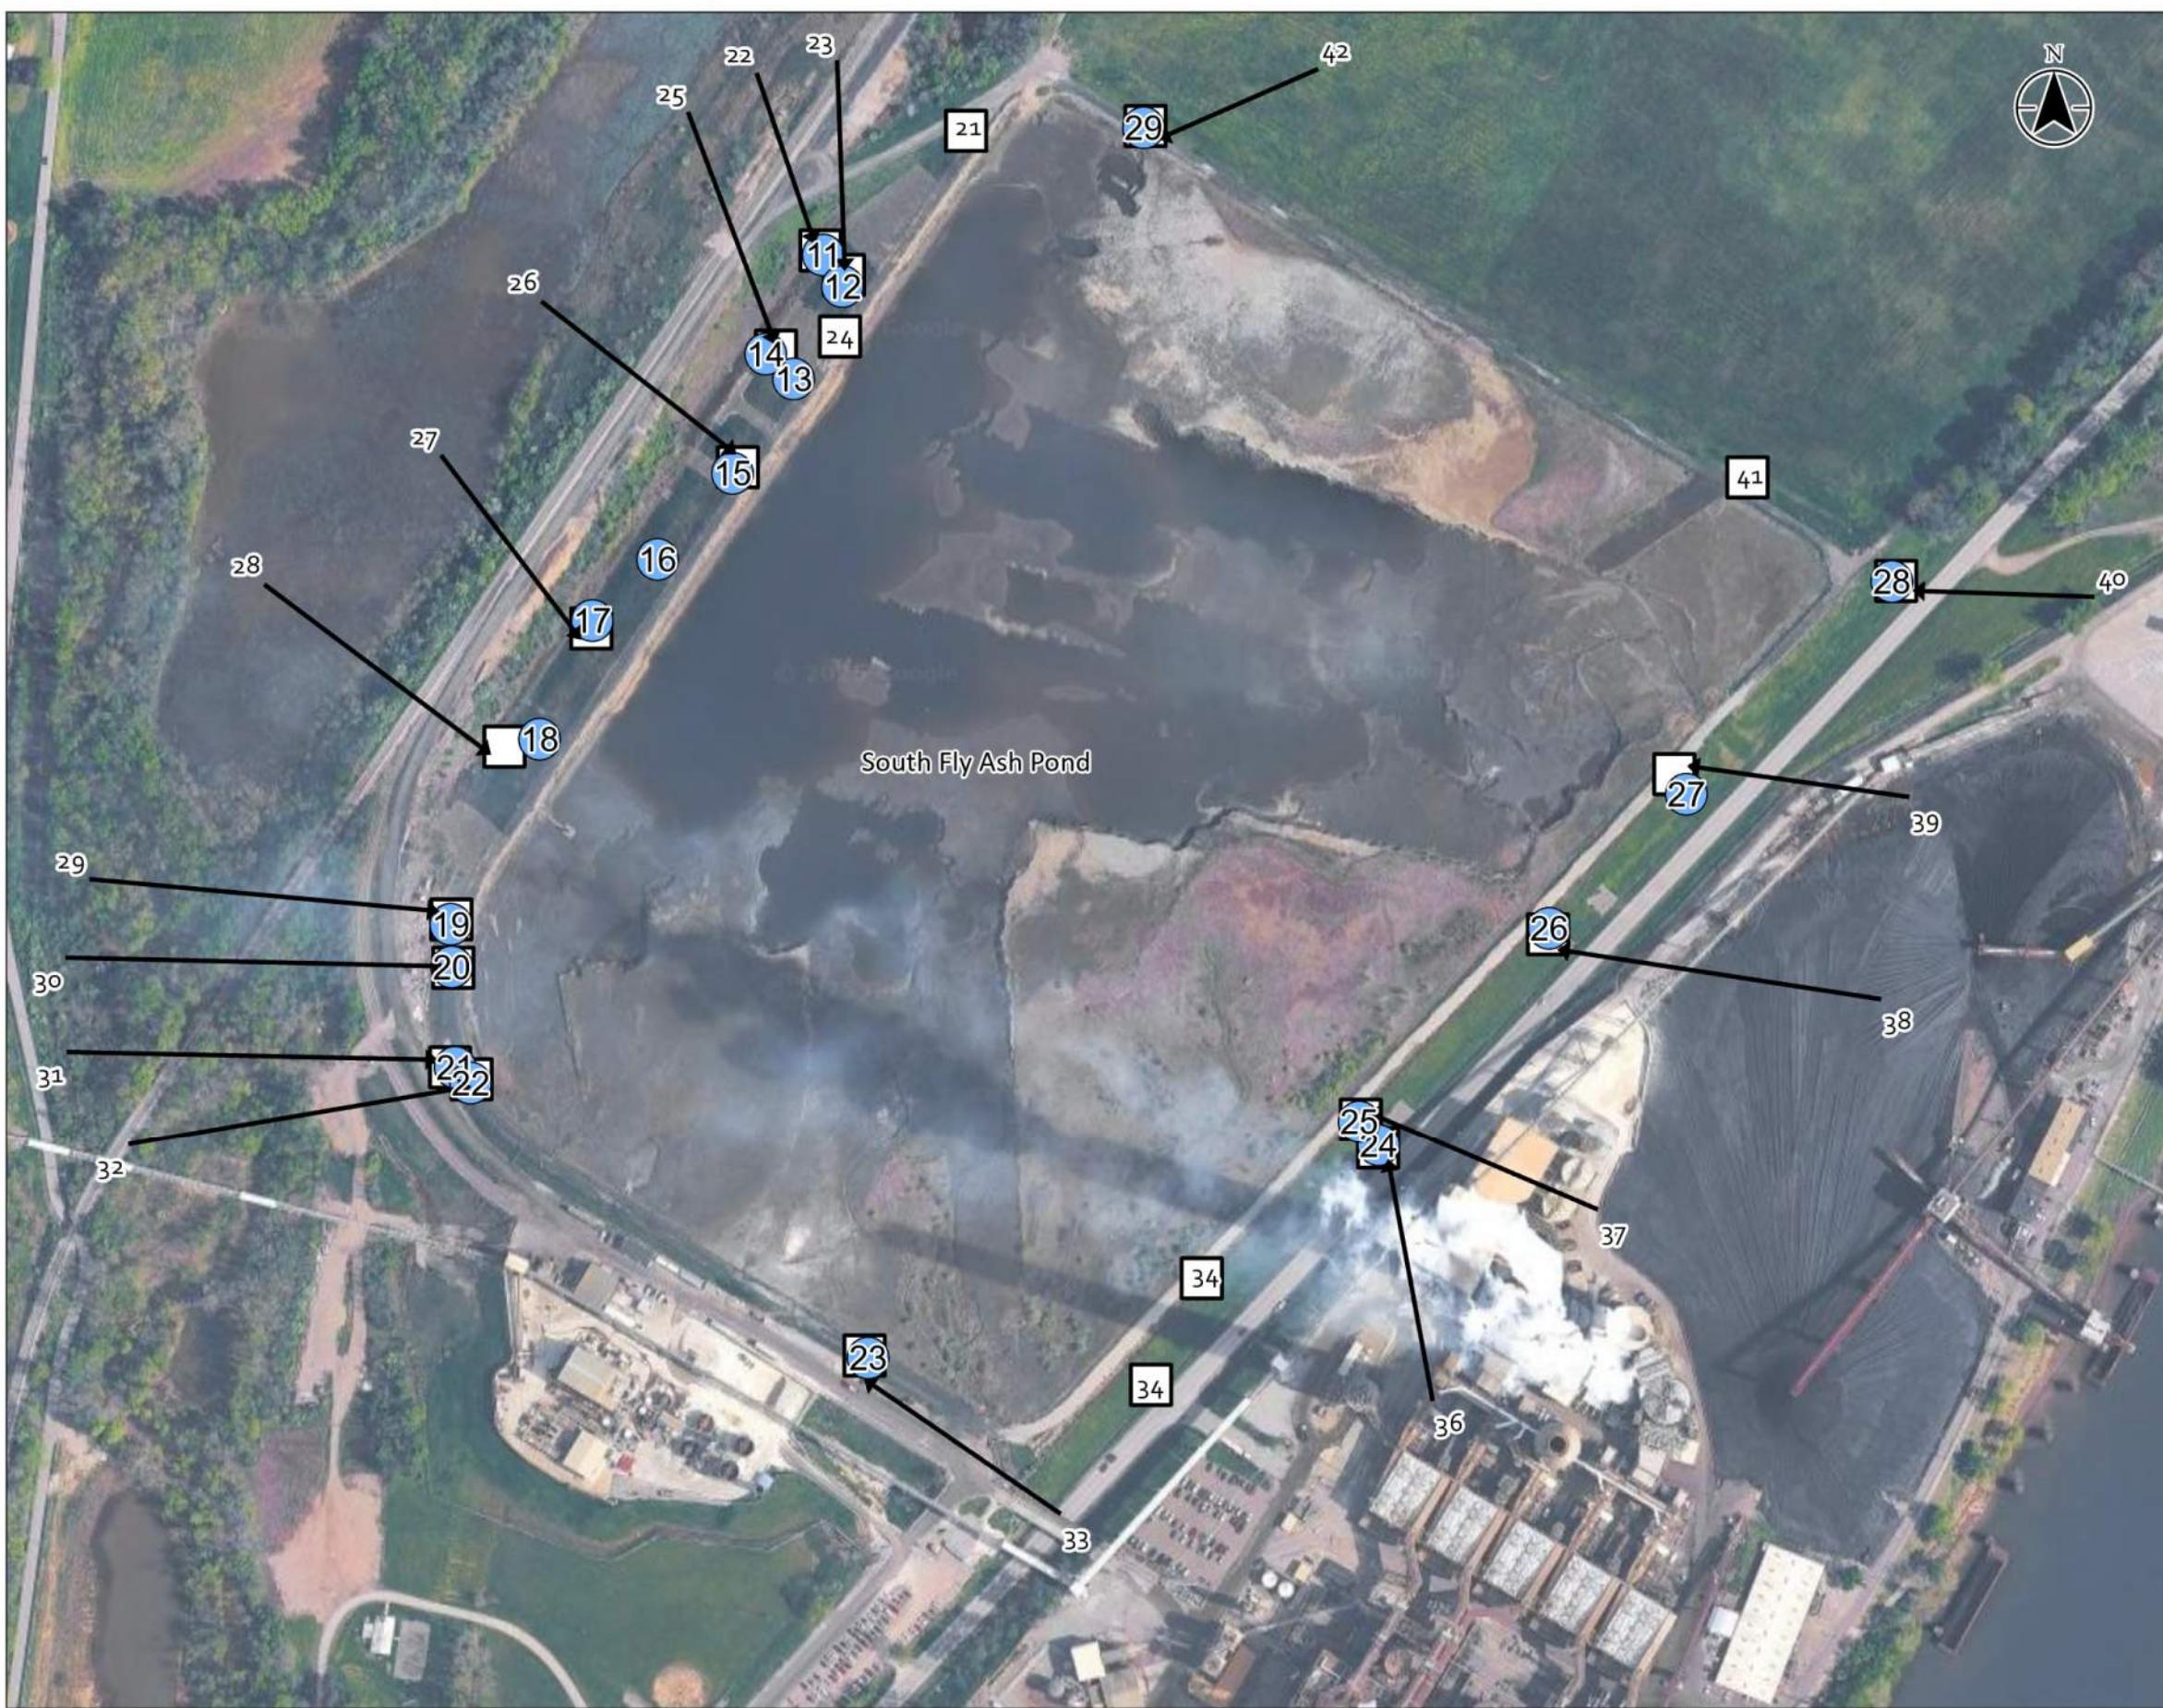
Client/Project  
Ohio Valley Electric Corporation  
South Fly Ash Pond

- No operational flow was evident at the time of the inspection at the inlet to the SFAP at the southeastern corner.
- A uniform depression in the northwest slope was documented along the length of that slope (Points 12, 13, 16, 17, and 18, Appendix A; Photos 23, 27, and 28, Appendix D).

- The splitter dike embankment shows no signs of rutting, erosion or instability (Photo 41, Appendix D).
- The ground surface metal cover to a piezometer at the crest of the splitter dike located under a steel plate appears to be damaged, exposing the piezometer to moisture from the ground surface (Point 29, Appendix A; Photo 42, Appendix D).

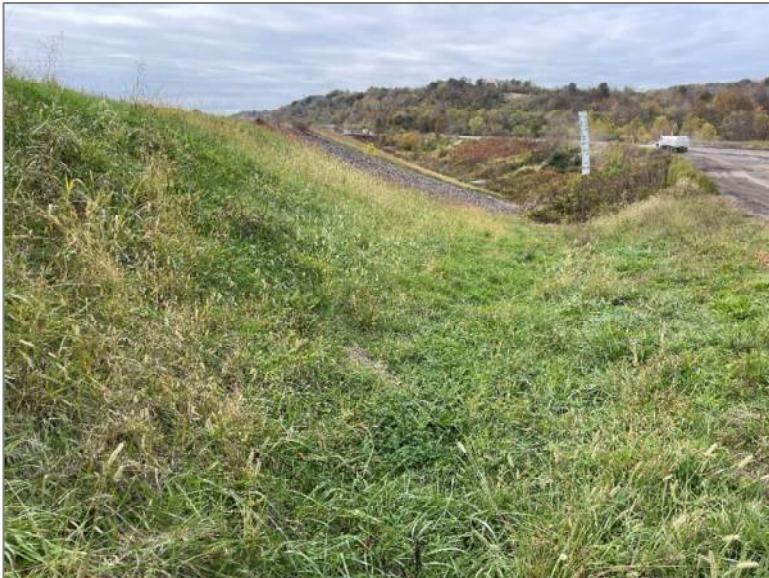
**Photo 21**

- In general, the downstream slopes appear to be in good condition with established, mowed grass and limited woody vegetation (Photos 21, 23, 27, 28, 34, and 41, Appendix D).

Northwest Exterior Slope –  
Facing southwest

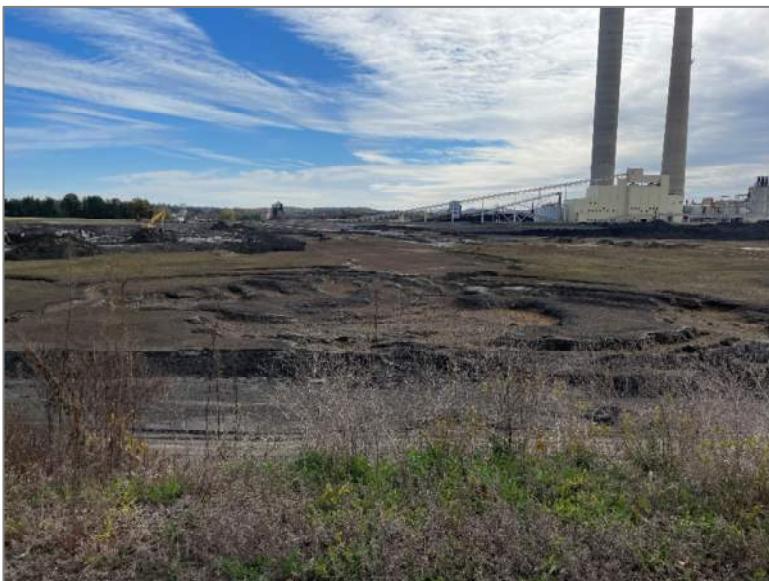
**Photo 24**  
Impoundment – Facing  
southeast

- Limited free water is visible within the impoundment due to dewatering for construction (Photo 24, Appendix D).
- Historic sluice lines are located along the southern and eastern dikes (Photos 35, 38, and 39, Appendix D).

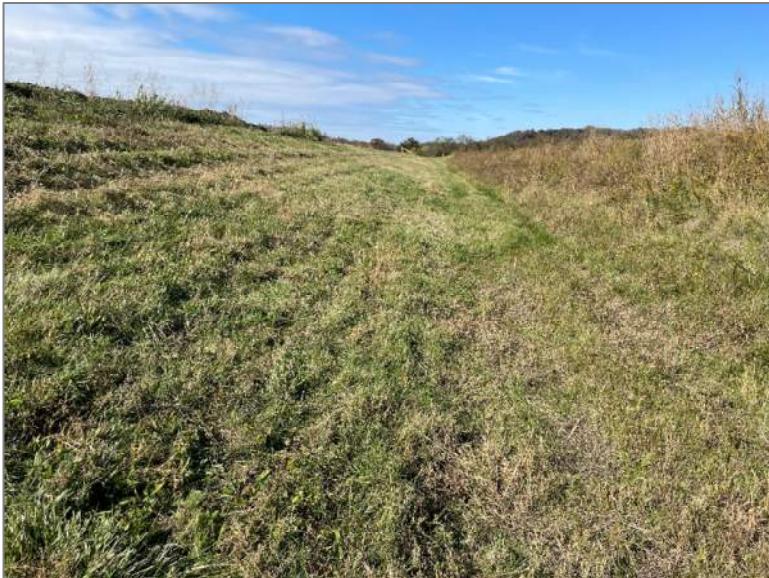
**Photo 41**

Splitter Dike Exterior Slope –  
Facing northwest.
