**2024 CCR Rule – Surface Impoundments
Kyger Creek Dam/Dike Inspections**

Kyger Creek Generating Station
Cheshire, Ohio
Gallia County

January 19, 2025

Stantec Consulting Services Inc.
Cincinnati, Ohio

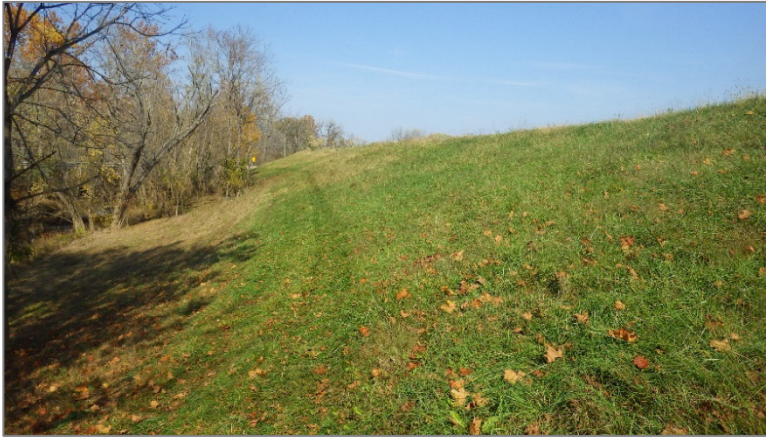
- The exterior slopes are mowed, vegetated, and uniform along the northwest and southwest perimeter of the pond. The southeastern slope was obscured by higher vegetation limiting observations (Photos 1, 15, 19, and 23; Appendix D).
- Surface erosion and erosion rills are noted, particularly as the material changes from the road surfacing to the grassy slopes near the crest along the perimeter embankment (Points 2 through 7 and 15 through 17, Appendix A; Photos 2 through 7 and 15 through 17, Appendix D).
- Surface erosion is noted near the toe of the perimeter embankment on its southeast side (Point 1, Appendix A; Photo 1, Appendix D).

Photo 19, Point 18
LVWTS – West Exterior Slope –
Looking north.

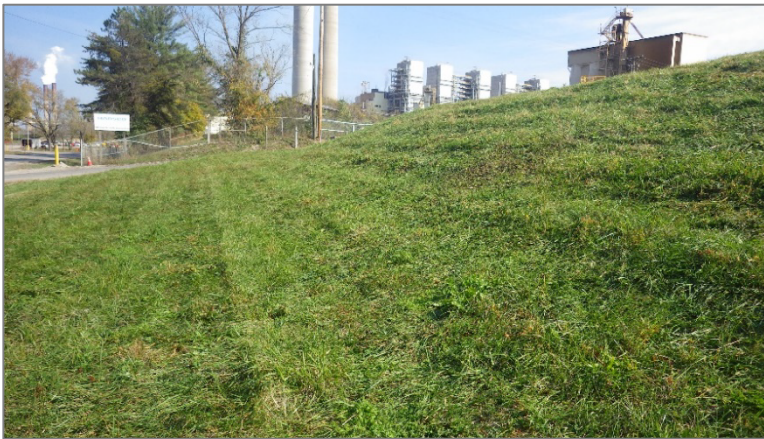
Photo 23, Point 22
LVWTS – West Exterior Slope –
Looking north at Primary Basin.

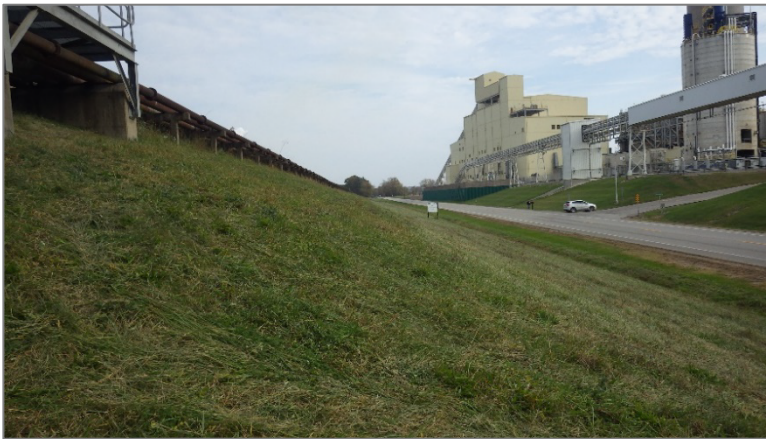
- In general, the downstream slopes appear to be in good condition with established, mowed grass and limited woody vegetation (Points 36 and 38, Appendix A; Photos 35 and 37, Appendix D). The southeastern slope was obscured by higher vegetation limiting observations.

Photo 35, Point 34
Southeast Exterior Slope –
Looking northwest.

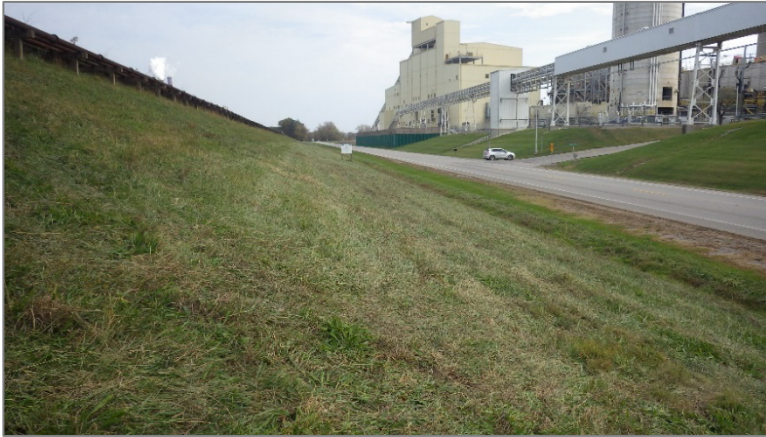
Photo 37, Point 36
Southeast Exterior Slope –
Looking northeast.

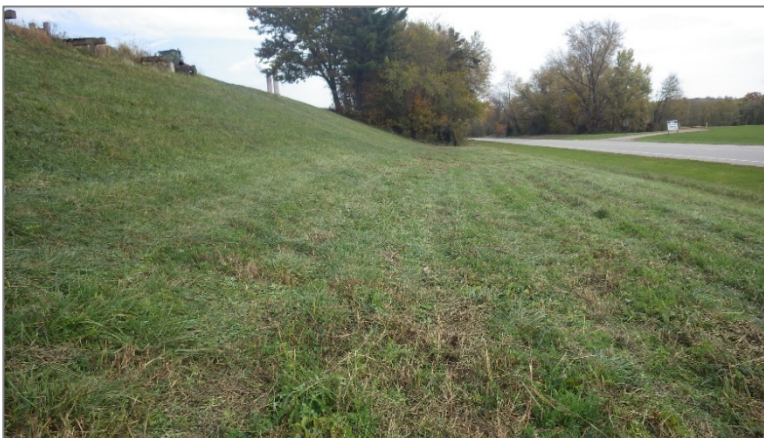
- The tie-in of the piping along the southeast side of the pond into the embankment does not show signs of inconsistency or instability (Points 43 and 44, Appendix A; Photos 42 and 43, Appendix D).
- The Splitter Dike embankment, composed of ash, shows no signs of rutting, erosion or instability (Point 46, Appendix A; Photo 45, Appendix D).
- Sloughing of soil is present near the toe at the west corner of the exterior embankment (Point 47, Appendix A; Photo 46, Appendix D).

Photo 42, Point 41
Southeast Exterior Slope –
Slope tie-in location.
