**2025 CCR Rule – Surface Impoundments
Kyger Creek Dam/Dike Inspections**

Kyger Creek Generating Station
Cheshire, Ohio
Gallia County

January 19, 2026

Stantec Consulting Services Inc.
Cincinnati, Ohio

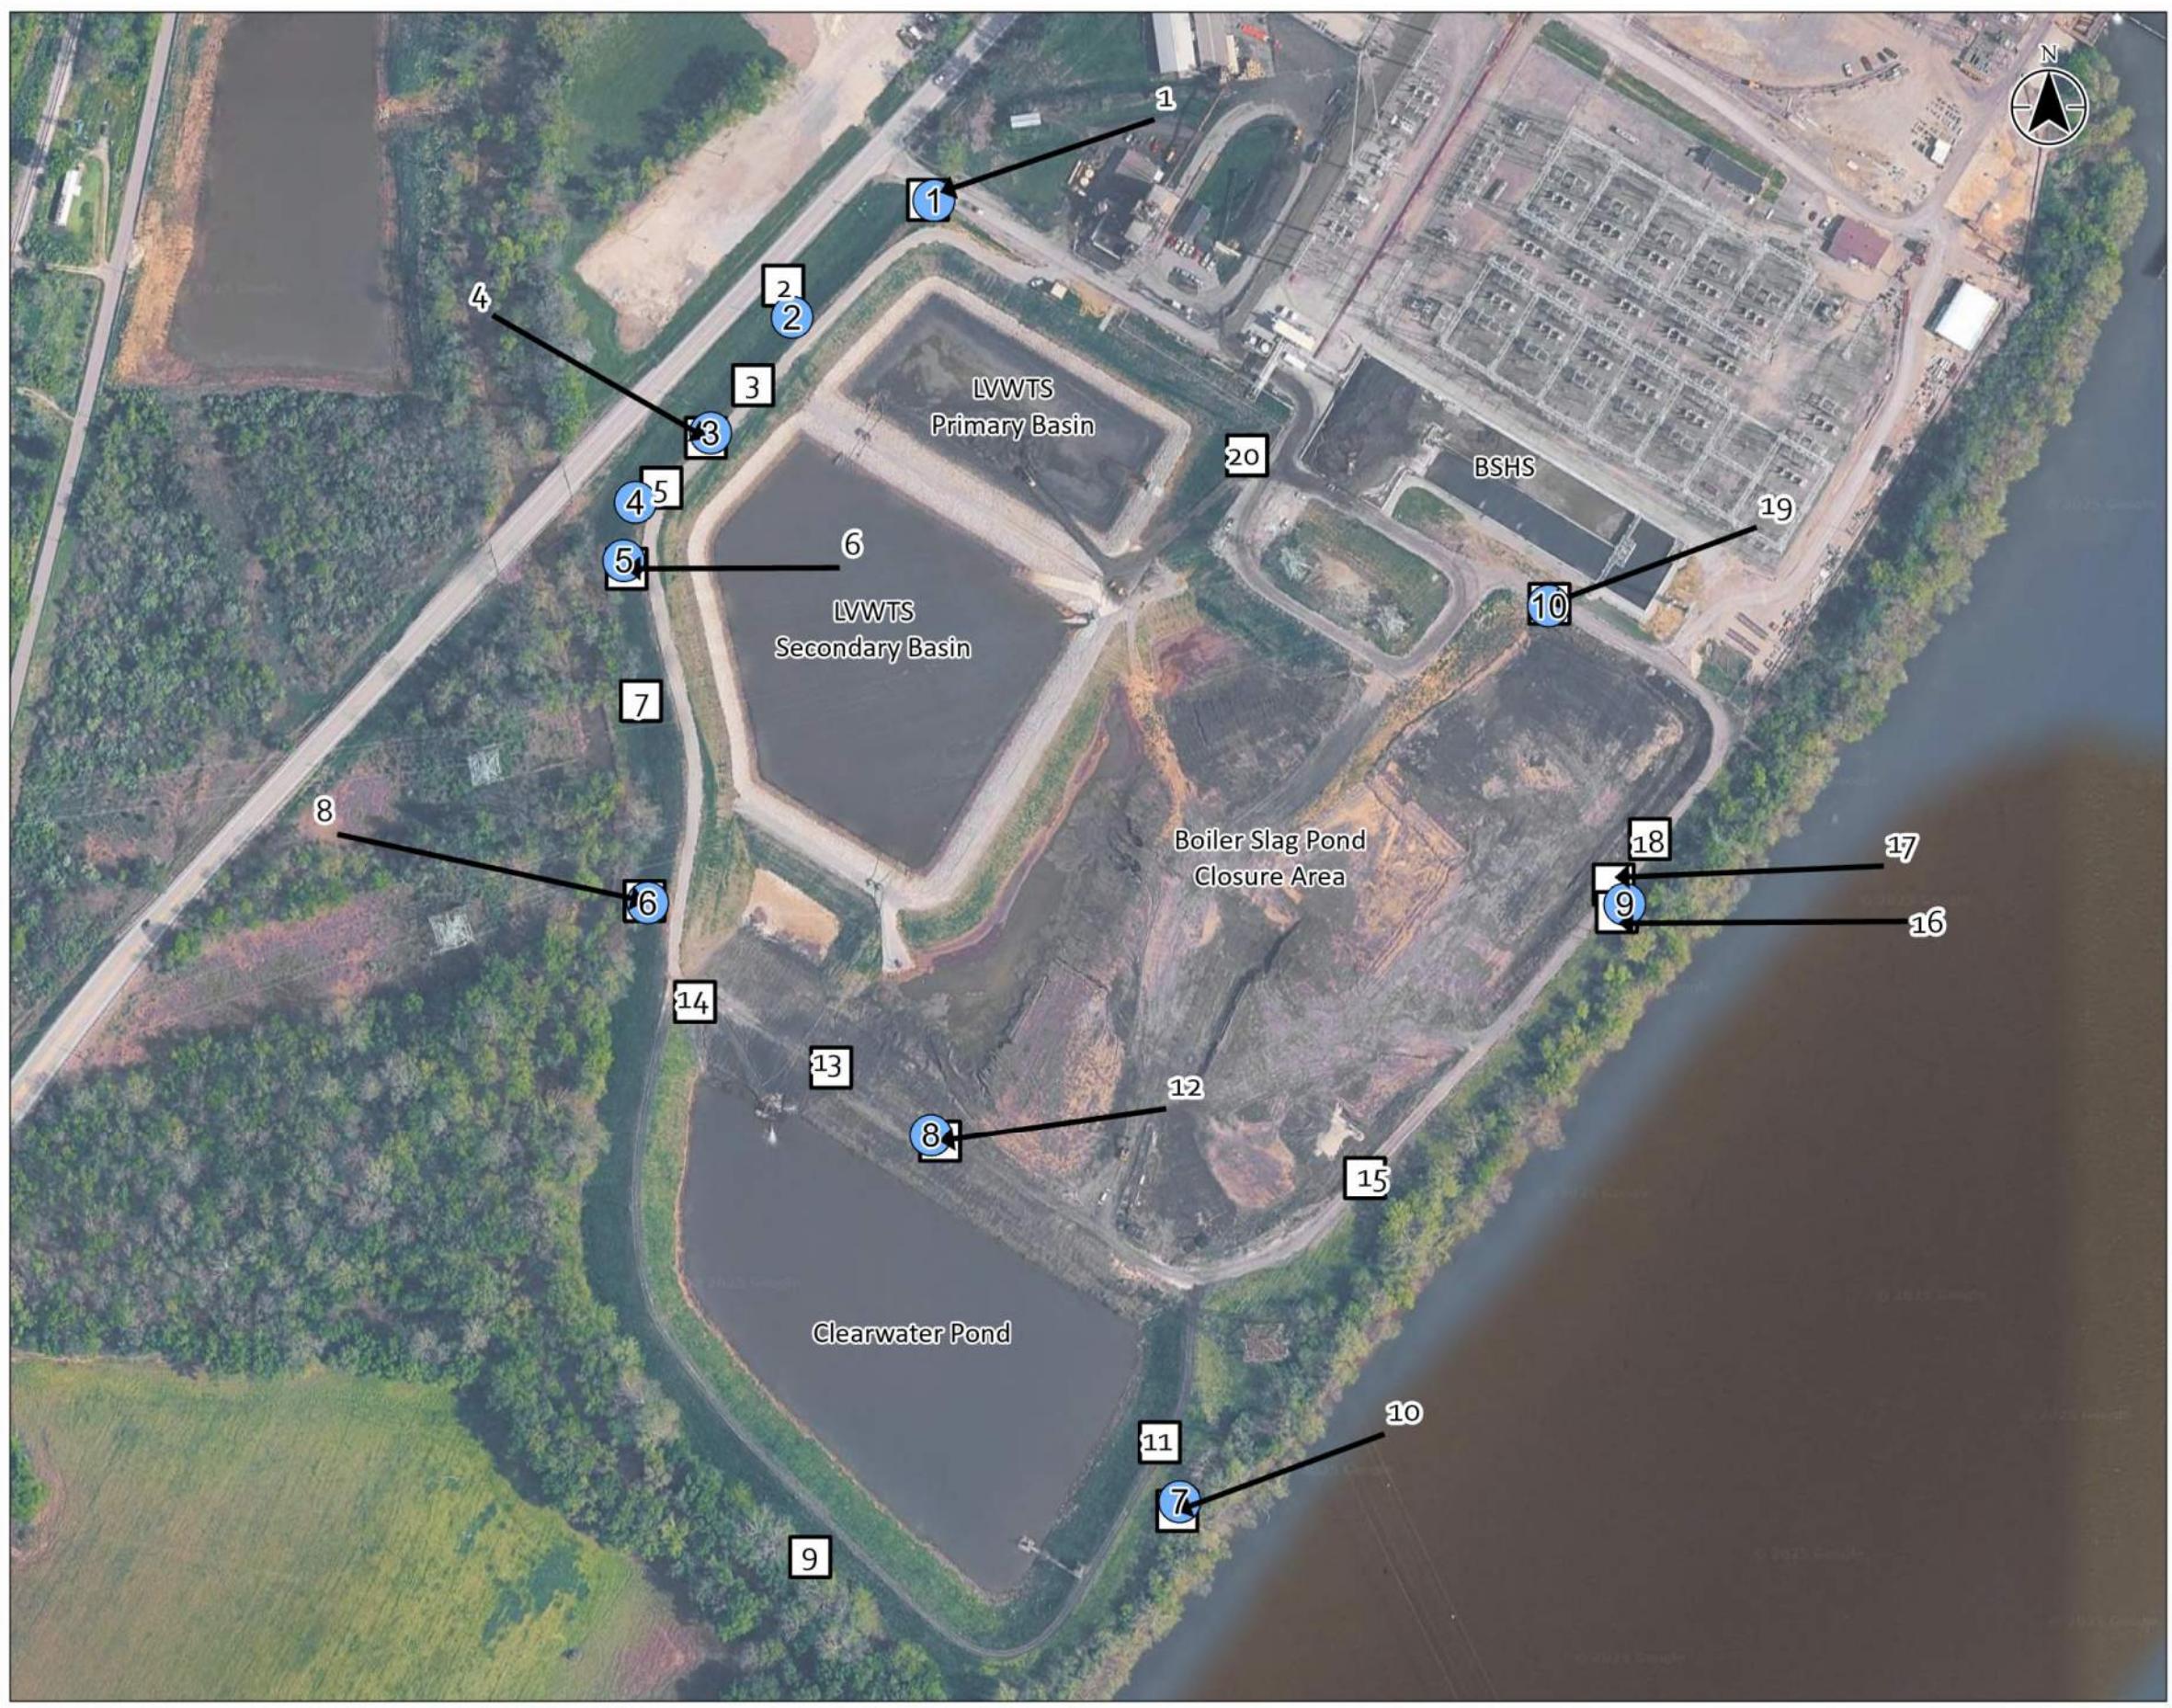
Figure No.
2
Title
2025 Annual CCR Surface Impoundment Inspection

embankment dam and dike, and inlet and outlet structures. Appendix A includes a plan view and table with inspection points identified in the field. Appendix D includes a photographic log of the conditions.

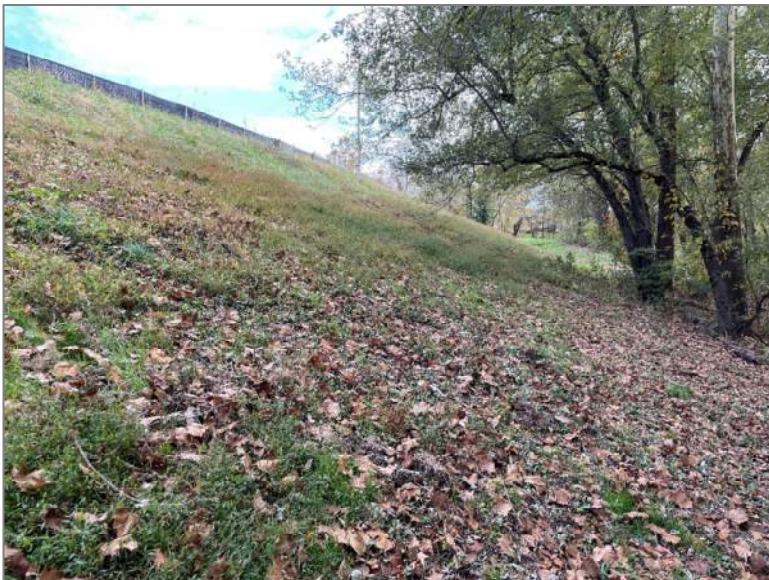
Photo 9

- The exterior slopes are mowed, vegetated, and uniform along the northwest, southwest, and southeast perimeter of the clearwater pond (Photo 9, Appendix D).
- Trees and woody vegetation are growing along the toe of the embankment and Kyger Creek (Photo 9, Appendix D).
- The topography is difficult to discern along the exterior toe of the southeast perimeter. Water may pond at the toe following rain events. Ground was firm and no standing water was observed at the exterior toe (Point 7, Appendix A; Photo 10, Appendix D).

Clearwater Pond – Southwest
Exterior Slope, facing southeast

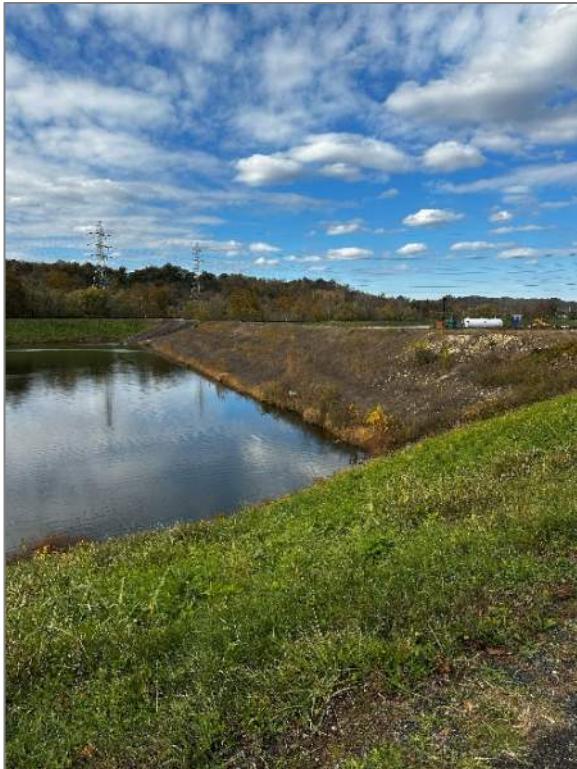
Photo 11

- Erosion rills were noted on both sides of the Splitter Dike near its crest and along the slopes of the dike (Point 12, Appendix A; Photos 11 through 14, Appendix D).

Clearwater Pond – Southwest slope of Splitter Dike facing northwest.

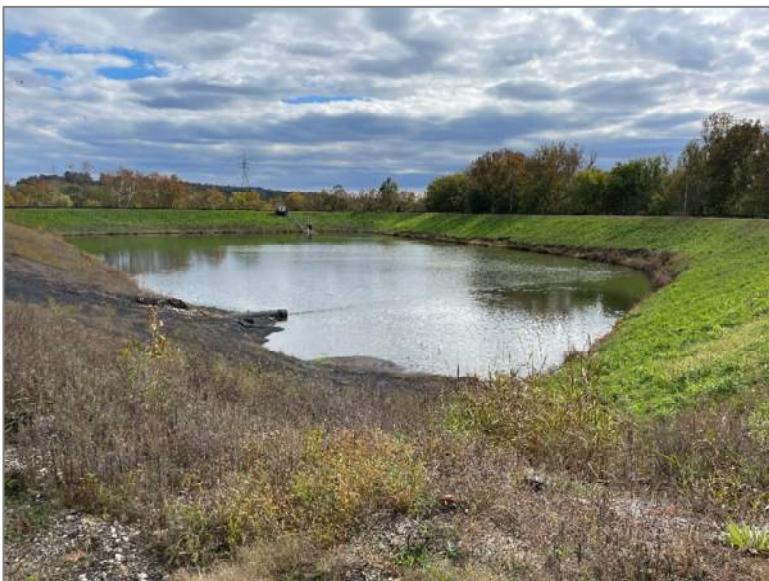
Photo 14

No operational flows were noted during the site visit into the boiler slag pond closure area. Ponded water was limited to an area at the toe of the LVWTS within the BSP closure area (Photo 13, Appendix D).

Clearwater Pond – Facing southeast from Splitter Dike

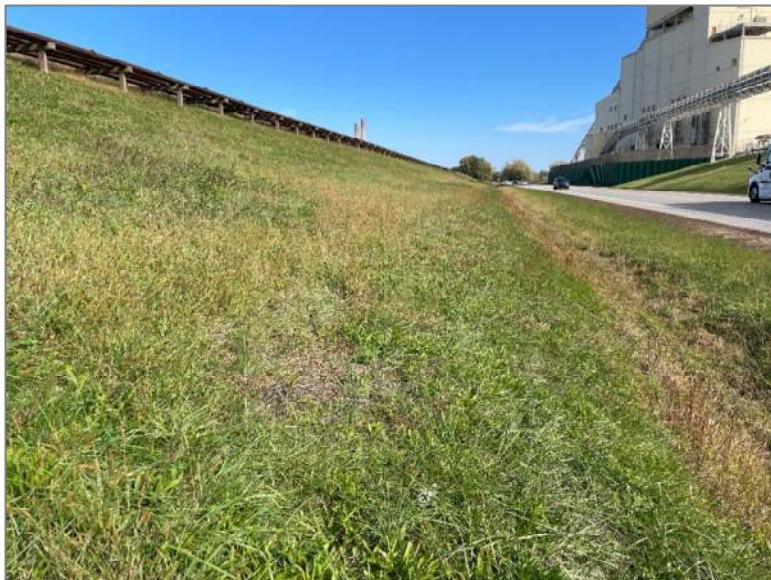
- In general, the downstream slopes appear to be in good condition with established, mowed grass and limited woody vegetation (Photos 21, 23, 27, 28, 34, and 41, Appendix D).

Photo 34
Southeast Exterior Slope –
Looking northeast.

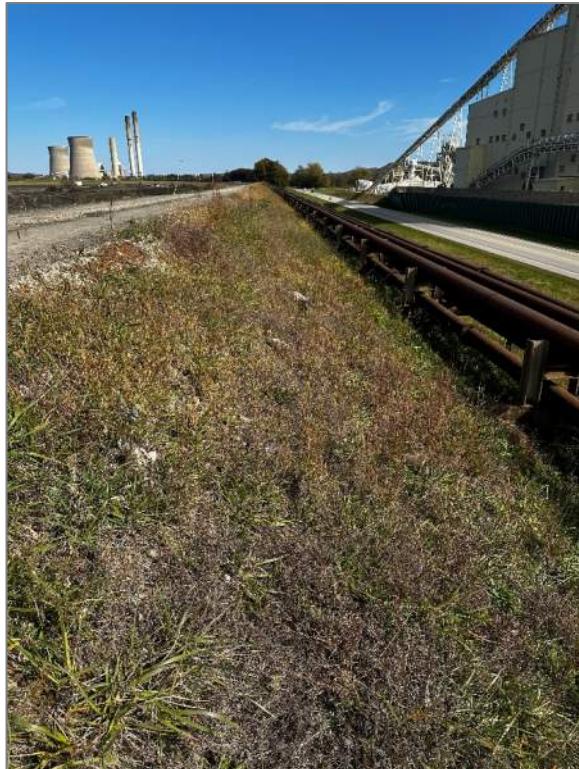
- Limited free water is visible within the impoundment due to dewatering for construction (Photo 24, Appendix D).
- Historic sluice lines are located along the southern and eastern dikes (Photos 35, 38, and 39, Appendix D).

Photo 35
Southeast Exterior Slope –
Looking northeast.
