**RE: Periodic Hazard Potential Classification Assessment
West Boiler Slag Pond
EPA Coal Combustion Residuals (CCR) Rule
Clifty Creek Station
Madison, Jefferson County, Indiana**

**RE: Initial Hazard Potential Classification Assessment
West Boiler Slag Pond and Landfill Runoff Collection Pond
EPA Final Coal Combustion Residuals (CCR) Rule
Clifty Creek Station
Madison, Jefferson County, Indiana**

Initial Hazard Potential Classification Assessment

Clifty Creek Station
West Boiler Slag Pond and Landfill
Runoff Collection Pond
Madison, Jefferson County, Indiana

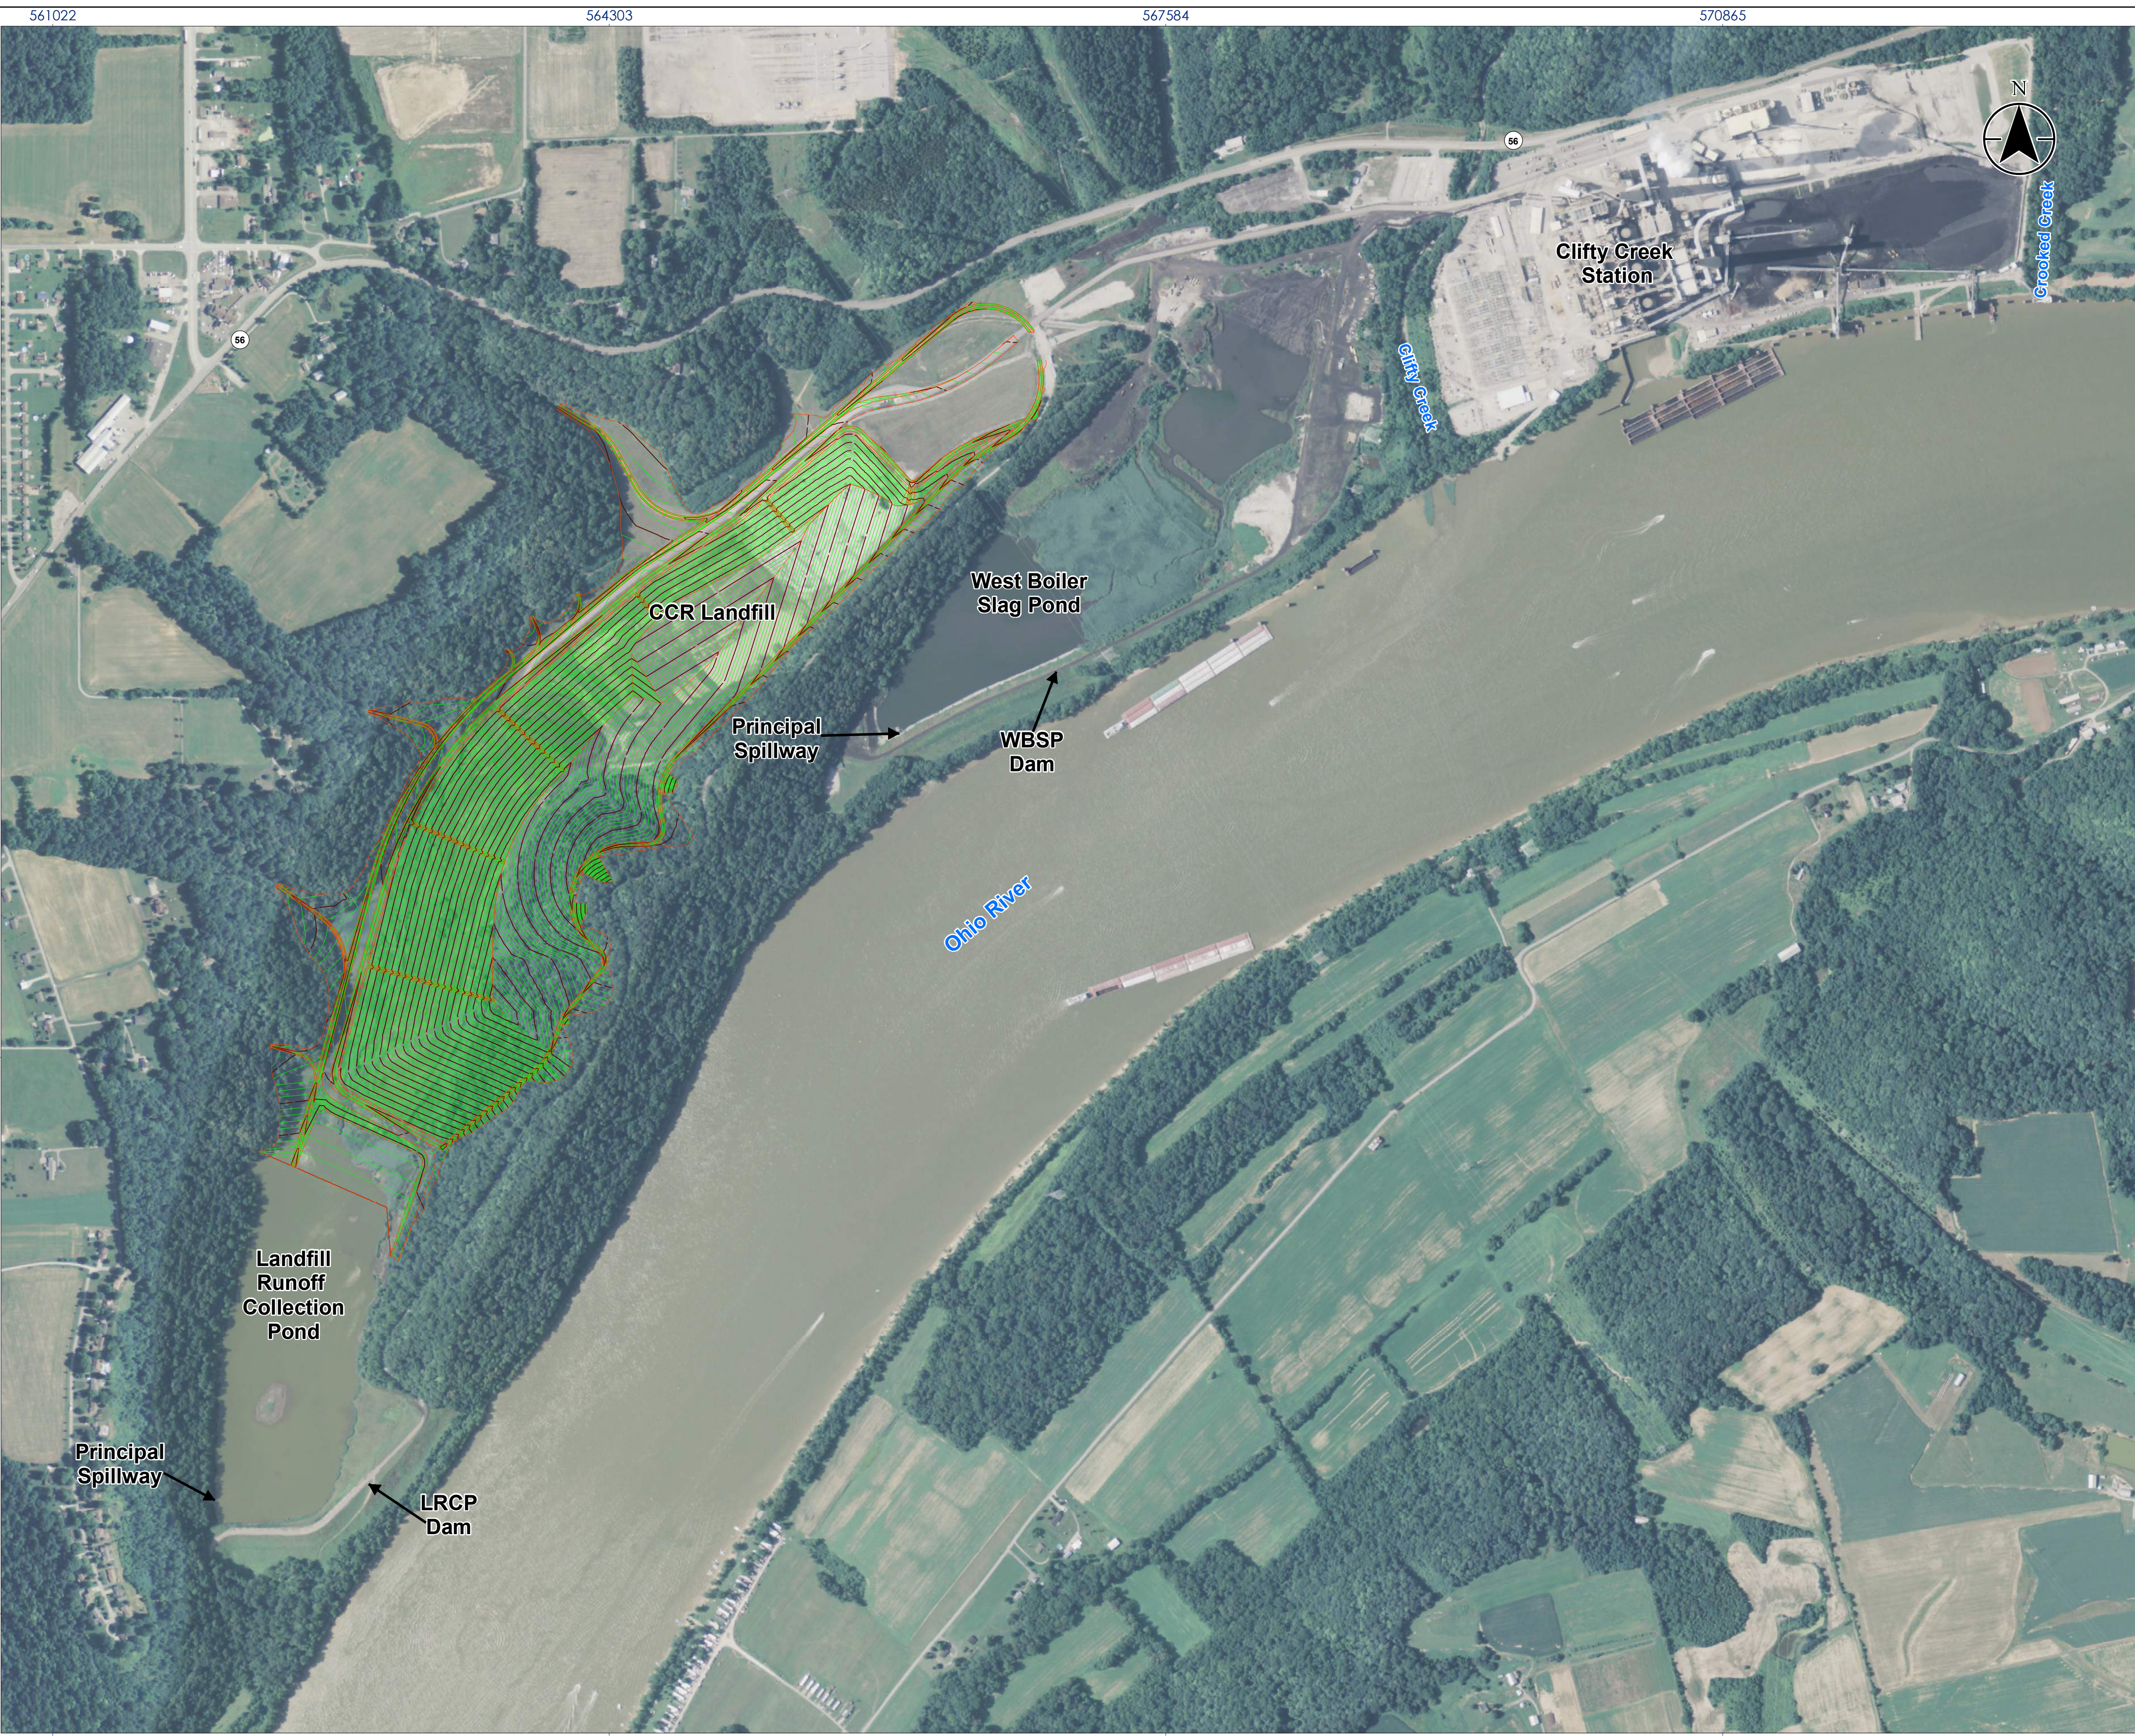
Figure No. **A-1**
 Title **Plan View of Clifty Creek Station**

Client/Project
 Clifty Creek Station
 Landfill Runoff Collection Pond and
 West Boiler Slag Pond

1.0	INTRODUCTION	1
1.1	OBJECTIVE	1
1.2	OUTLINE OF RULE REQUIREMENTS	1
2.0	SUMMARY OF FINDINGS	2
2.1	WEST BOILER SLAG POND DAM - EMERGENCY ACTION PLAN – BREACH ANALYSIS REVIEW	2
2.1.1	WBSP Facility Description	2
2.1.2	Development of Hydrologic and Hydraulic Model	3
2.1.3	Breach Parameters	3
2.1.4	Dam Breach and Downstream Routing	4
2.1.5	Flood Profiles and Floodplain Delineation	4
2.1.6	WBSP Hazard Classification	4
2.2	LANDFILL RUNOFF COLLECTION POND DAM - EMERGENCY ACTION PLAN – BREACH ANALYSIS REVIEW	5
2.2.1	LRCP Facility Description	5
2.2.2	Development of Hydrologic and Hydraulic Model	5
2.2.3	Breach Parameters	6
2.2.4	Dam Breach and Downstream Routing	6
2.2.5	Flood Profiles and Floodplain Delineation	7
2.2.6	LRCP Hazard Classification	7
3.0	CONCLUSION	7
4.0	REFERENCES.....	8
	LIST OF FIGURES	
	Figure 1 Plan View of Clifty Creek Station	9
