**RE: Periodic Hazard Potential Classification Assessment
 Landfill Runoff Collection Pond
 EPA Coal Combustion Residuals (CCR) Rule
 Clifty Creek Station
 Madison, Jefferson County, Indiana**

**RE: Initial Hazard Potential Classification Assessment
West Boiler Slag Pond and Landfill Runoff Collection Pond
EPA Final Coal Combustion Residuals (CCR) Rule
Clifty Creek Station
Madison, Jefferson County, Indiana**

Initial Hazard Potential Classification Assessment

Clifty Creek Station
West Boiler Slag Pond and Landfill
Runoff Collection Pond
Madison, Jefferson County, Indiana

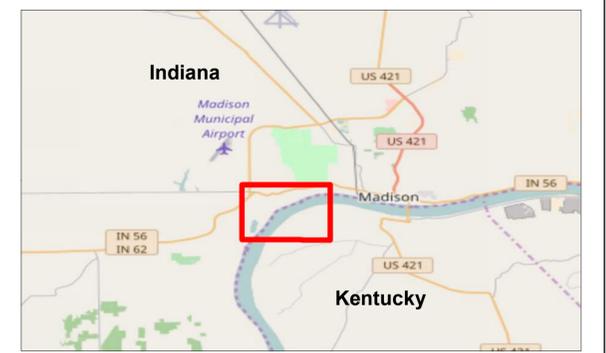
Project Location 175534018
 Madison Jefferson County, IN Prepared by AP on 2016-10-13
 Technical Review by JH on 2016-10-13
 Independent Review by SH on 2016-10-13

0 500 1,000 Feet
 1:6,000 (At original document size of 11x17)

- Notes**
1. Coordinate System: NAD 1927 StatePlane Indiana East FIPS 1301
 2. USDA - NAIP 2014 Ortho-Imagery
 3. Fuller, Mossbarger, Scott, & May, Inc. (FMSM) (2006b). Permit Drawings. Indiana-Kentucky Electric Corporation. Clifty Creek Coal Ash Landfill Modification. Jefferson County, Madison Township, Indiana. November. Dwg. No. 16-30500-09-A. Coal Ash Landfill. Top of Cover

1.0	INTRODUCTION	1
1.1	OBJECTIVE	1
1.2	OUTLINE OF RULE REQUIREMENTS	1
2.0	SUMMARY OF FINDINGS	2
2.1	WEST BOILER SLAG POND DAM - EMERGENCY ACTION PLAN – BREACH ANALYSIS REVIEW	2
2.1.1	WBSP Facility Description	2
2.1.2	Development of Hydrologic and Hydraulic Model	3
2.1.3	Breach Parameters	3
2.1.4	Dam Breach and Downstream Routing	4
2.1.5	Flood Profiles and Floodplain Delineation	4
2.1.6	WBSP Hazard Classification	4
2.2	LANDFILL RUNOFF COLLECTION POND DAM - EMERGENCY ACTION PLAN – BREACH ANALYSIS REVIEW	5
2.2.1	LRCP Facility Description	5
2.2.2	Development of Hydrologic and Hydraulic Model	5
2.2.3	Breach Parameters	6
2.2.4	Dam Breach and Downstream Routing	6
2.2.5	Flood Profiles and Floodplain Delineation	7
2.2.6	LRCP Hazard Classification	7
3.0	CONCLUSION	7
4.0	REFERENCES.....	8
	LIST OF FIGURES	
	Figure 1 Plan View of Clifty Creek Station	9
