HISTORY OF CONSTRUCTION

CFR 257.73(c)(1)

Boiler Slag Pond

Kyger Creek Station Cheshire, Ohio

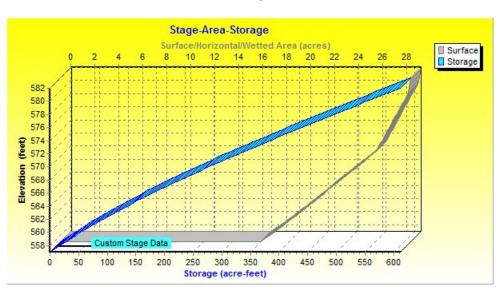
The area capacity curve for the Boiler Slag Pond is described within the Hydrology and Hydraulic Analysis Report by DLZ, September 2015 located in Attachment E.
