**RE: Periodic Hazard Potential Classification Assessment  
South Fly Ash Pond  
EPA Coal Combustion Residuals (CCR) Rule  
Kyger Creek Station  
Cheshire, Gallia County, Ohio**

**RE: Initial Hazard Potential Classification Assessment  
South Fly Ash Pond and Boiler Slag Pond  
EPA Final Coal Combustion Residuals (CCR) Rule  
Kyger Creek Station  
Cheshire, Gallia County, Ohio**

## **Initial Hazard Potential Classification Assessment**

Kyger Creek Station  
South Fly Ash Pond and Bottom  
Slag Pond  
Cheshire, Gallia County, Ohio

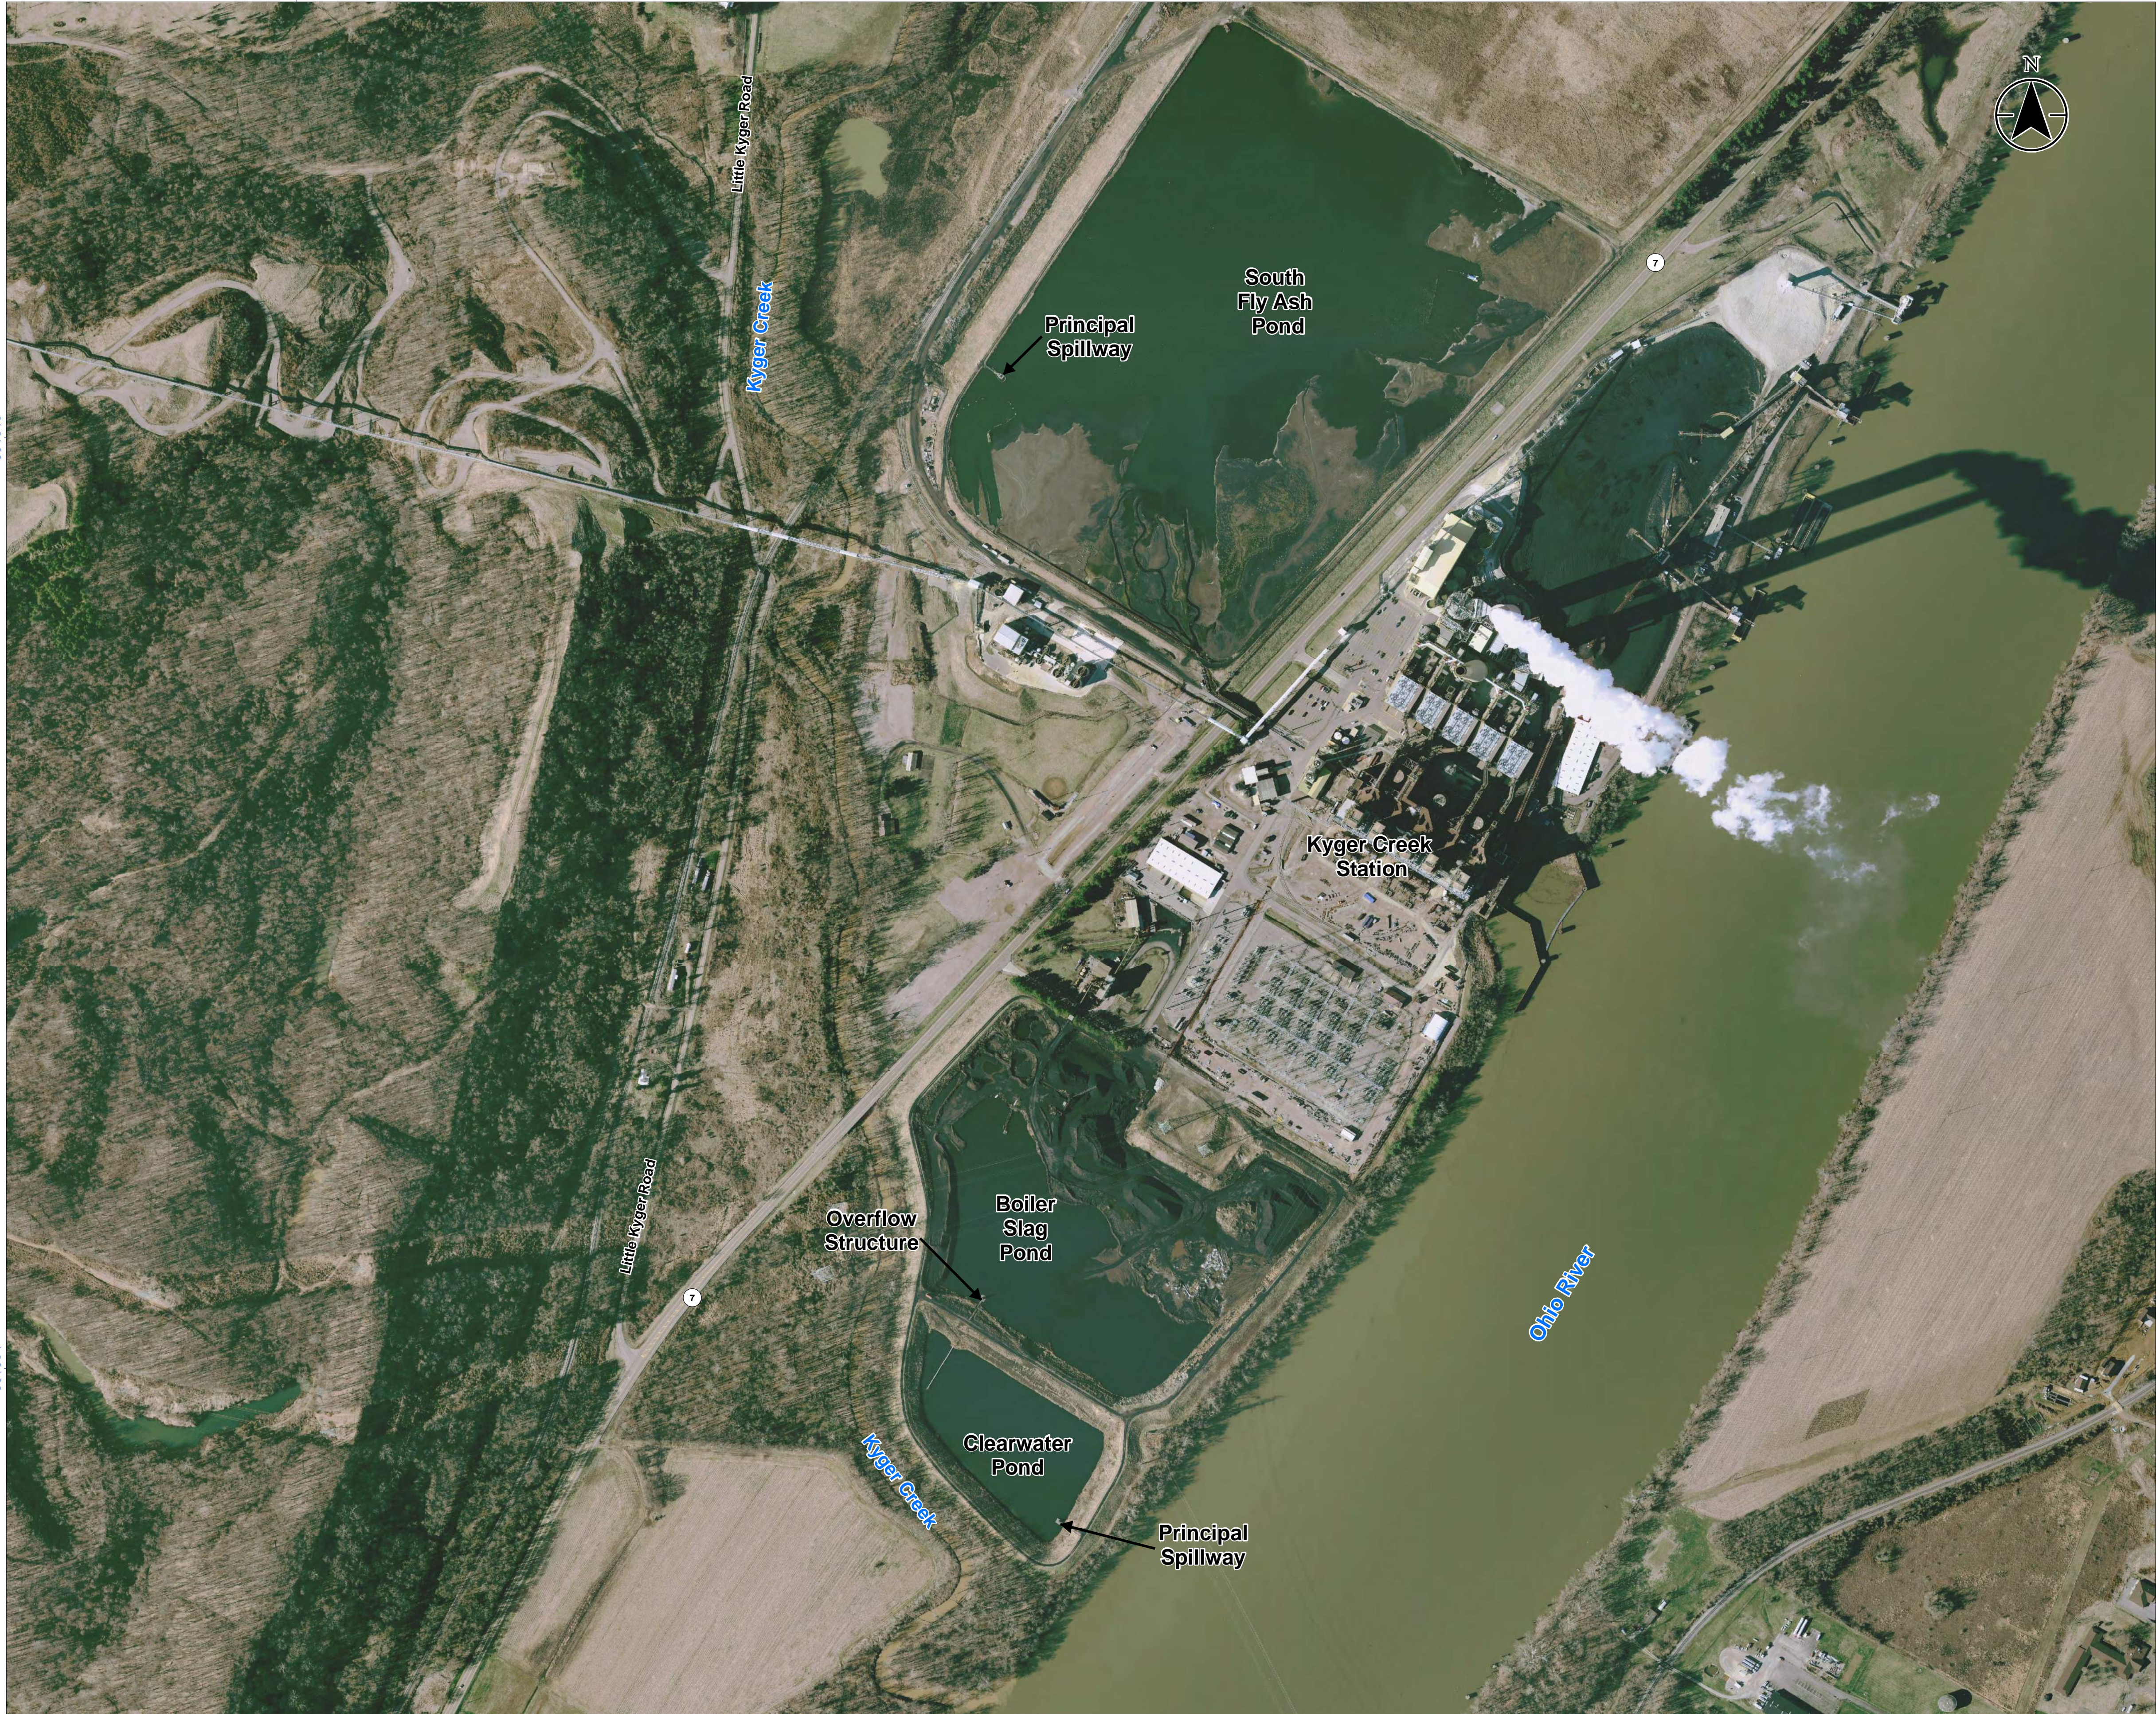
Figure No.  
**A-1**  
 Title  
**Plan View of Kyger Creek Station**

Client/Project  
**Kyger Creek Station**  
**South Fly Ash Pond and Boiler Slag Pond**
