**Re: Indiana-Kentucky Electric Corporation
Notification of CCR Rule Information Posting
Temporary Lined Basin – Location Restrictions**

**RE: Location Restrictions Compliance Demonstrations
Temporary Lined Basin
West Boiler Slag Pond
EPA Final Coal Combustion Residuals (CCR) Rule
Clifty Creek Station
Madison, Jefferson County, Indiana**

This letter documents Stantec's certification of the location restrictions compliance demonstrations for the Indiana-Kentucky Electric Corporation (IKEC) Clifty Creek Station's temporary lined basin located within the West Boiler Slag Pond (WBSP). It is considered a new CCR surface impoundment and is constructed within the existing WBSP footprint.

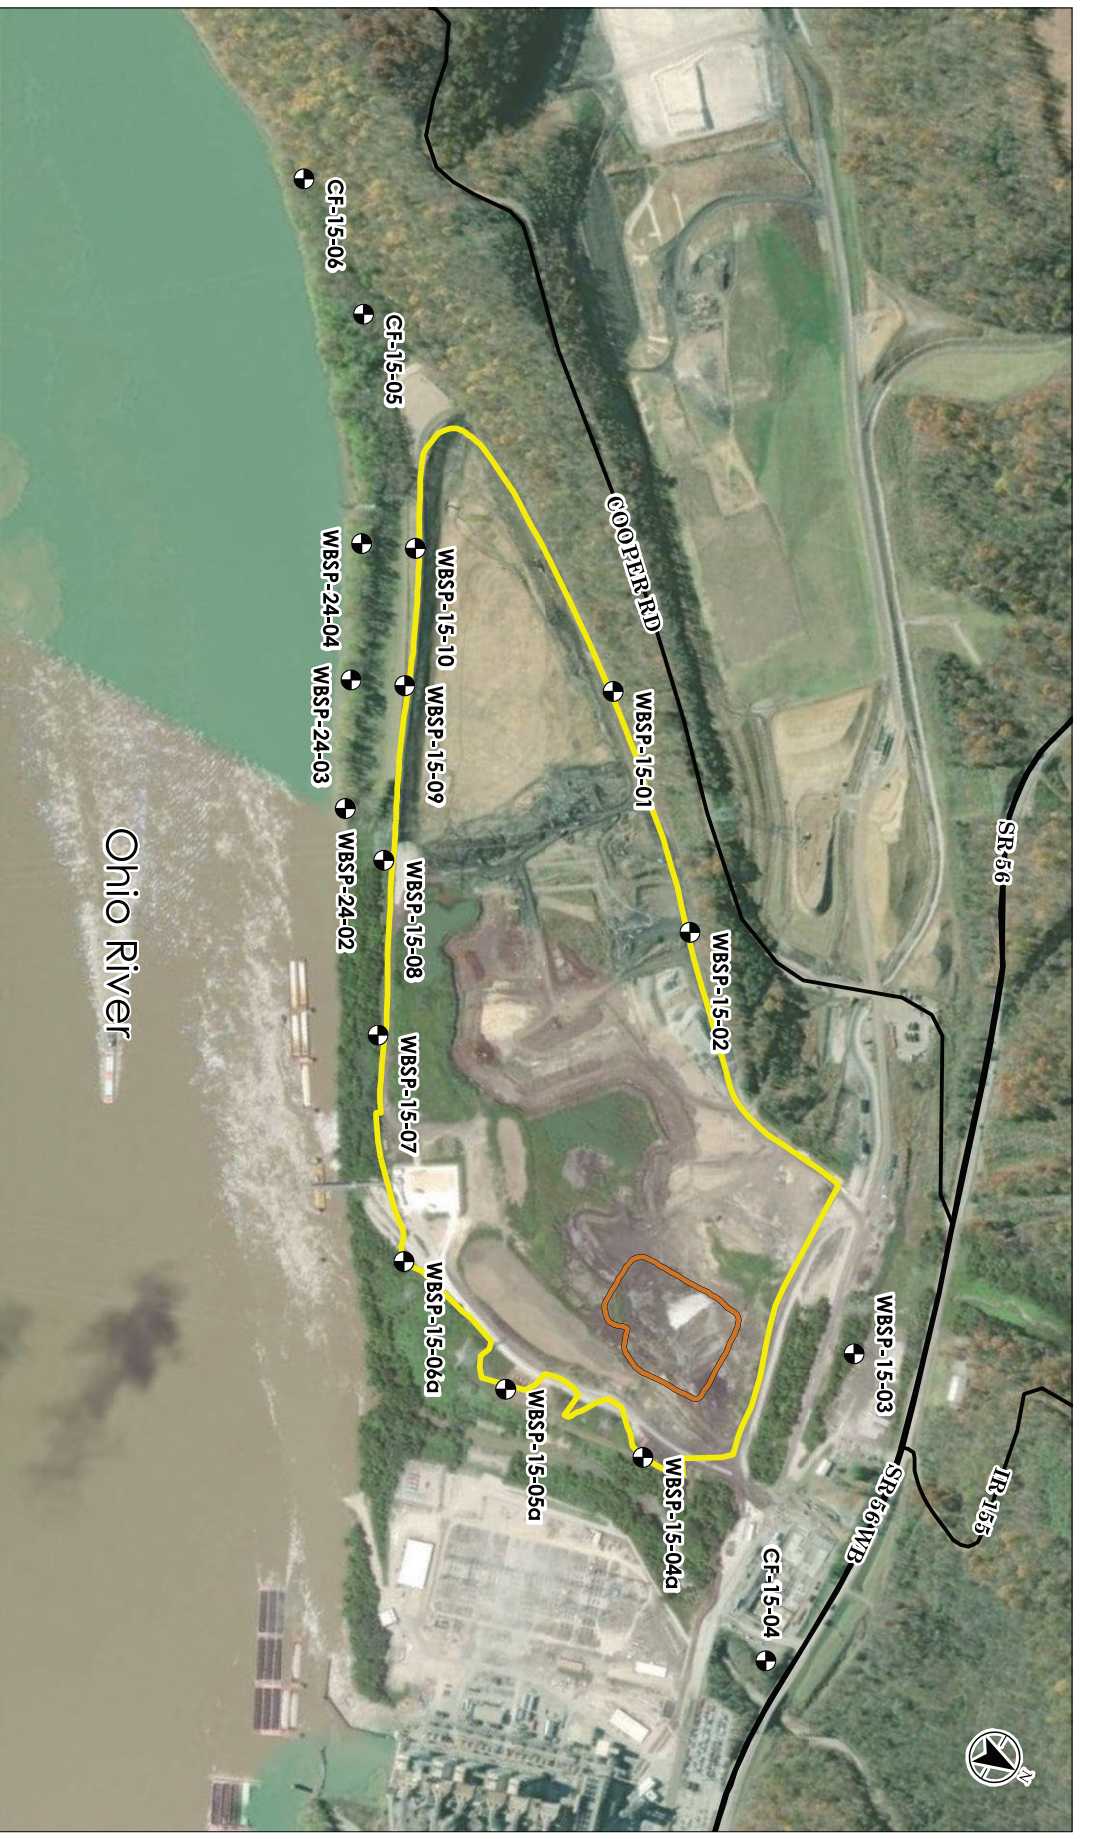
FIGURES

- Legend**
- Monitoring Well
 - Temporary Lined Basin (TLB)
 - Road
 - Site Boundary

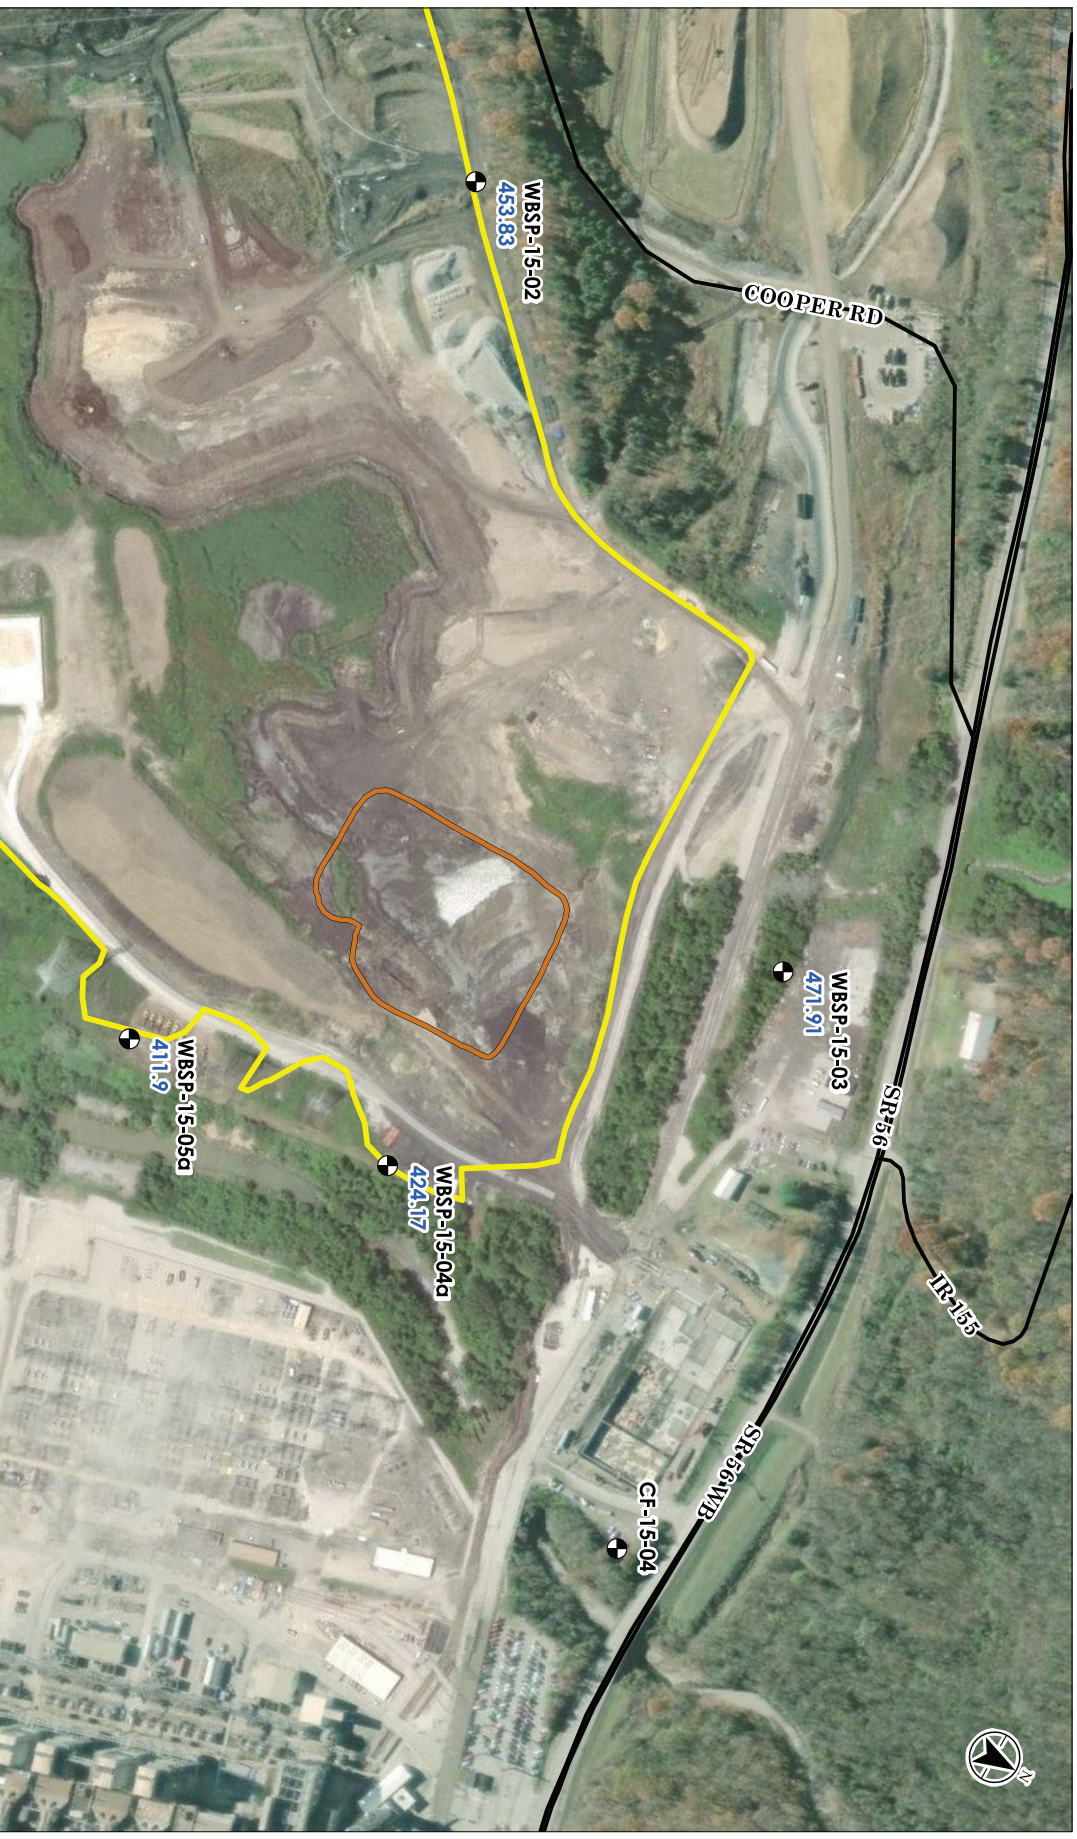
Figure No.
2

Title
WEST BOILER SLAG POND

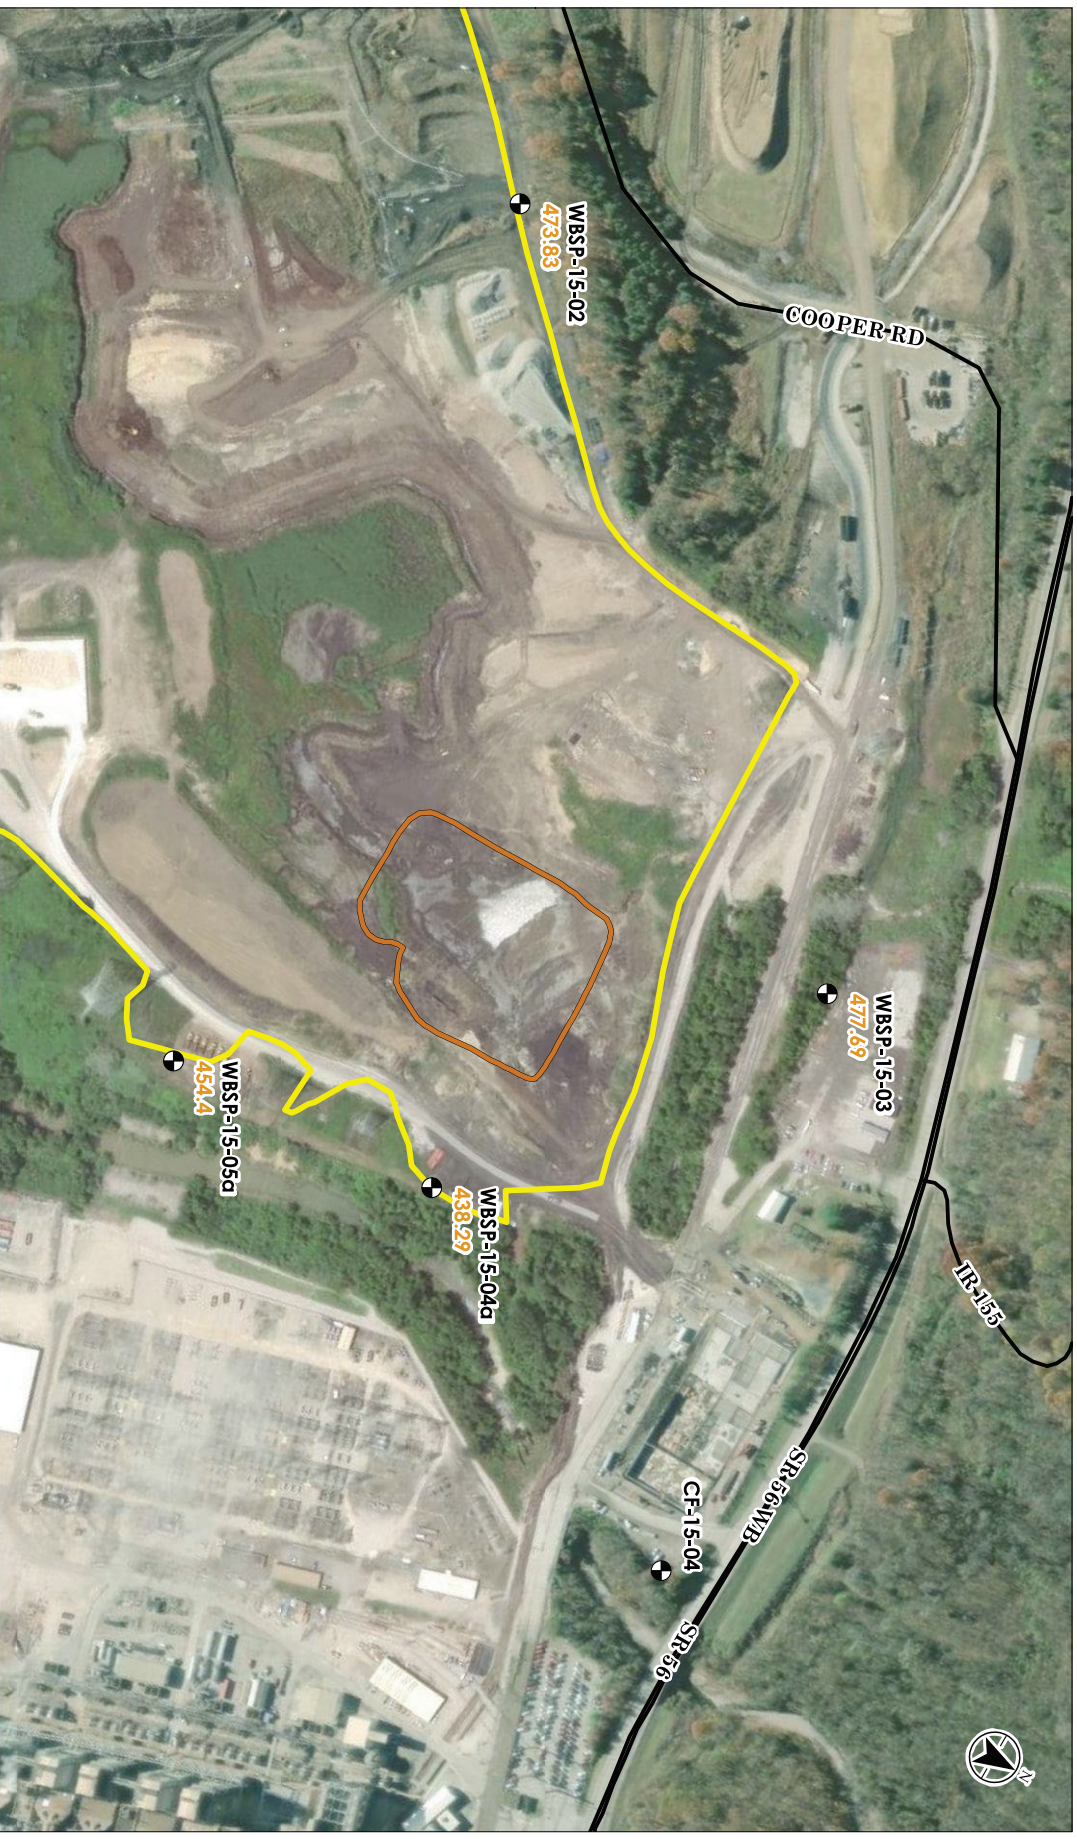
Figure No.
3

Title
**ESTIMATED TOP OF
 THE UPPERMOST AQUIFER
 WEST BOILER SLAG POND
 TEMPORARY LINED BASIN**

The review of groundwater elevation data indicates that groundwater within the UMA is generally present under confined conditions; therefore, the top of the UMA beneath the TLB and the WBSP is defined based on the structure of the top of the UMA, when present. For this demonstration, the top of the UMA was identified as the transition from finer grained material consistent with the alluvium that is present above the UMA to material consistent with the UMA. In areas where material consistent with the UMA was not present beneath the Unit, the UMA was conservatively identified as either the stratigraphic top of bedrock (as discussed in section 2.3) or the first encountered intermittent sand seam or lens.

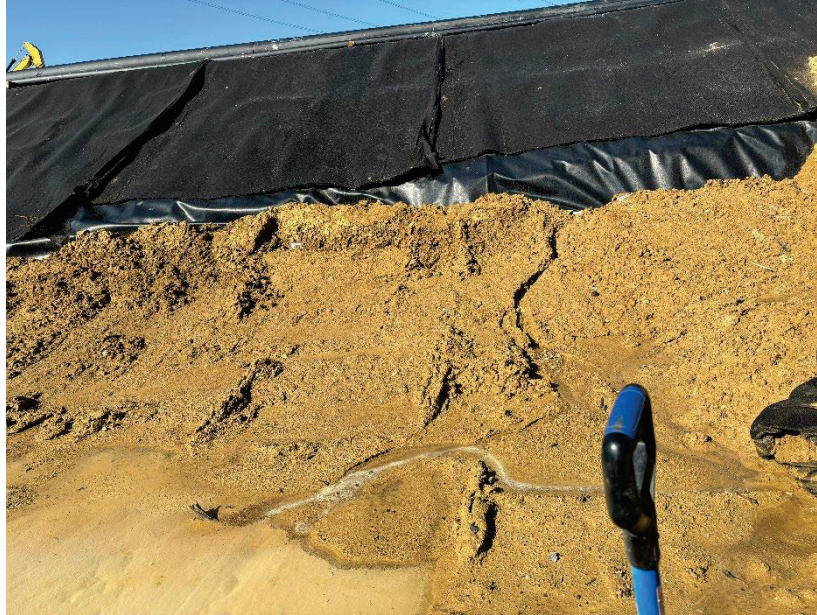
Photograph 1. View of upland (active construction area) at wetland determination sample point SP01. Photograph taken facing west.

The reconnaissance investigation was conducted on March 9, 2026. Stantec biologists conducted a pedestrian survey to ascertain whether any areas of potential wetlands were present within the study area (as shown on Attachment A). Two locations were examined for potential wetland presence (SP01 and SP02) but were found to be within upland areas. At wetland determination sample point location SP01, two primary indicators of hydrology (surface water and saturation) were observed. However, the sample point location did not meet the criteria for hydric soil or hydrophytic vegetation. No wetland indicators were observed within wetland determination sample point location SP02. The wetland determination data forms completed by Stantec are provided in Attachment B and representative photographs are provided in Attachment C.

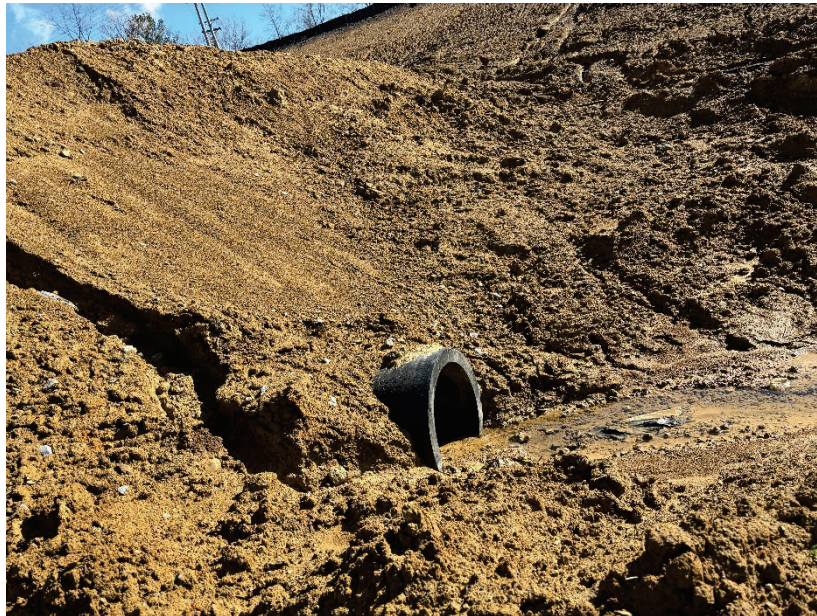
Photograph 2. View of upland (active construction area) at wetland determination sample point SP01. Photograph taken facing northeast.

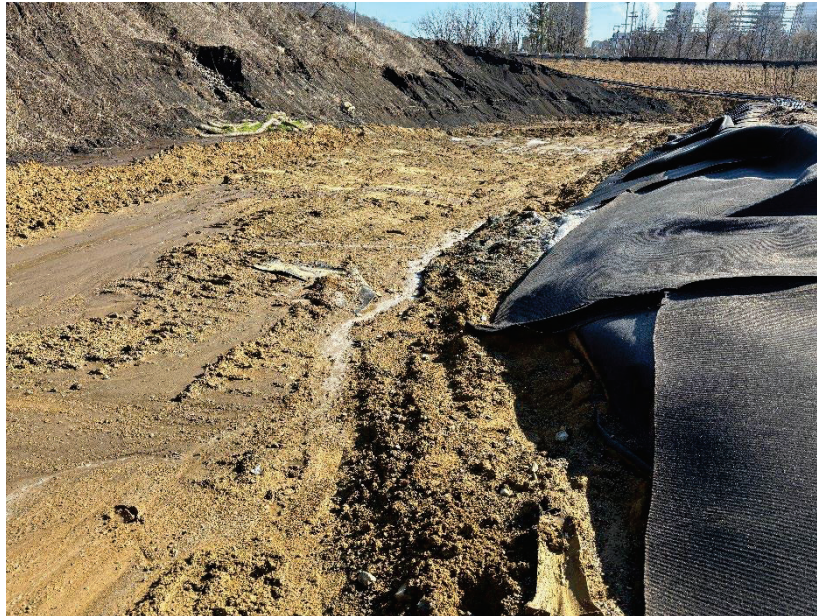
Photograph 3. View of upland (active construction area) at wetland determination sample point SP02. Photograph taken facing northeast.

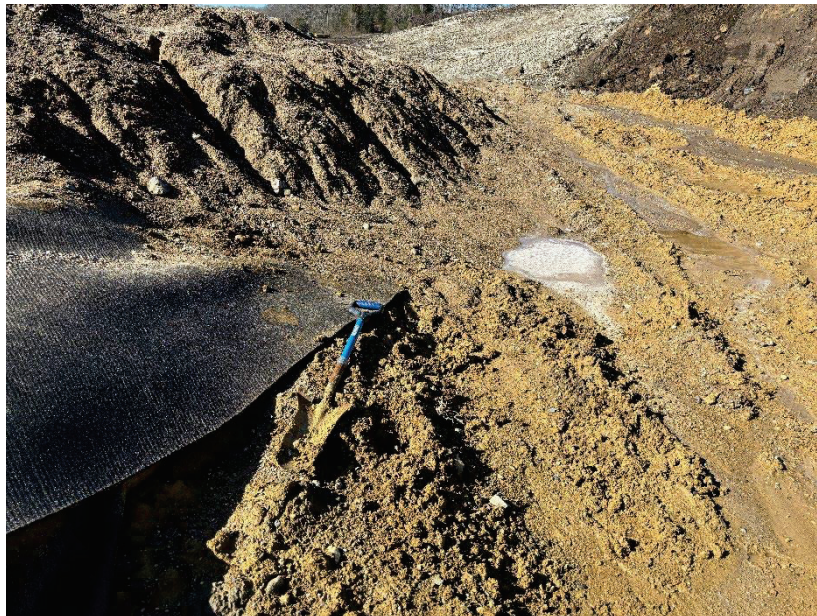
Photograph 4. View of upland (active construction area) at wetland determination sample point SP02. Photograph taken facing west.

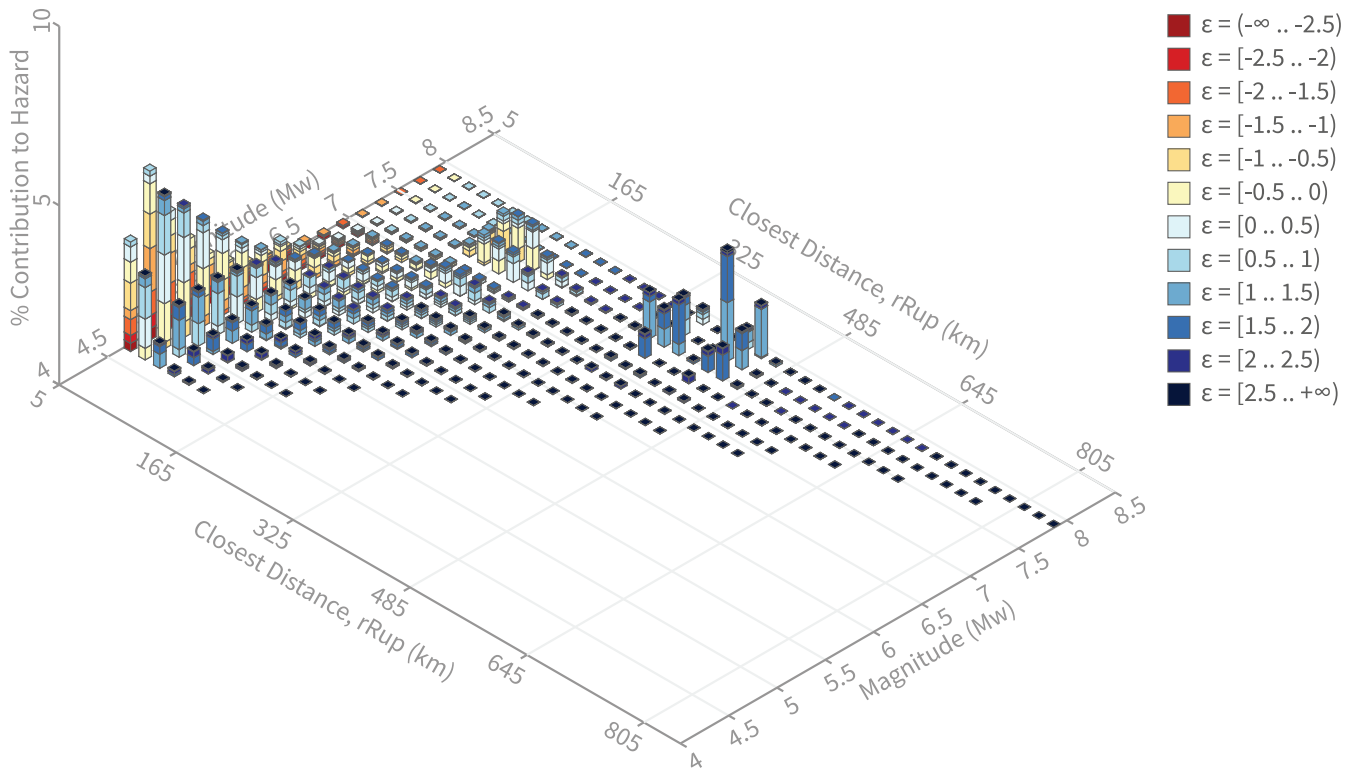
Summary statistics for, Deaggregation: Total

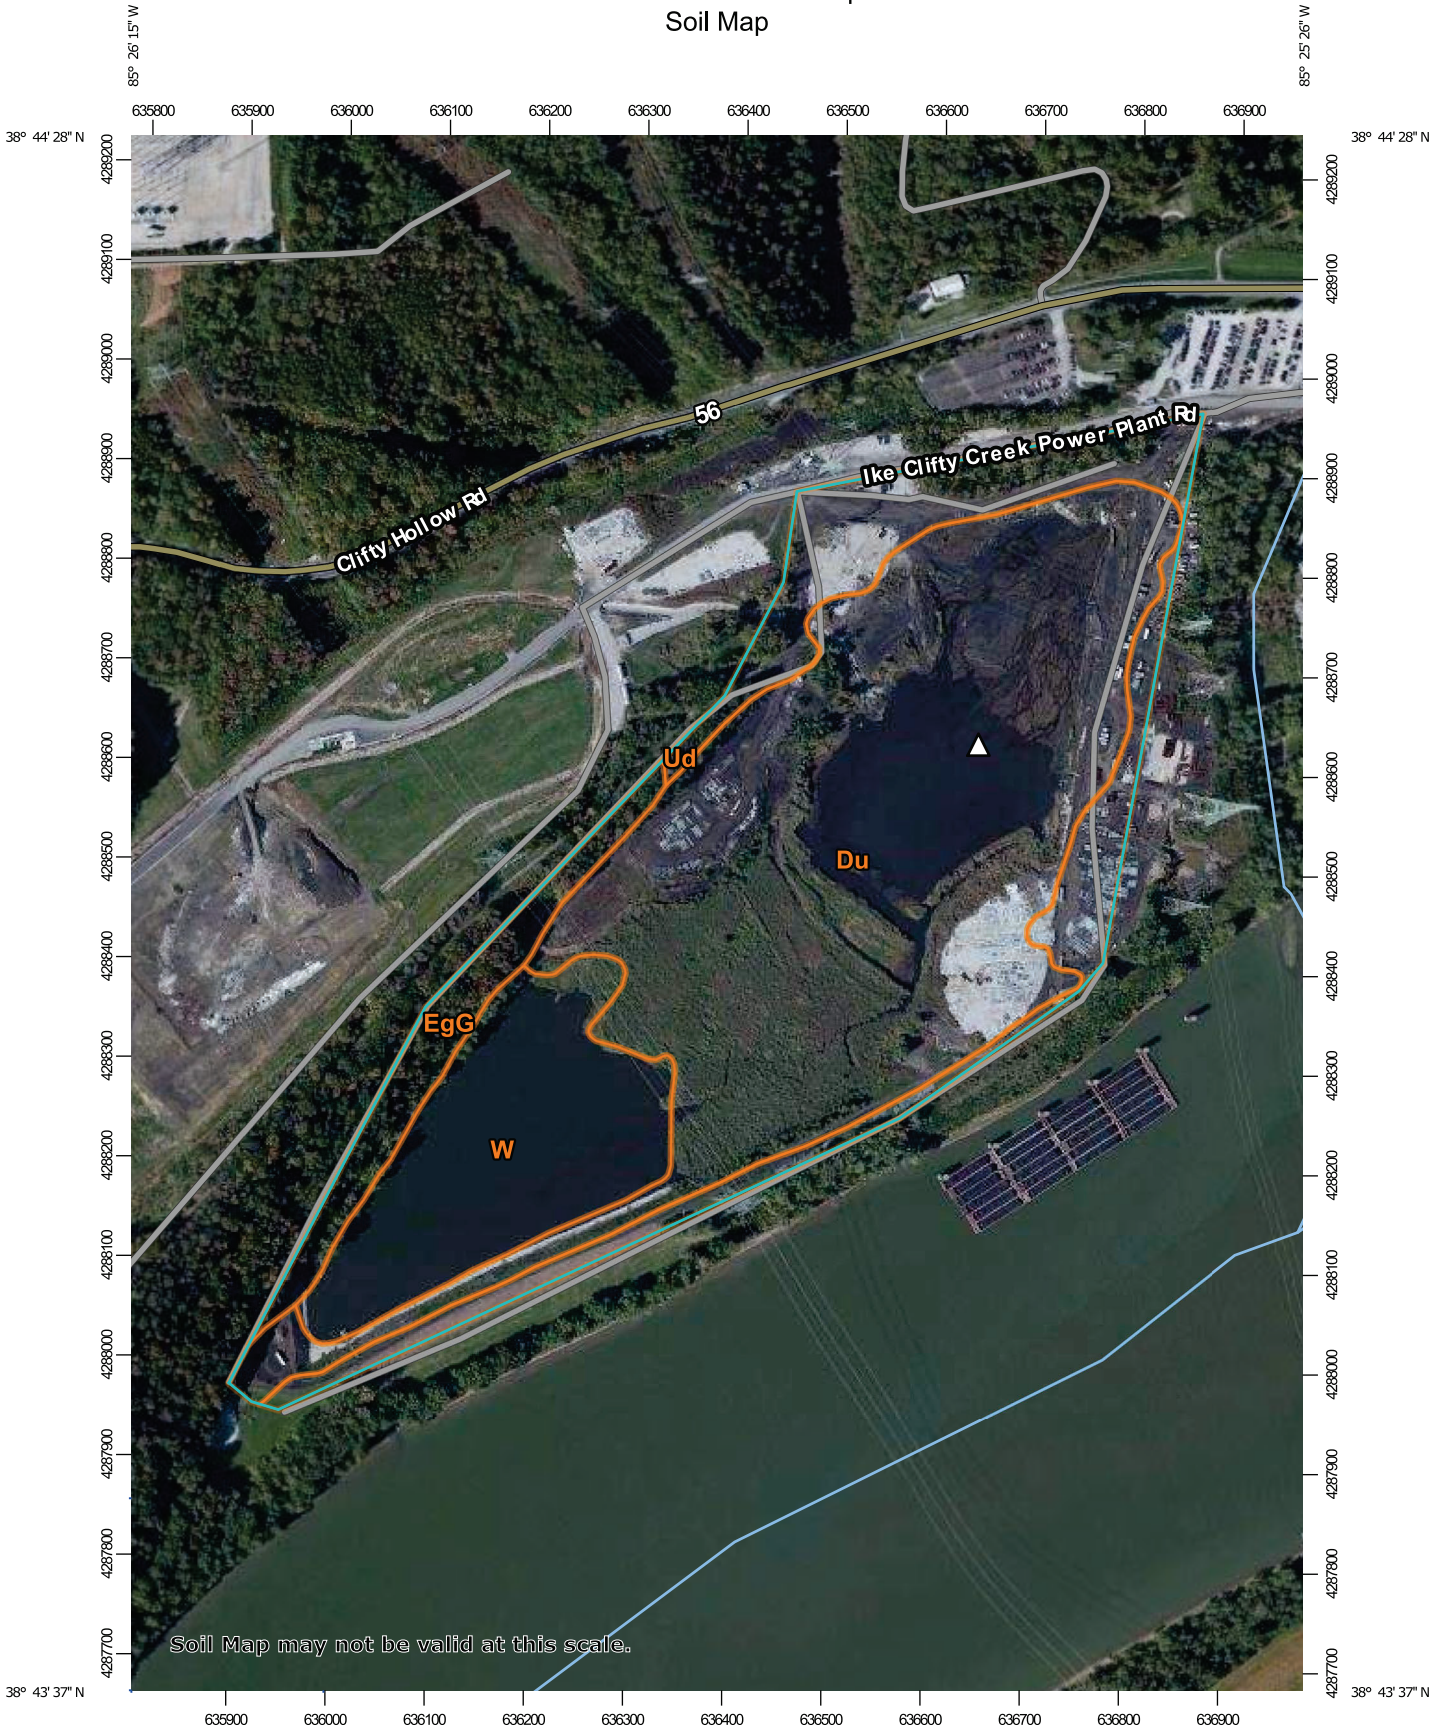
Custom Soil Resource Report Soil Map

Soil Map may not be valid at this scale.

Map Scale: 1:7,610 if printed on A portrait (8.5" x 11") sheet.

The soil map section includes the soil map for the defined area of interest, a list of soil map units on the map and extent of each map unit, and cartographic symbols displayed on the map. Also presented are various metadata about data used to produce the map, and a description of each soil map unit.
