**Re: Indiana-Kentucky Electric Corporation
Clifty Creek Station
Notification of CCR Rule Information Posting
Annual Certified CCR Dam and Dike (Surface Impoundment)
Inspection Report Posting**

**2025 CCR Rule – Surface Impoundments
Clifty Creek Dam/Dike Inspections**

Clifty Creek Generating Station
Madison, Indiana
Jefferson County

January 19, 2026

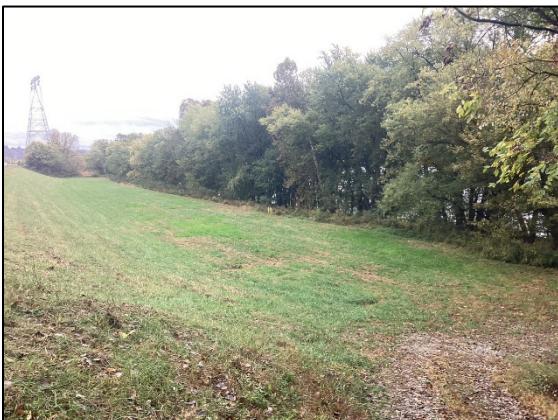
Photo 5, Point 3

WBSP Dam looking east from LVWTS.

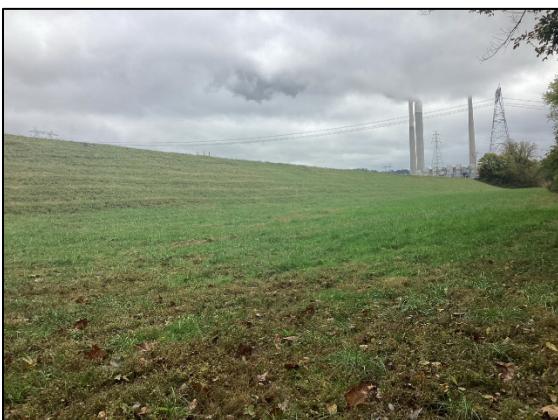
Photo 6, Point 4

WBSP Dam looking north.

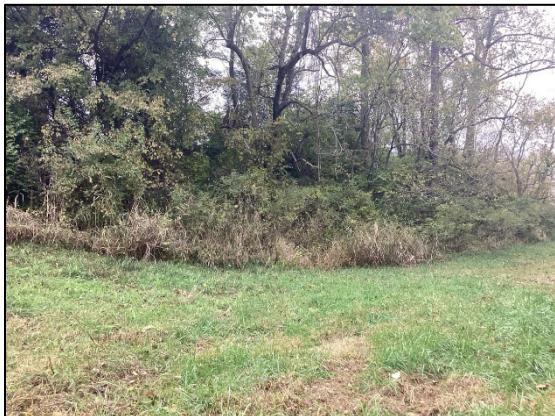
Photo 16, Point 13
High vegetation overgrowth on Dam face.

The upstream and downstream dike slopes and crest areas, east of the LVWTS, are overgrown with small to large trees and heavy brush (Photographs 16, 17, and 18 in Appendix D). These conditions make it virtually impossible to inspect the slopes. The trees and larger brush can also provide seepage pathways as the larger foliage dies off. Trees that topple in windstorms can leave large holes exposed in the face of the dam. Stantec recommends that the overgrown crest and downstream side of the dam be stripped of foliage, graded for ease of maintenance, and seeded with grass to protect it from erosion. This will allow for future inspections to be conducted on this portion of the dam.

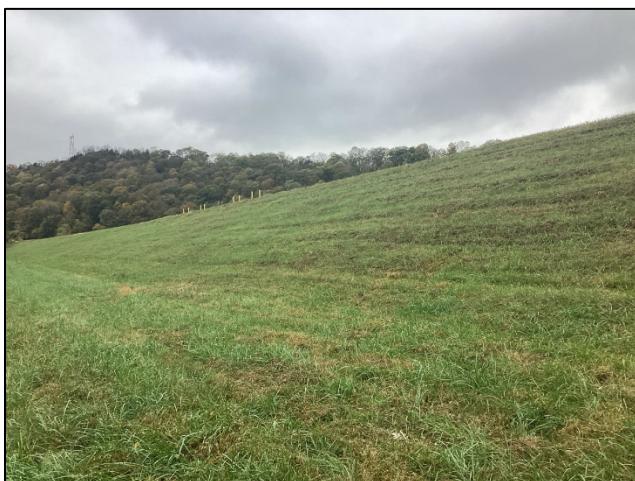
Photo 21, Point 17
WBSP Dam looking west from toe.

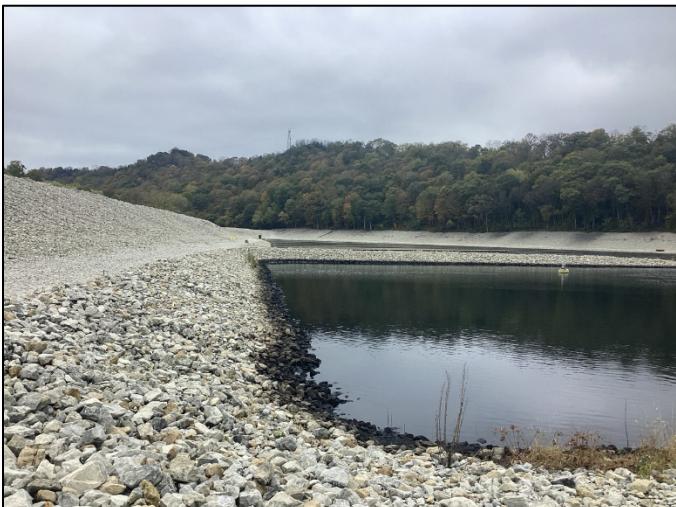
Photo 33, Point 26

LVWTS looking west.

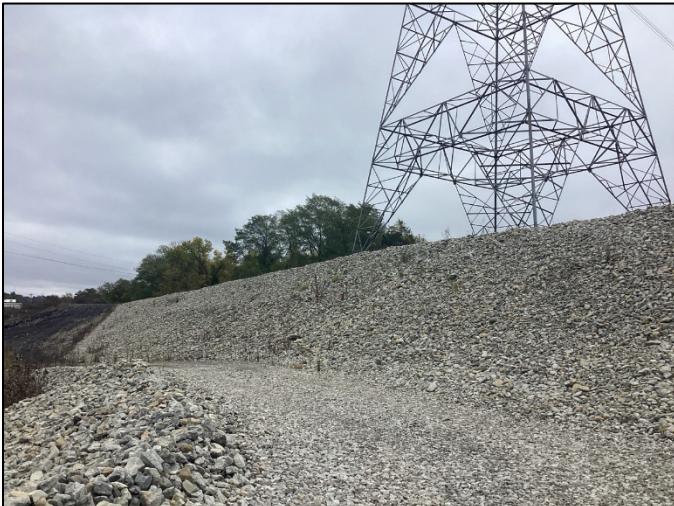
Photo 34, Point 26
WBSP CCR closure excavation area
looking north from LVWTS.

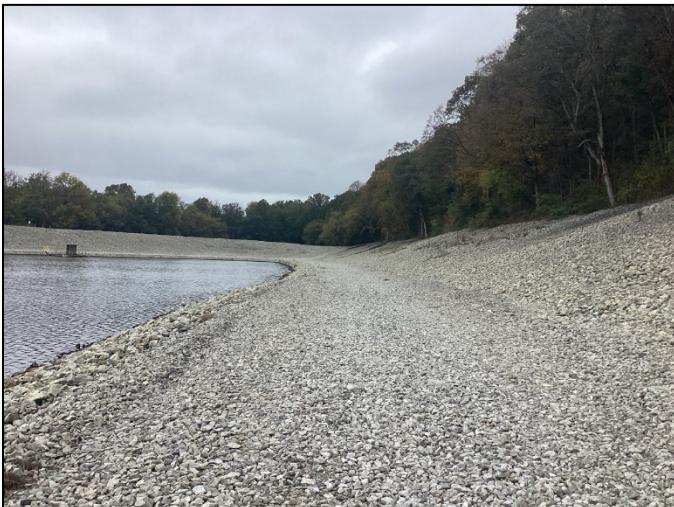
Photo 35, Point 26
LVWTS Slope supporting electric tower.

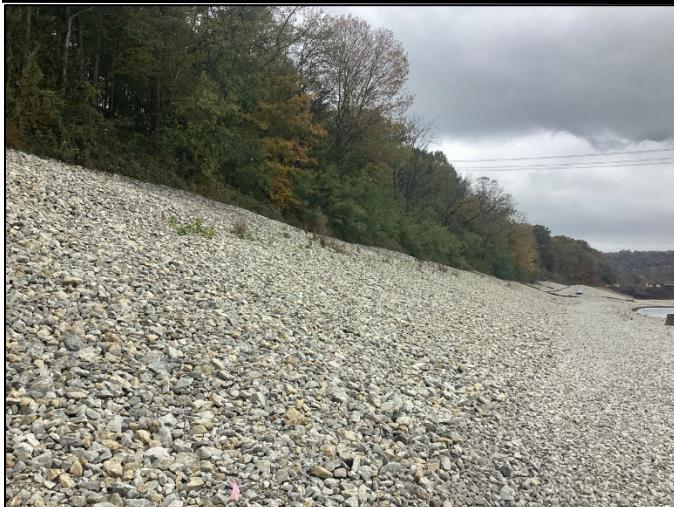
Photo 36, Point 27
LVWTS slope along Devil's Backbone
formation.

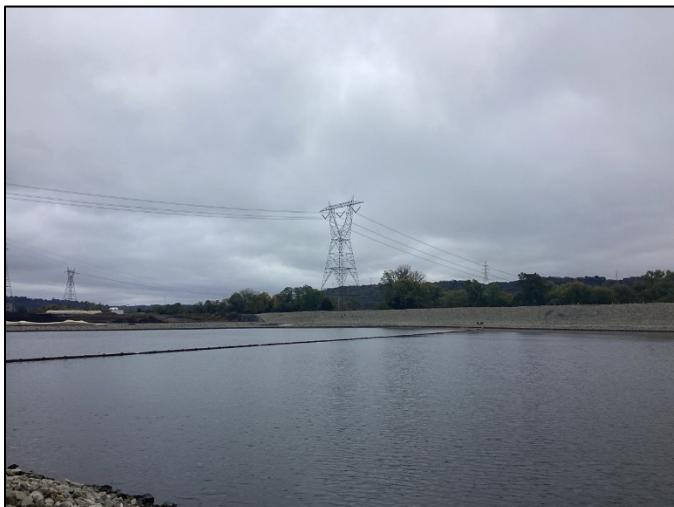
Photo 37, Point 27
LVWTS slope along Devil's Backbone formation.

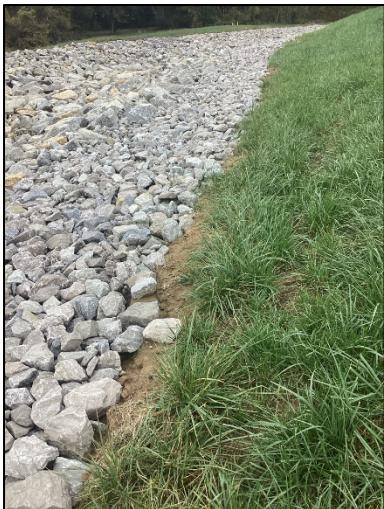
Photo 43, Point 30

Erosion and scouring pin flagged on
WBSP-Devil's Backbone Road slope.

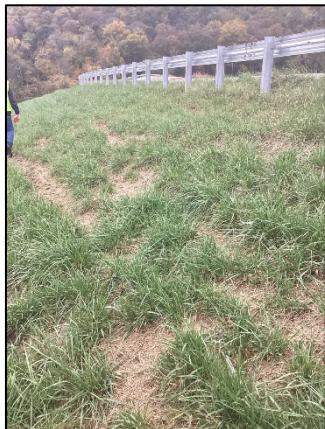
Photo 1, Point 1
Erosion along channel riprap.

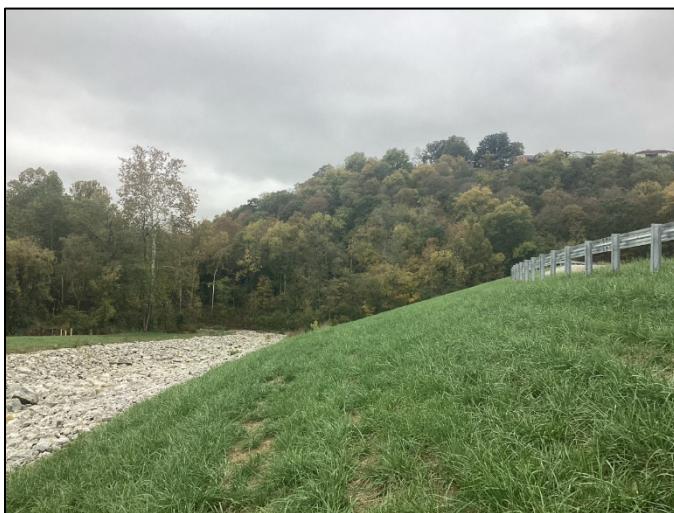
Photo 2, Point 1
Bare areas.

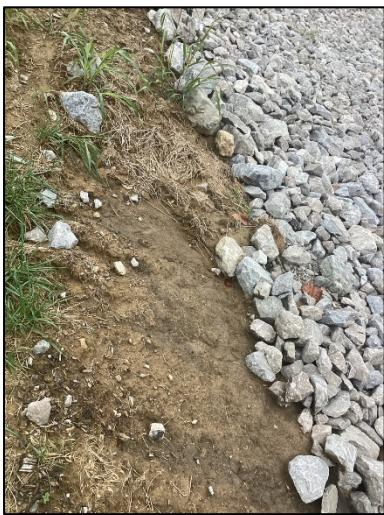
Photo 8, Point 6
Animal burrowing.

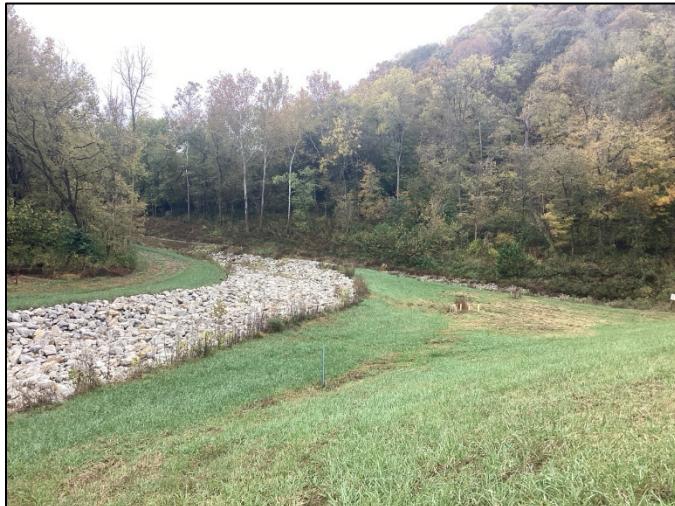
Photo 10, Point 7
Riprap channel side erosion.

Some additional riprap and revegetation may be necessary along the downstream channel to fill in bare spots due to removed silt fencing (Photograph 9 and 10).

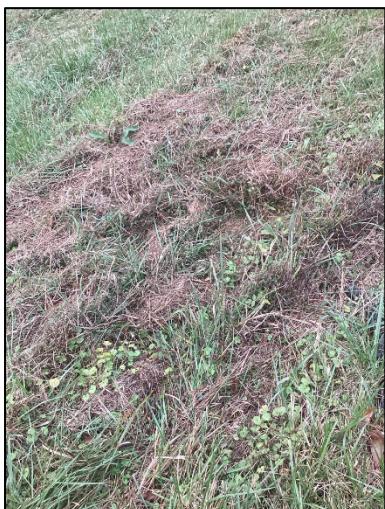
Photo 14, Point 11
Dead grass and depression.

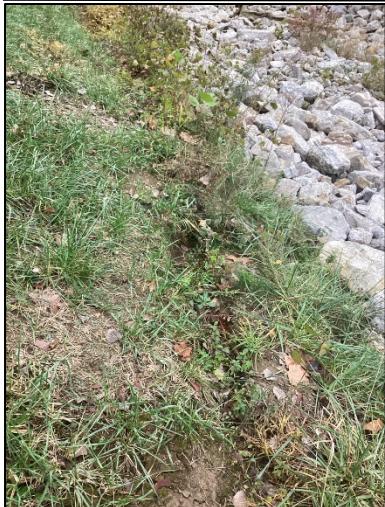
Photo 21, Point 16
LRCP Dam face looking north.

Minor maintenance for the LRCP includes repairing the erosion rills above and below the downstream channel, and monitoring the surface-sloughed area beneath the access road to the toe will likely require attention as well (Photographs 19, 21, 22, 24, and 30).

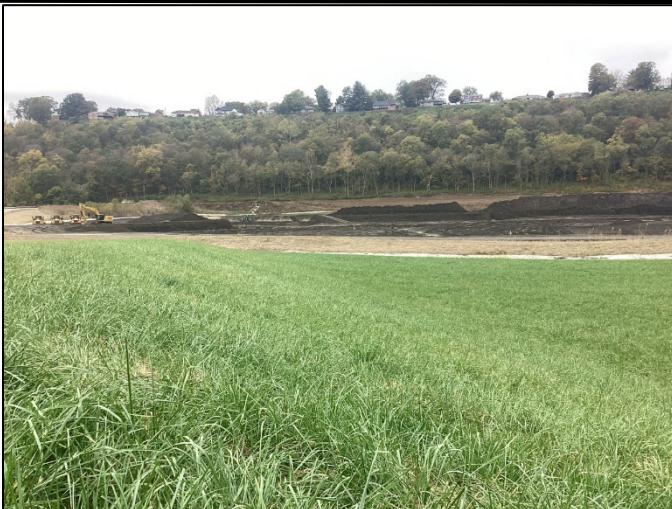
Photo 33, Point 22

LRCP Dam face riprap blanket view west.

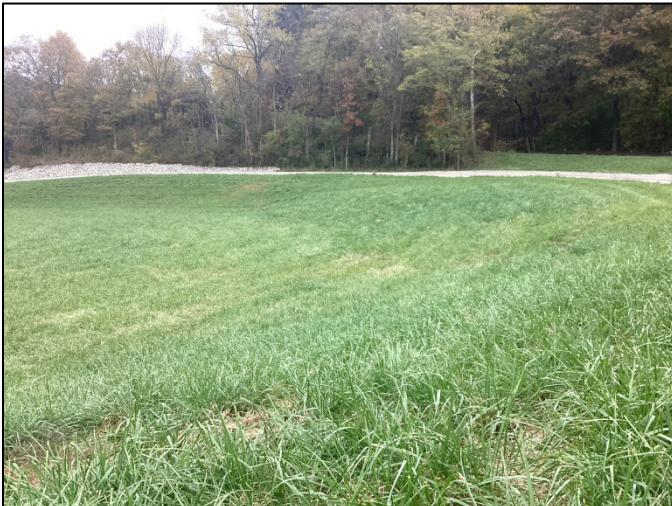
Photo 34, Point 23
LRCP Teardrop area and diversion channel.
