**2025 CCR Rule – Surface Impoundments  
Clifty Creek Dam/Dike Inspections**

Clifty Creek Generating Station  
Madison, Indiana  
Jefferson County

January 19, 2026

Stantec Consulting Services Inc.  
Cincinnati, Ohio

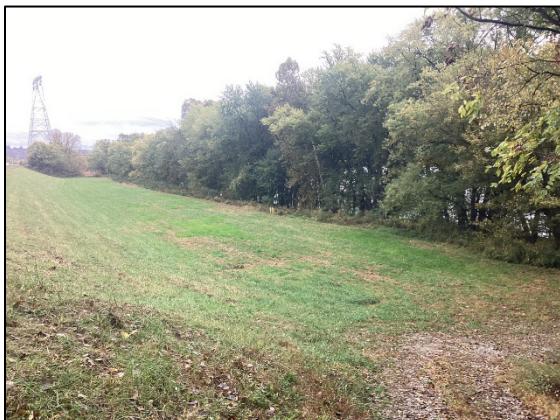
**Photo 5, Point 3**

WBSP Dam looking east from LVWTS.

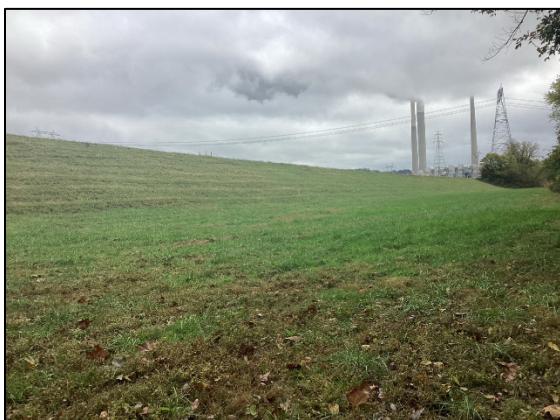
**Photo 6, Point 4**

WBSP Dam looking north.

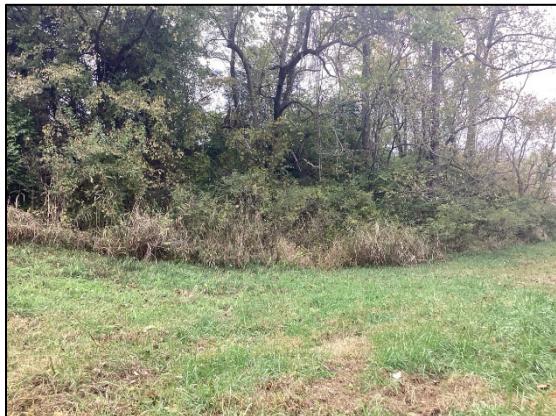
**Photo 16, Point 13**

The upstream and downstream dike slopes and crest areas, east of the LVWTS, are overgrown with small to large trees and heavy brush (Photographs 16, 17, and 18 in Appendix D). These conditions make it virtually impossible to inspect the slopes. The trees and larger brush can also provide seepage pathways as the larger foliage dies off. Trees that topple in windstorms can leave large holes exposed in the face of the dam. Stantec recommends that the overgrown crest and downstream side of the dam be stripped of foliage, graded for ease of maintenance, and seeded with grass to protect it from erosion. This will allow for future inspections to be conducted on this portion of the dam.

High vegetation overgrowth on Dam face.

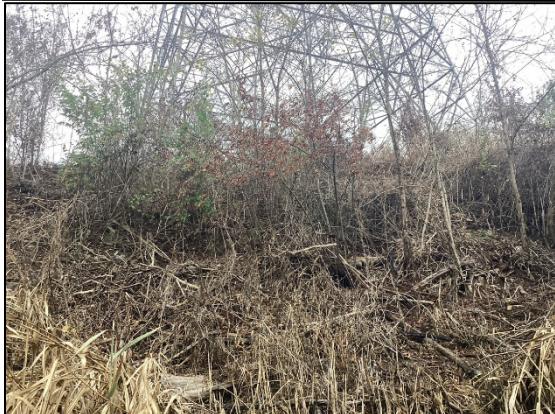
**Photo 19, Point 15**  
Scour and vegetation on electric tower slope.

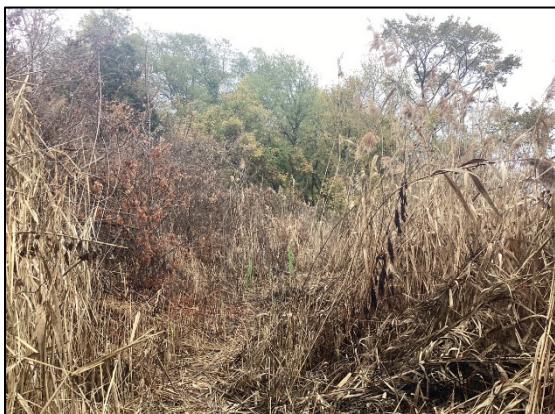
**Photo 20, Point 16**  
High overgrowth on dam face slopes.

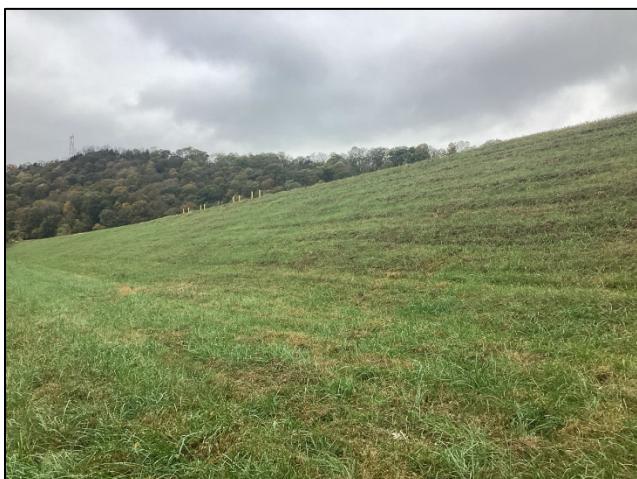
**Photo 21, Point 17**  
WBSP Dam looking west from toe.

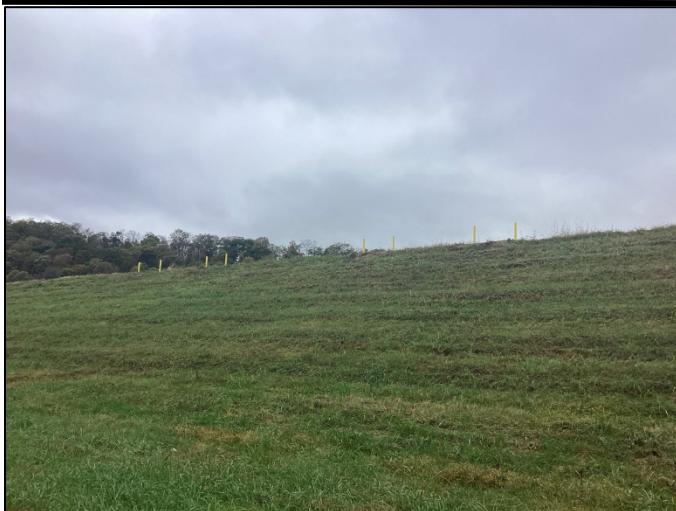
**Photo 22, Point 18**  
Roadside monitoring instruments.

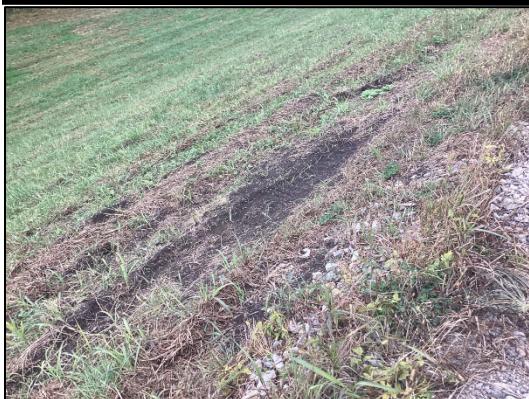
**Photo 25, Point 20**

Roadside dam slope erosion and exposed ash.

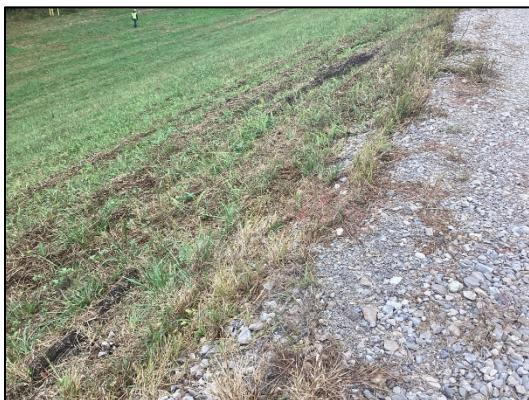
**Photo 26, Point 21**

Roadside dam slope erosion and exposed ash.

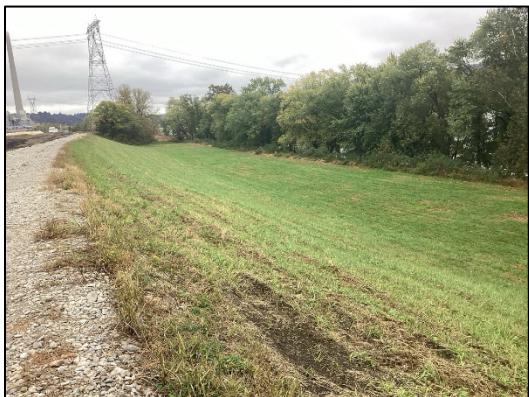
**Photo 27, Point 22**

Roadside dam slope erosion and exposed ash.

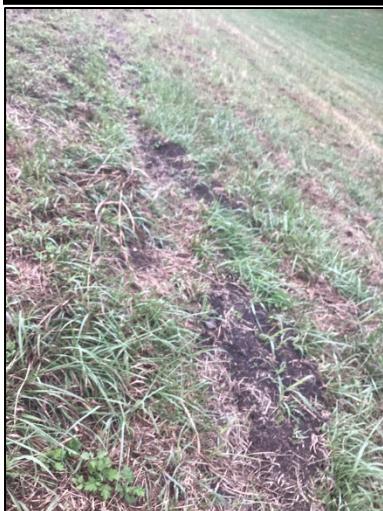
**Photo 28, Point 23**  
Bare spots with exposed ash.

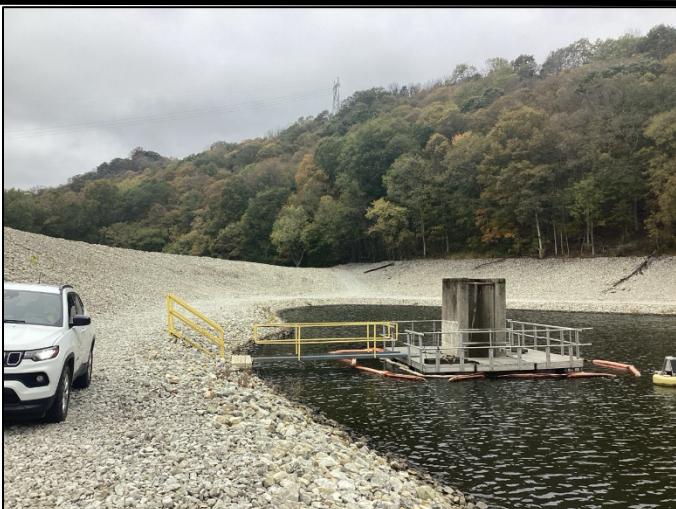
**Photo 31, Point 25**

LVWTS discharge structure and surrounding slopes.

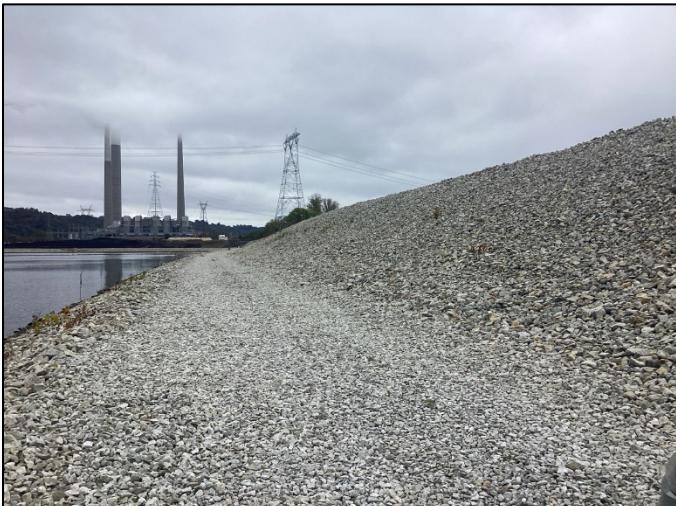
**Photo 32, Point 25**

LVWTS slopes looking northeast.

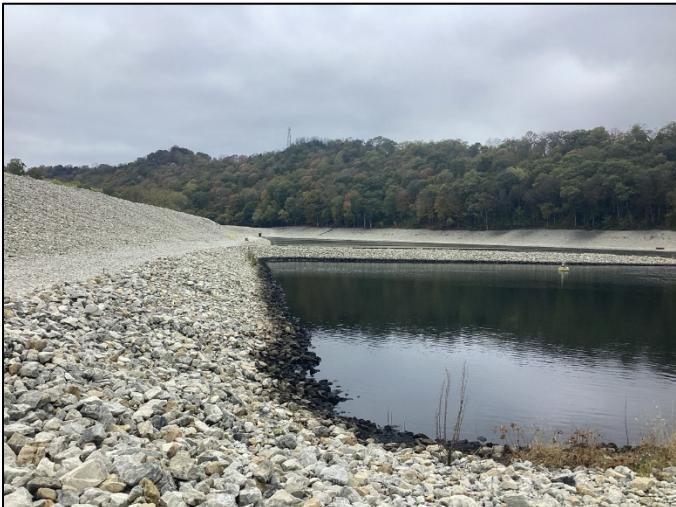
**Photo 33, Point 26**

LVWTS looking west.

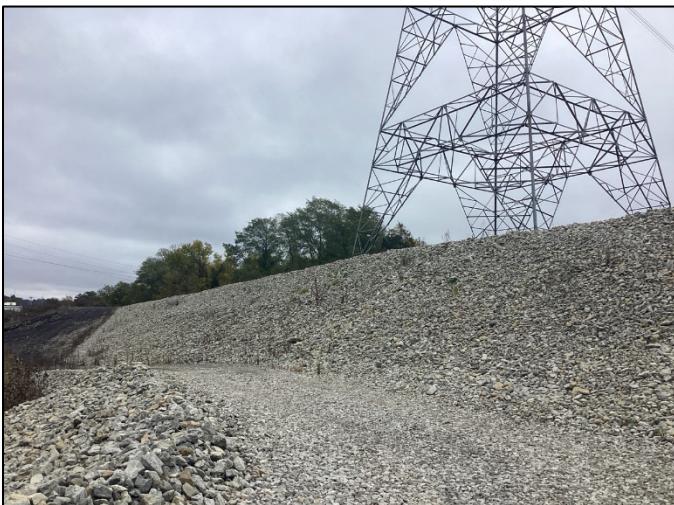
**Photo 34, Point 26**  
WBSP CCR closure excavation area  
looking north from LVWTS.

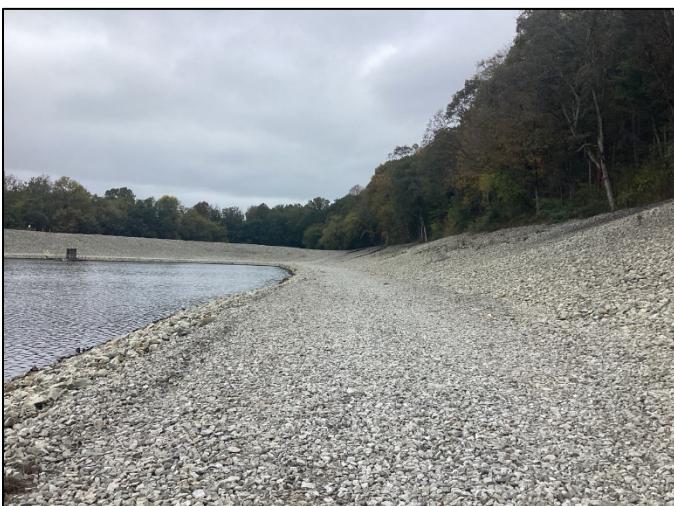
**Photo 35, Point 26**  
LVWTS Slope supporting electric tower.

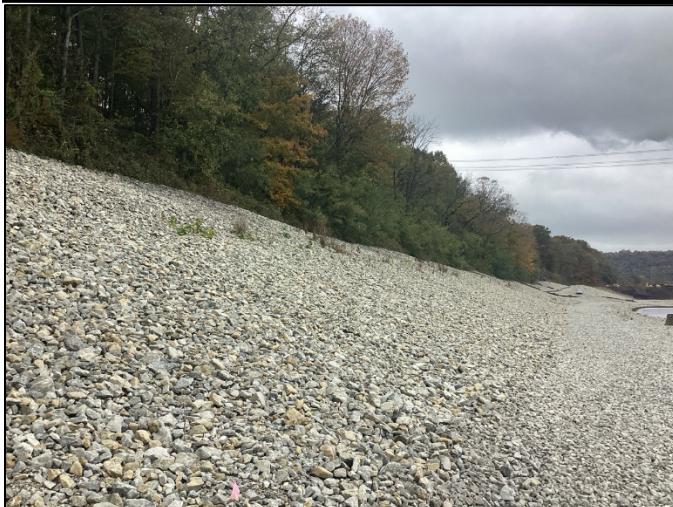
**Photo 36, Point 27**  
LVWTS slope along Devil's Backbone  
formation.

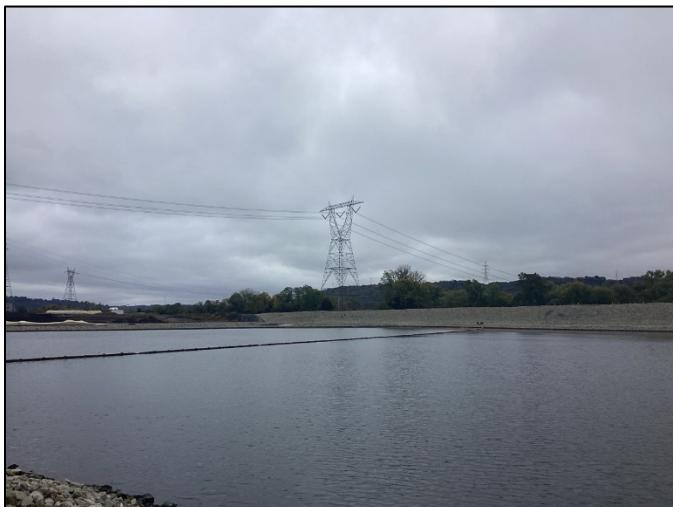
**Photo 37, Point 27**  
LVWTS slope along Devil's Backbone formation.

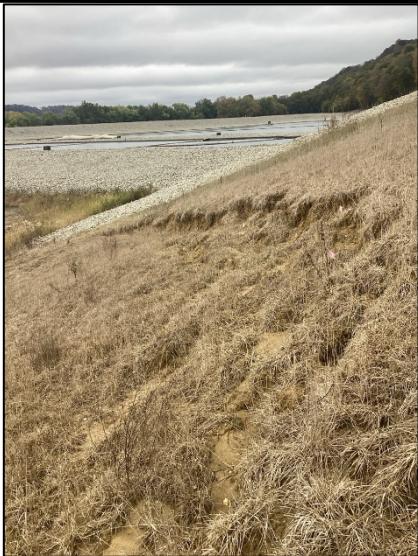
**Photo 39, Point 28**  
Erosion pin flagged on WBSP-Devil's Backbone Road slope.

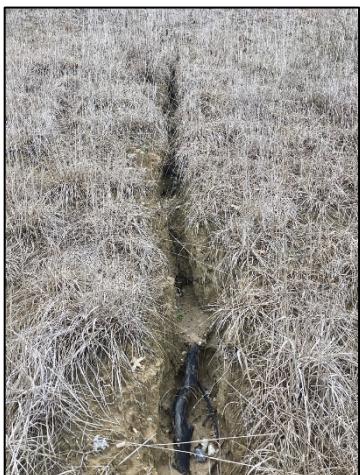
**Photo 40, Point 28**

Erosion and scouring pin flagged on WBSP-Devil's Backbone Road slope.

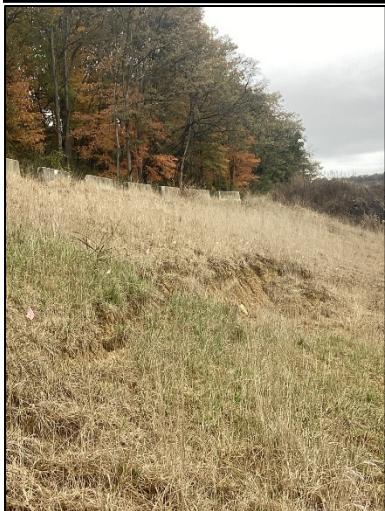
**Photo 42, Point 29**

Erosion and riprap blanket on WBSP-Devil's Backbone Road slope.

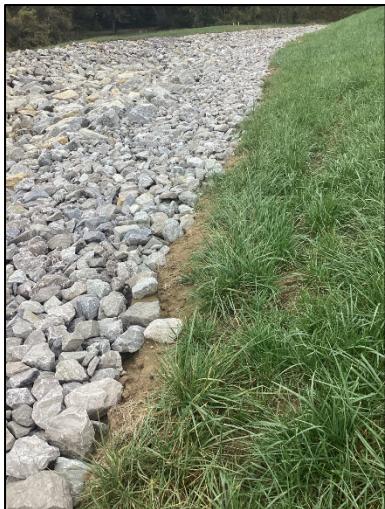
**Photo 43, Point 30**

Erosion and scouring pin flagged on  
WBSP-Devil's Backbone Road slope.

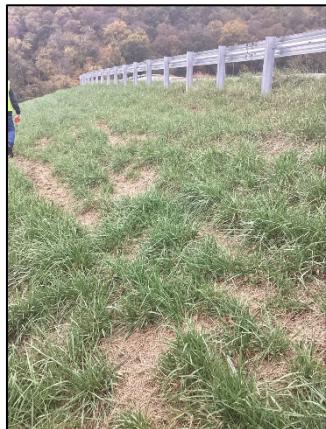
**Photo 1, Point 1**  
Erosion along channel riprap.

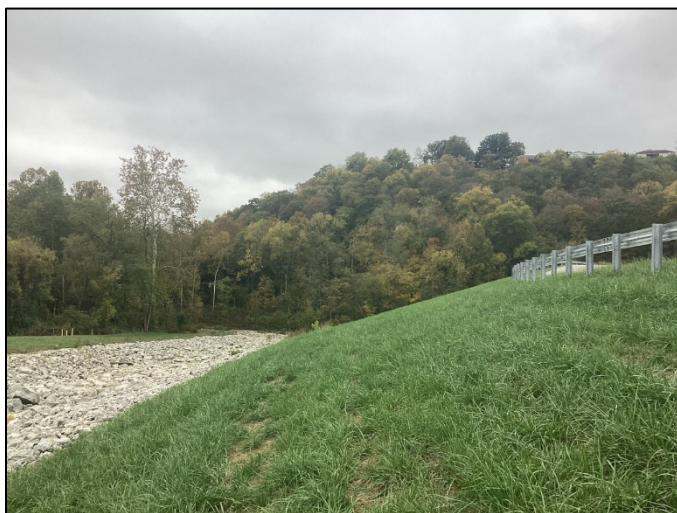
**Photo 2, Point 1**  
Bare areas.

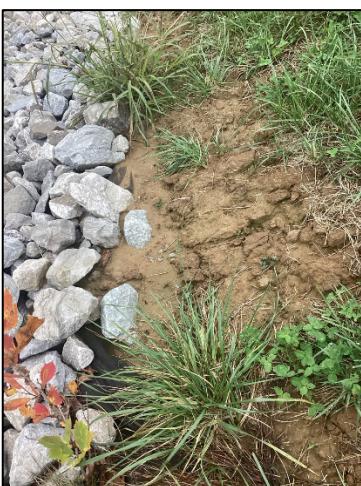
**Photo 5, Point 4**  
Exposed liner from erosion.

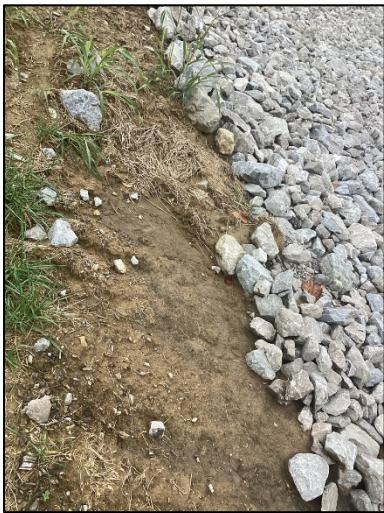
**Photo 8, Point 6**  
Animal burrowing.

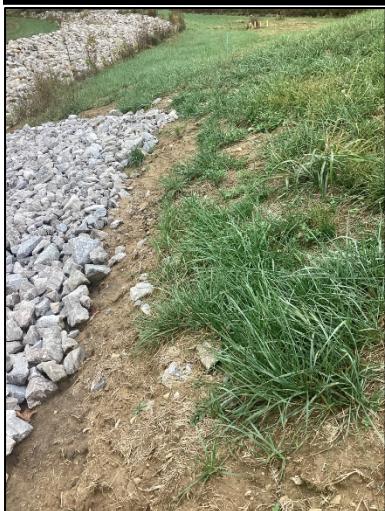
**Photo 9, Point 7**  
Riprap channel side erosion.

Some additional riprap and revegetation may be necessary along the downstream channel to fill in bare spots due to removed silt fencing (Photograph 9 and 10).

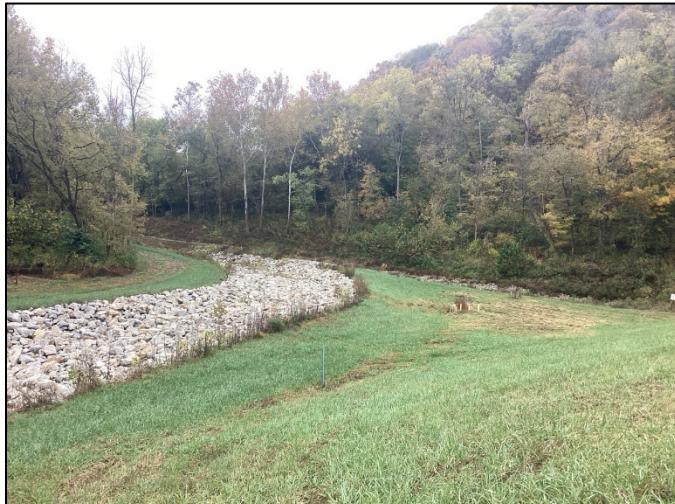
**Photo 10, Point 7**  
Riprap channel side erosion.

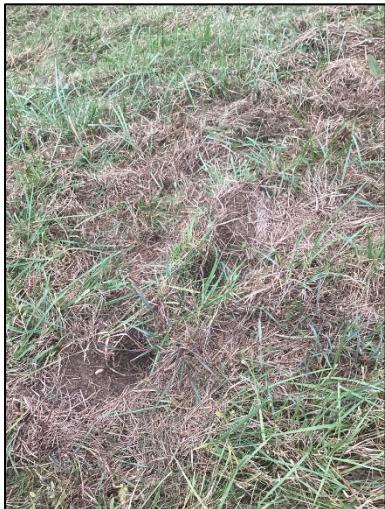
**Photo 12, Point 9**  
Soft area on dam face.

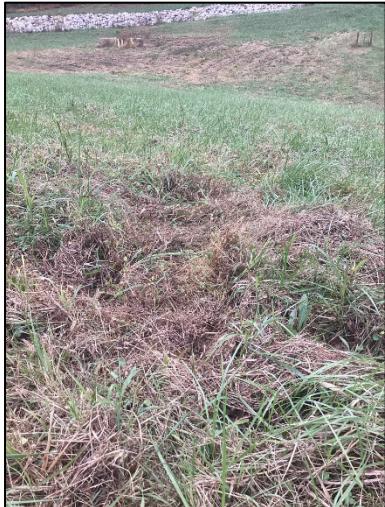
**Photo 13, Point 10**  
Animal burrowing.

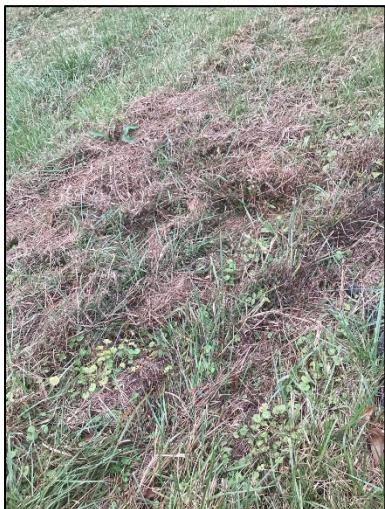
**Photo 14, Point 11**  
Dead grass and depression.

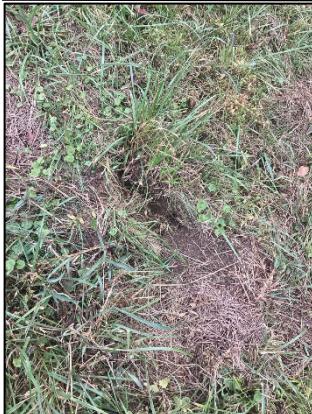
**Photo 15, Point 12**  
Dead grass and depression.

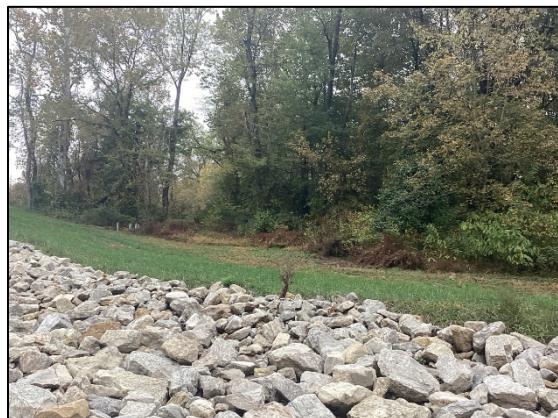
**Photo 19, Point 15**  
Bare, soft areas near monitoring well area.

Minor maintenance for the LRCP includes repairing the erosion rills above and below the downstream channel, and monitoring the surface-sloughed area beneath the access road to the toe will likely require attention as well (Photographs 19, 21, 22, 24, and 30).

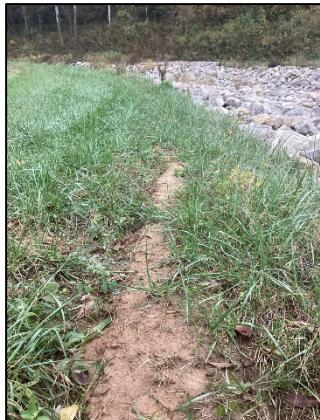
**Photo 22, Point 17**  
Channel riprap side erosion.

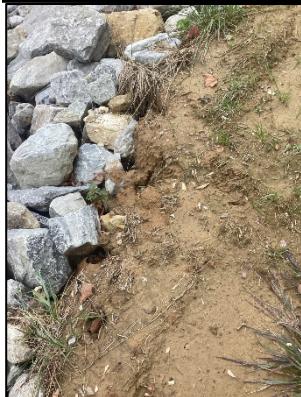
**Photo 24, Point 18**  
Bare area along diversion channel.

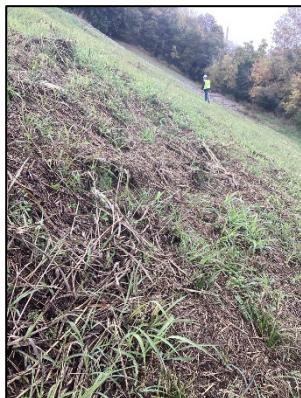
**Photo 25, Point 18**  
Riprap channel side erosion.

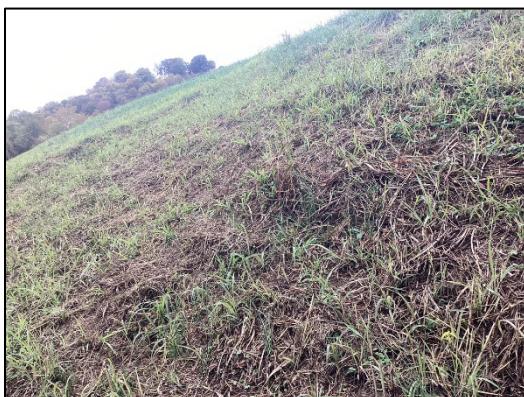
**Photo 26, Point 19**  
Dam face depression.

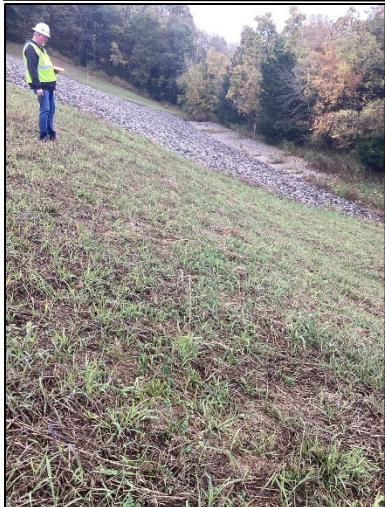
**Photo 27, Point 20**  
Bare area with dead grass.

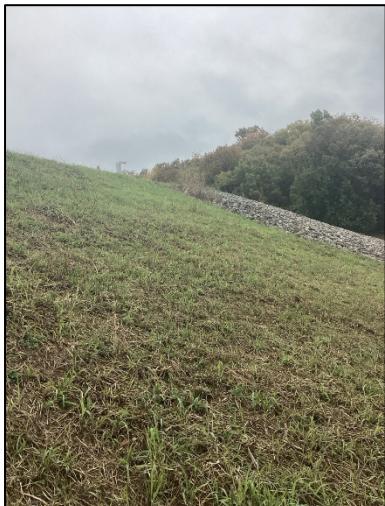
**Photo 28, Point 21**

Depression and bulging near middle of the dam face and riprap blanket.

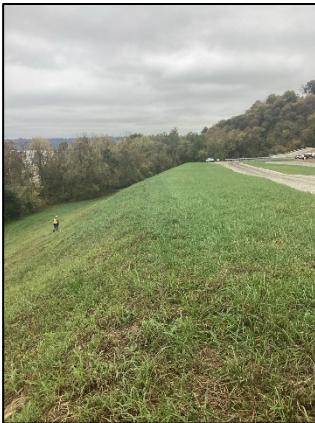
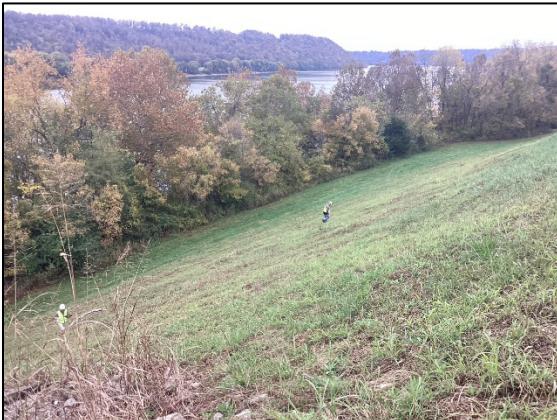
**Photo 31, Point 22**

LRCP Dam face view southwest.

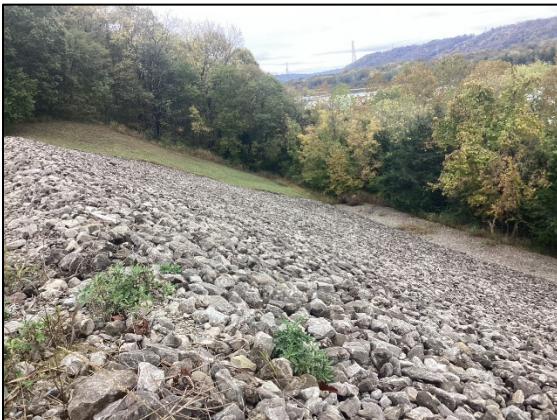
**Photo 32, Point 22**

LRCP Dam face view south.

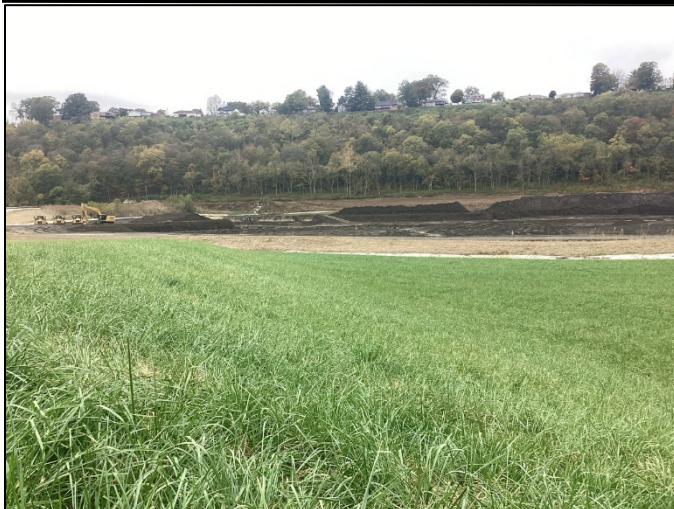
**Photo 33, Point 22**

LRCP Dam face riprap blanket view west.

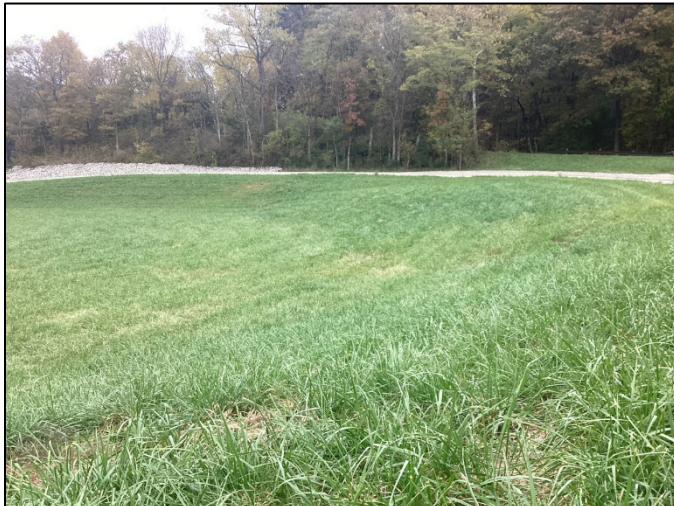
**Photo 34, Point 23**  
LRCP Teardrop area and diversion channel.
